Arboricultural Impact Assessment and Report

**Steve Moneghetti Track
Lake Wendouree Foreshore
Ballarat, VIC**

20 March 2020

C91757

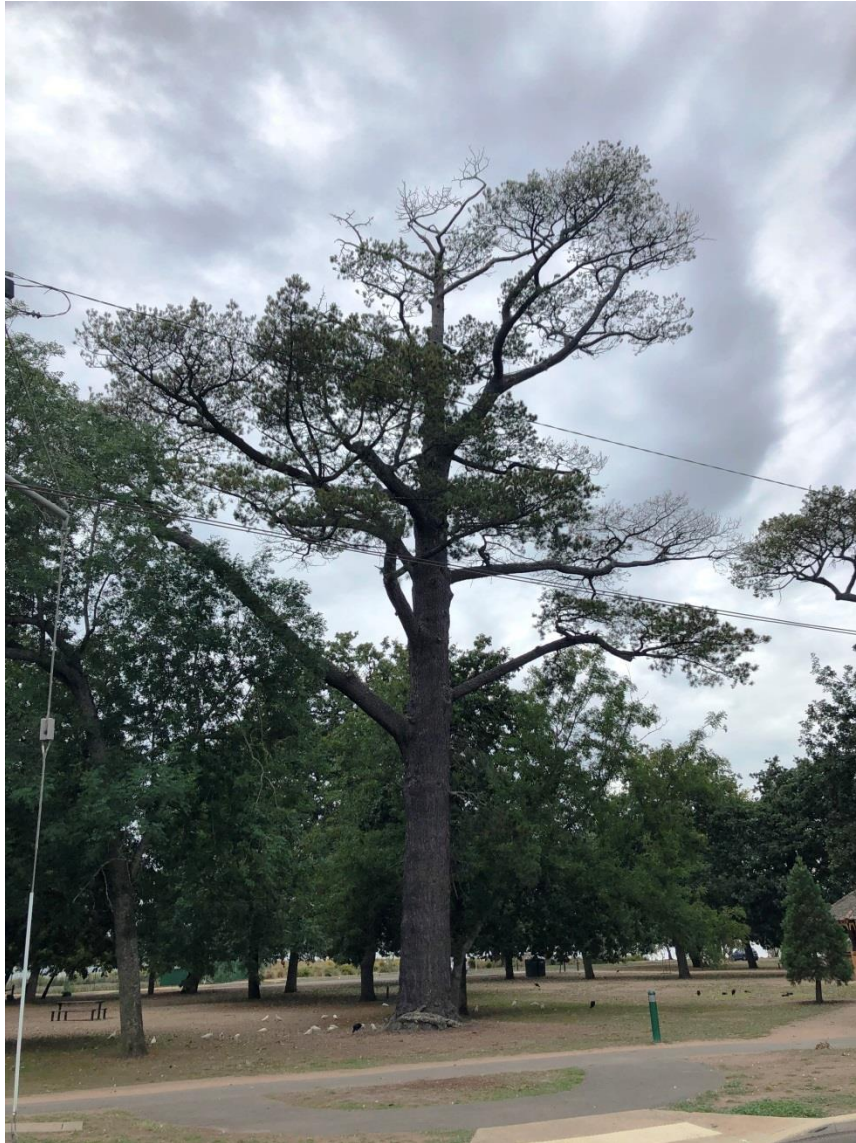
- 5.9.1 Forty four (44) specimens of *Pinus radiata* were assessed as part of this report with several of them being observed to be in the senescent stage of their life cycle (Figure 4), evidenced by an overall reduction in canopy density, the dying back of branch extremities, the accumulation of canopy deadwood and the shortening of their foliage length.

Figure 4. Example of a senescent *Pinus radiata*, Lake Wendouree. (Lachlan Andrews, 5 March, 2020).

- 5.9.2 Senescent *Pinus radiata* were therefore predicted to continue to decline, ultimately resulting in their death. This decline can at time be rapid, especially in the presence of fungal pathogens such as *Phaeolus schweinitzii* (Velvet-top Fungus) (Figure 5). Fruiting bodies of this pathogen were observed close to the base of a large tree adjacent Loreto College and is possibly more prevalent around Lake Wendouree than it appears given the level of decline observed in many *Pinus radiata*.
- 5.9.3 Despite the current absence of visible fruiting bodies, the recent, rapid decline and death of a tree to the east of the St. Patrick's Boat Sheds (not assessed for this report) may also have been linked to *Phaeolus schweinitzii*.

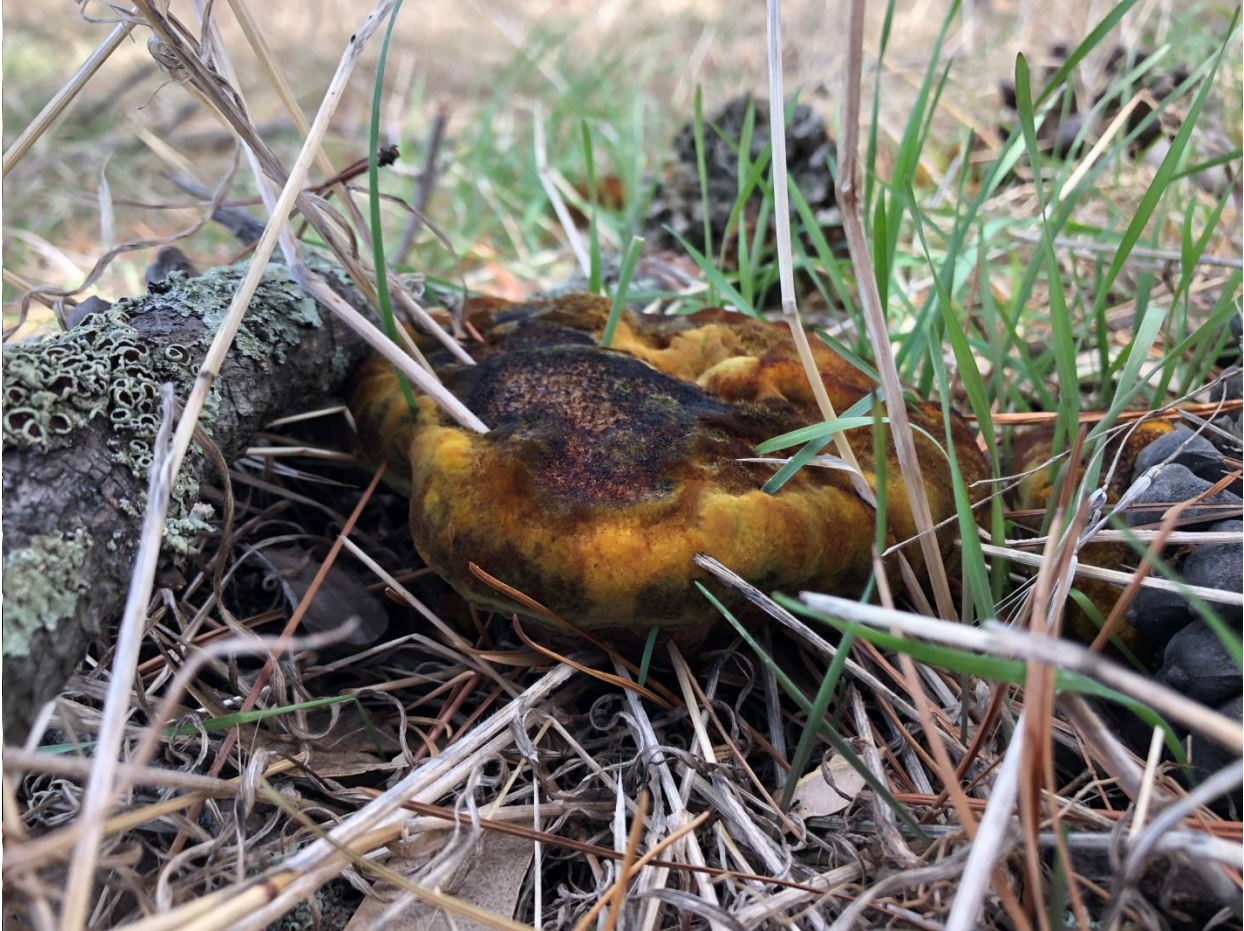
Figure 5. View of *Phaeolus schweinitzii*, Glendaruel. (Lachlan Andrews, 3 March 2020).

- 6.3.1 Typically known for attacking a range of conifers, especially *Pinus radiata* (Monterey Pine), *Phaeolus schweinitzii* is a moderately aggressive pathogenic, root-rotting fungus. As a part of its pathogenic nature it degrades cellulose, thereby resulting in a loss of tensile strength which can result in failure of the lower trunk or root crown. Early detection is therefore important.
- 6.3.2 Late summer and early autumn is generally a good time to inspect near to, and around the base of your conifers (especially if there has been some rain) as the appearance of fruiting bodies is an annual event and so for much of the year they cannot be seen.

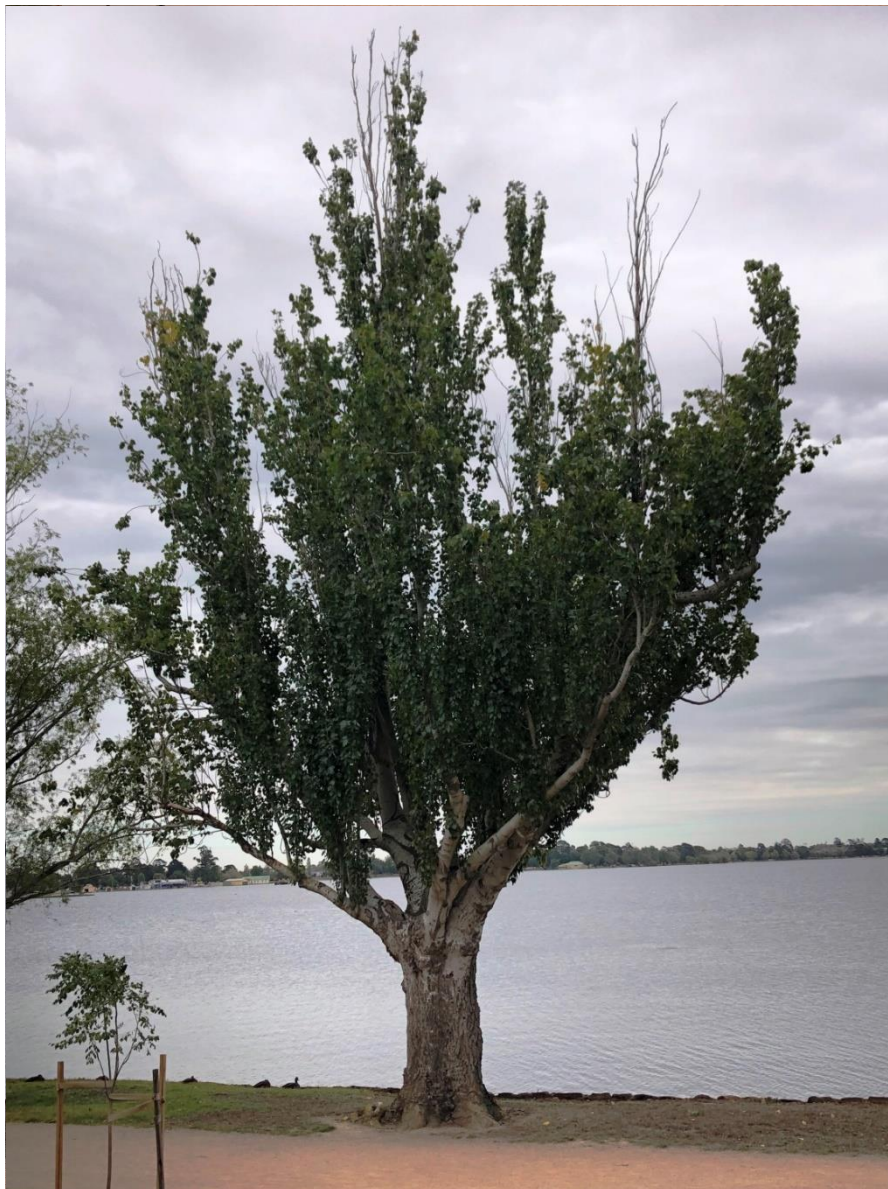
- 5.11.2 Members of the *Salicaceae*, to which *Populus* sp. belong are generally known for their moderate to poor compartmentalisation capabilities and are therefore prone to decreases in strength as a result of the onset of decay. Monitoring areas of decay resulting from root scalping, past pruning works and/or branch failure is an important management consideration for this genus due to their relative inability to control the spread of decay, thereby increasing some specimens' probability of branch or trunk failure.

Figure 6. Typical example of *Populus alba* 'Pyramidalis', Lake Wendouree. (Lachlan Andrews, 5 March, 2020).

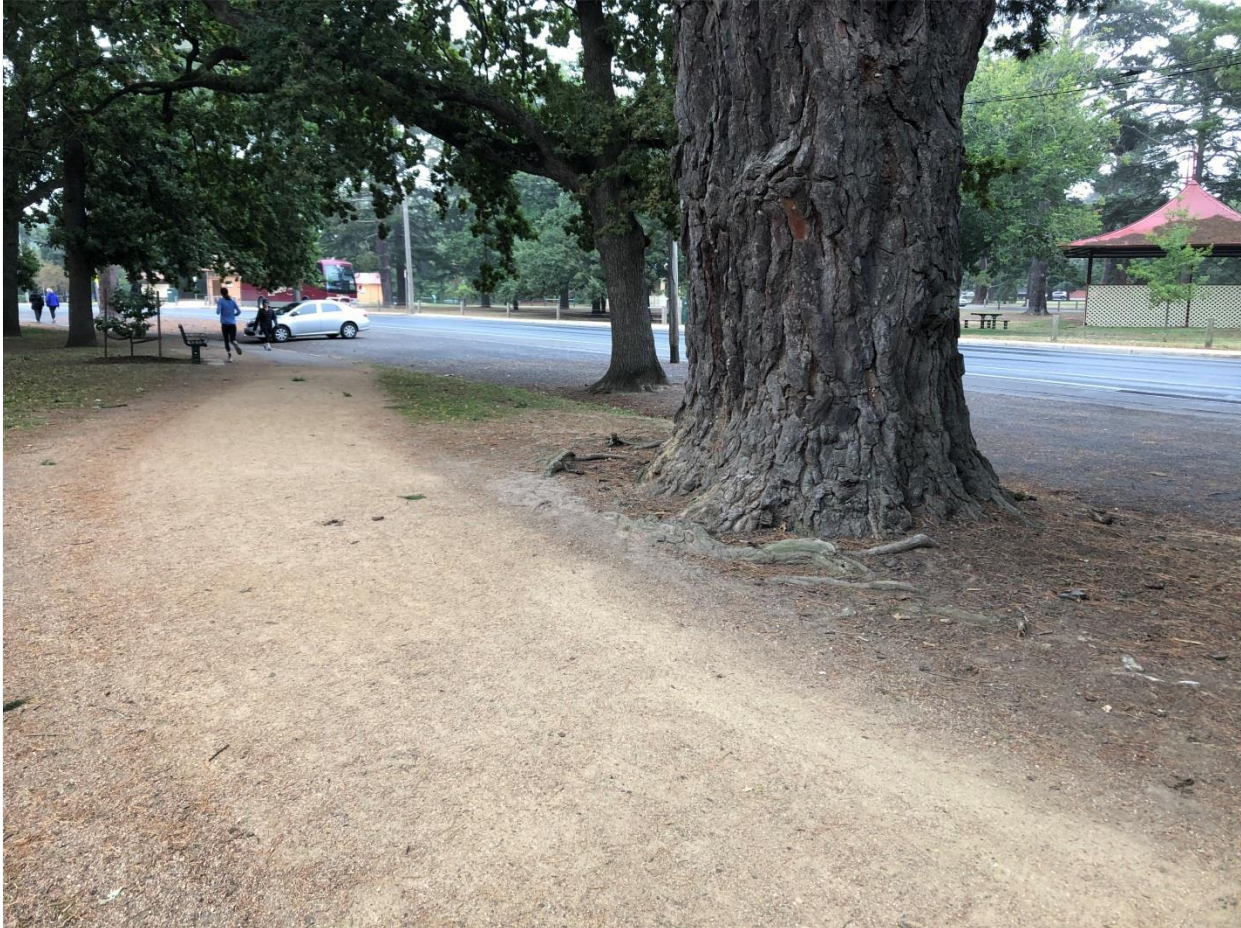
- 6.5.1 As a result of the assessment and measurements made as part of this report, and from viewing the supplied plans, all four hundred (400) subject trees have the potential to be impacted upon by the proposed works for it is these trees whose TPZ and/or SRZ (Figure 7) falls within the Steve Moneghetti Track.

Figure 7. Area where proposed works fall within an SRZ, Lake Wendouree. (Lachlan Andrews, 20 February 2020).

- 6.5.2 The proposed works are to involve the installation of electrical conduit around the entire Steve Moneghetti Track with each of the one hundred and ninety-four (194) proposed light poles connected to it. Each light pole will also require a footing, which also involves soil excavation. The probability for root damage/severance to occur during these works therefore is high and as a result must be planned and executed with this in mind.

- 7.1.3 Where possible, the route of the main electrical conduit should be located outside the TPZ and/or SRZ of the subject trees. Where placement of a light pole is required within a TPZ, design consideration should be given to using short branch lines, off the main electrical conduit line which would be situated outside the TPZ, coming in at right angles to the trunk to minimise root damage due to excessive 'cutting' across the root zone.
