HER MAJESTY'S THEATRE BALLARAT

FEASIBILITY REPORT

December 2006

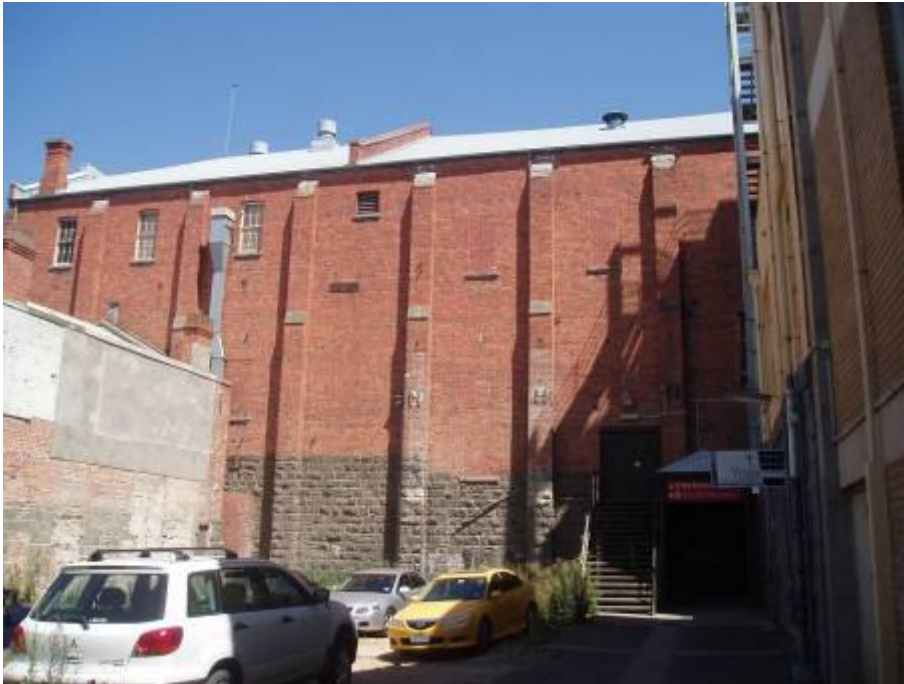
Photograph 3.

Note the ridge settlement to the east (Fly Tower) and west (Auditorium) of the Proscenium Arch brick load bearing wall at the line of the brick parapet.

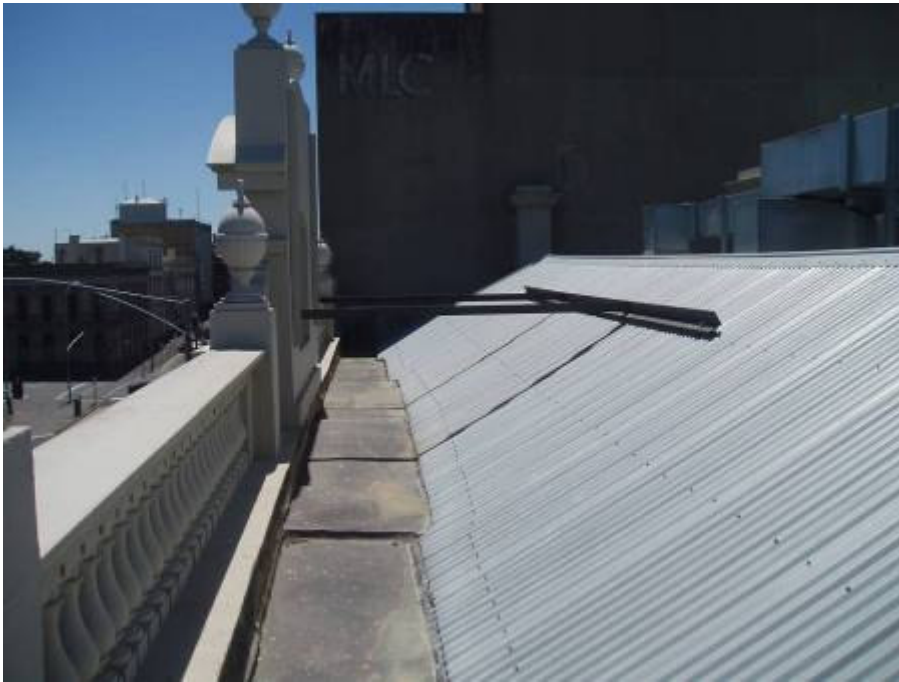
Photograph 5

Steel support frame to front (west) parapet is showing some rust staining on the roofing iron. Angle frame should be painted with galvanic primer to ensure protection to frame and cladding.

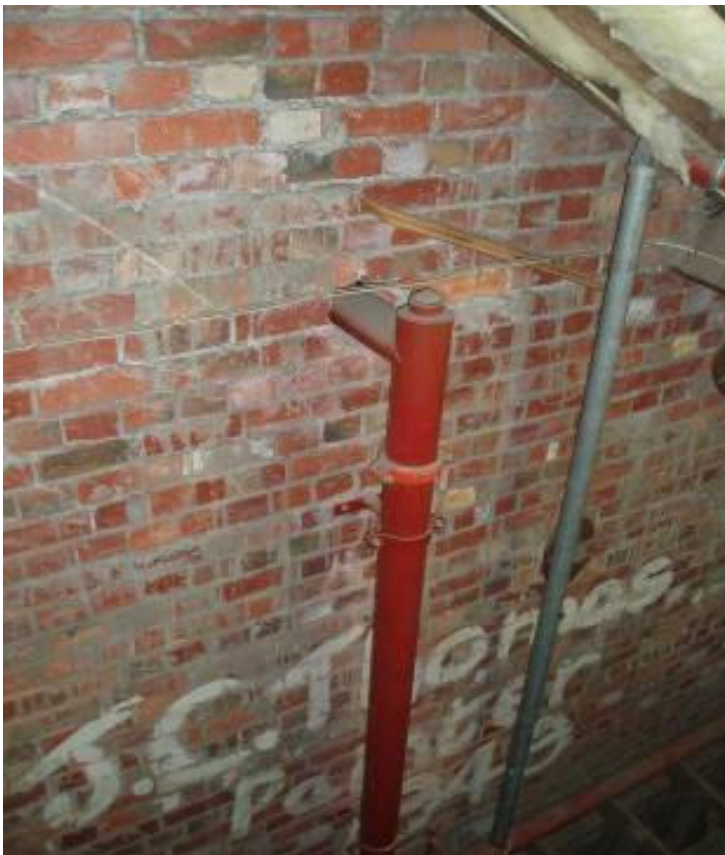
Photograph 6B.

Note auditorium side of the brick firewall to the Proscenium Arch. An expanding foam fire sealant such as 'White Frost' or similar could be employed or the surrounding void around the pipe could be mortared up with a near dry 1:1:10 Lime/cement/sand mortar mix. The former recommendation is the quickest and simplest given the difficulty of working access.

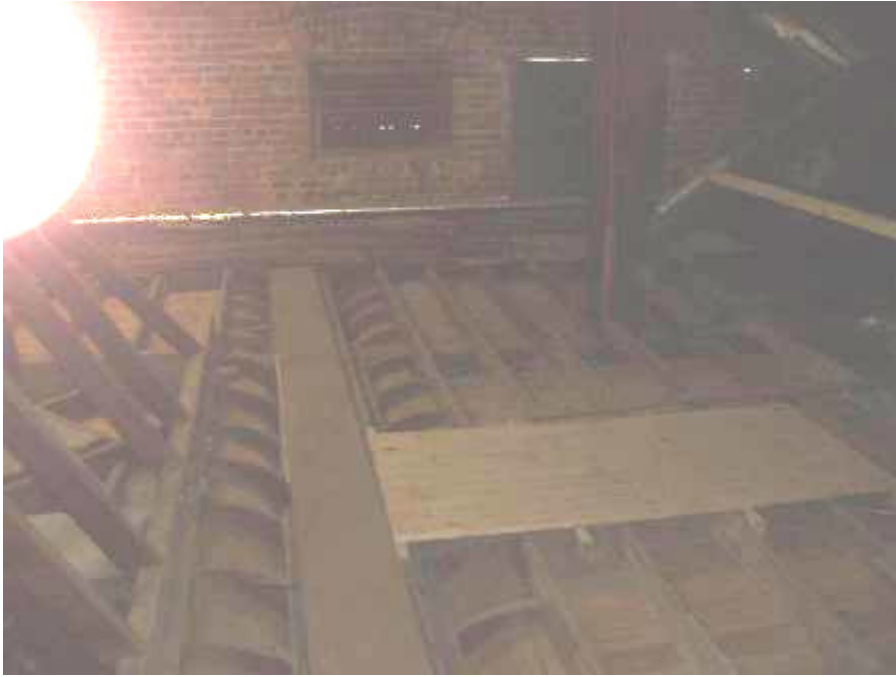
Photograph 7

Note that an access hatch through the fire wall needs to be sealed off to achieve fire protection. A stud frame with two layers of FIRECHECK plaster would achieve satisfactory separation without having to brick up the opening in a difficult access area.

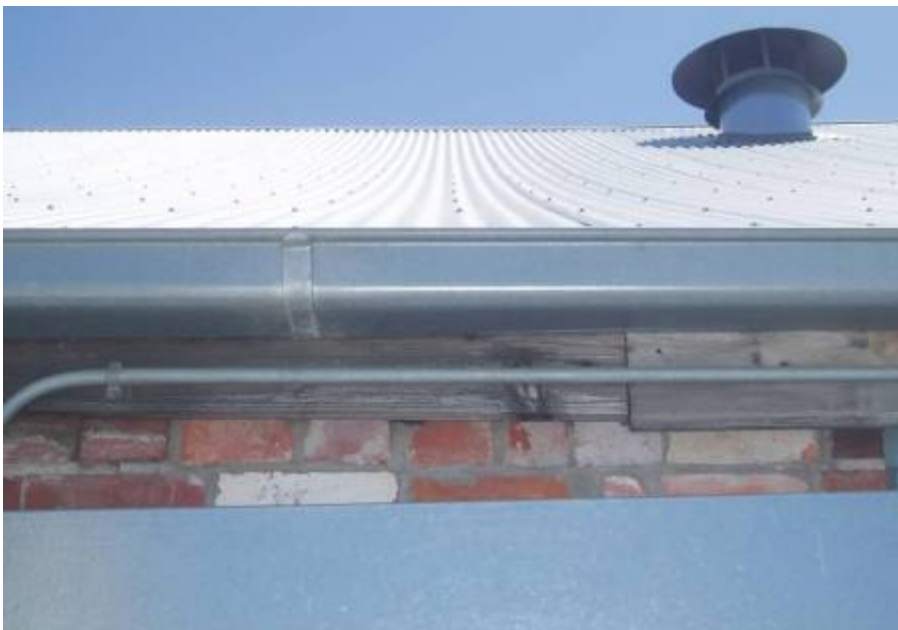
Photograph 11.

Note the flush mounted 'D' mould fascia gutter. If the gutter is blocked by debris or by a hailstone storm, the likelihood of water entry into the roof space is very high particularly as the new gutter has been attached to the old fascia boards in an inconsistent manner.

The gutter brackets have sagged in some locations and the downpipes are 'propping' up the gutter to make the drainage points at downpipes higher than the rest of the gutter.

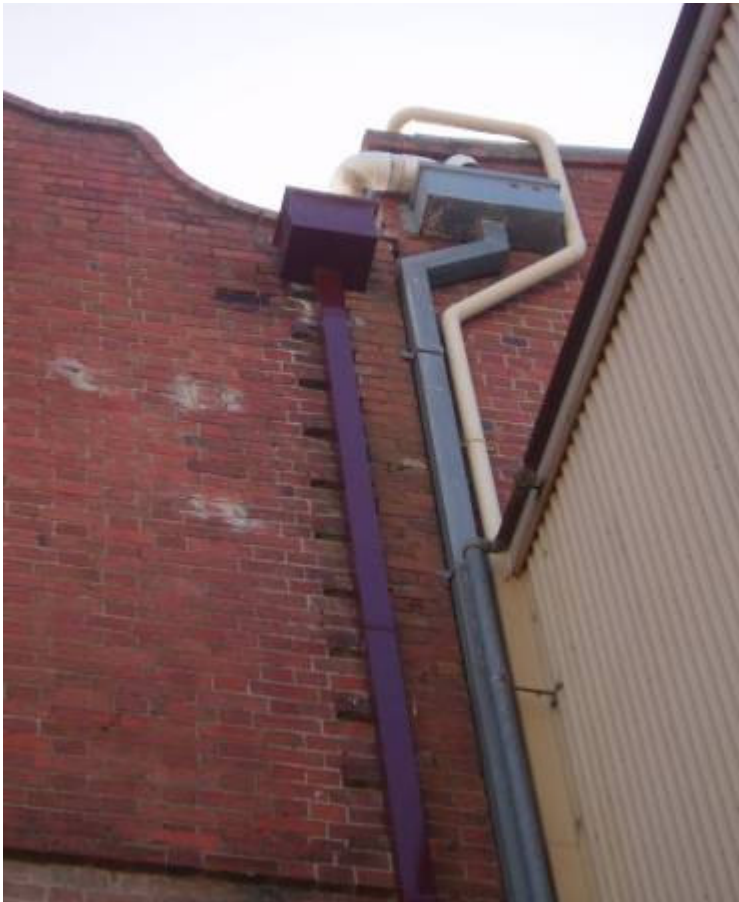
Photograph 12.

Note multiple 90° bends prone to debris blockage rather than 135° bends capable of flushing out debris. Bends should be eliminated wherever possible and have straight runs of 125 diameter downpipes for large roof areas and at least a minimum 100 diameter downpipe rather than the 75 diameter domestic scale downpipes frequently employed on the theatre.

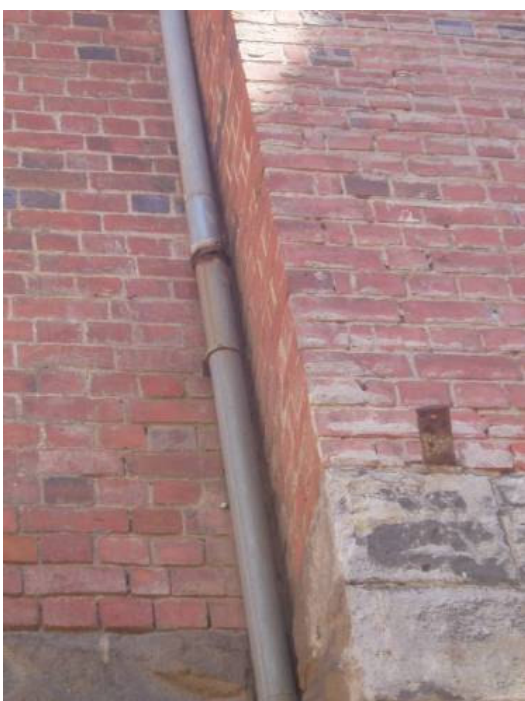
Photograph 13.

Note north wall downpipe corroded at joint and sleeved - but corroded again.

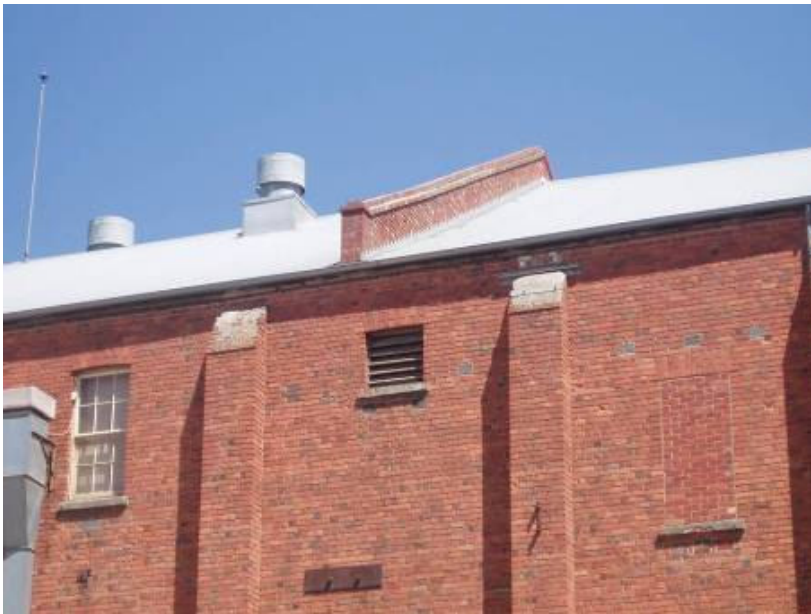
Photograph 14

Note huge area of roof runoff with only one small diameter downpipe. Larger downpipes with rain heads are required to stop overflow in heavy rain conditions.

The rendered parging to the top of the brick piers needs to be made good to prevent falling damp entering the brickwork and causing further damage.

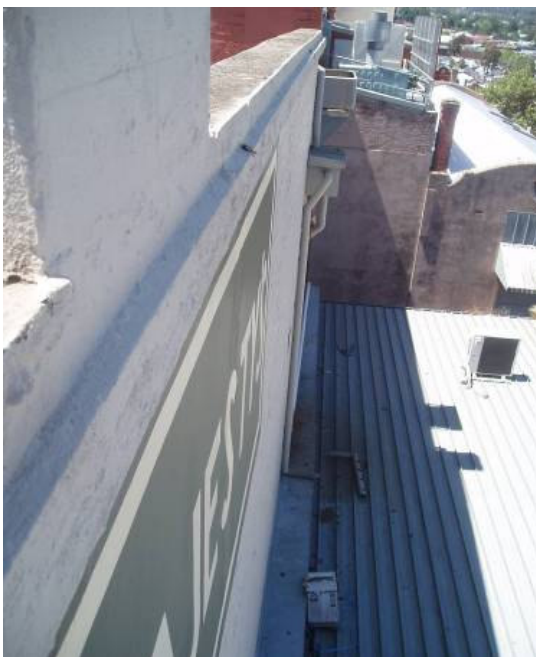
Photograph 15

Note the rain heads and downpipes overhang the southern neighbour's property which is not legal nor desirable. The rain spreader is broken and laying on the neighbour's roof.

This water should be discharged to a legal point of discharge rather than issuing onto the neighbours roof.

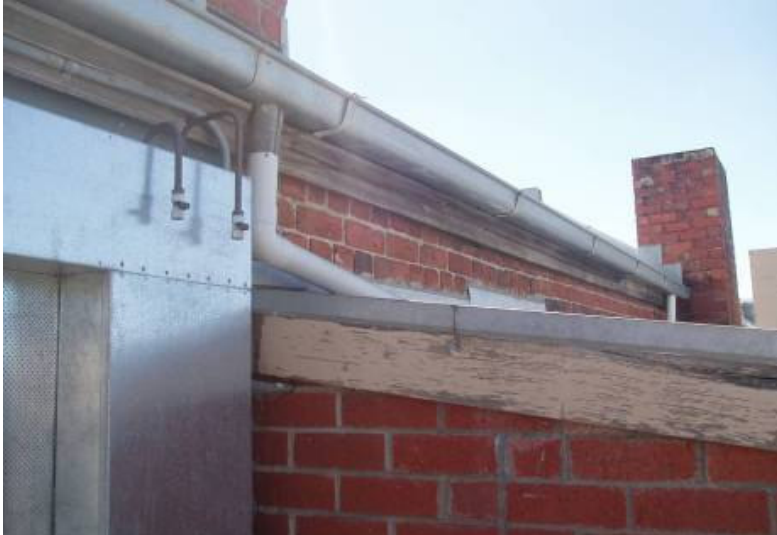
Photograph 16

Note sagging of roof gutter at eastern end of this section of the southern roof gutter.

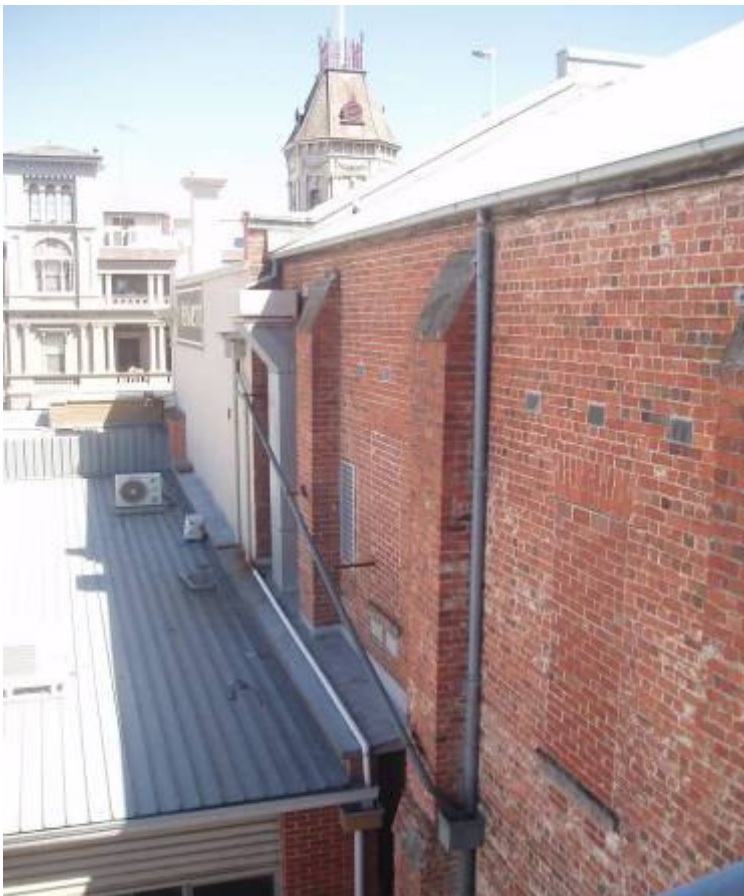
Photograph 17

Note PVC downpipe discharges into neighbours rain head and gutter and metal downpipe appears to be the high point of the roof gutter.

Roof gutter falls should be checked.

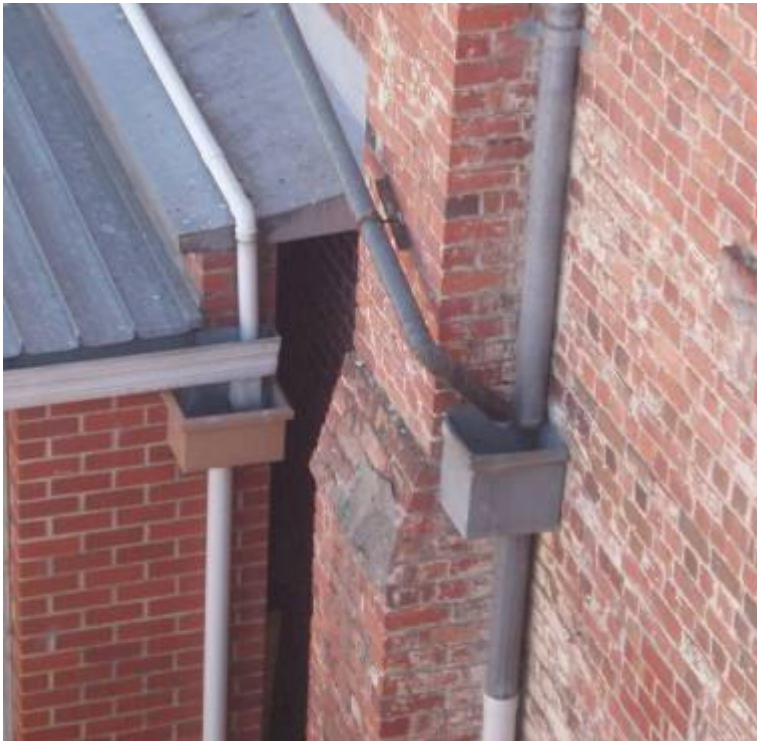
Photograph 18

Render parging missing from raked top of brick pier should be made good to prevent falling damp entry to brickwork.

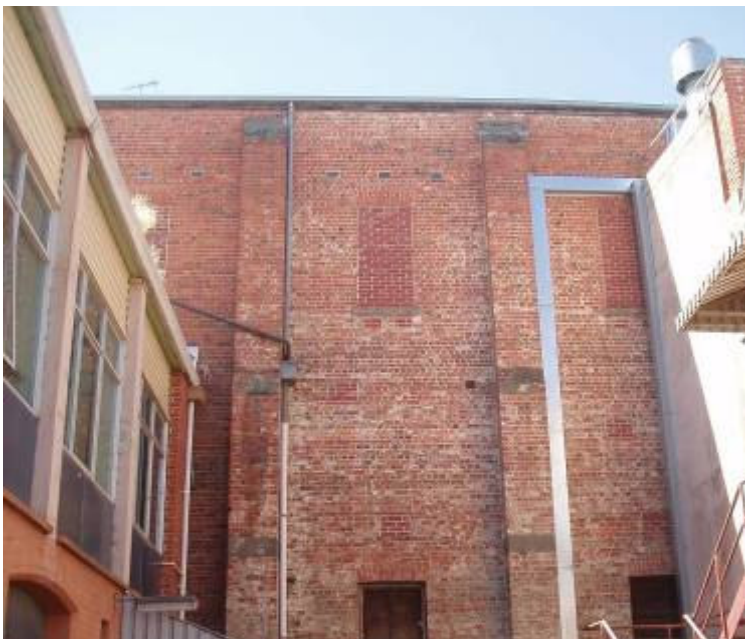
Photograph 19

Note one small diameter single downpipe serving a huge roof area of the auditorium and direct entry of downpipe into roof gutter without a rain head.

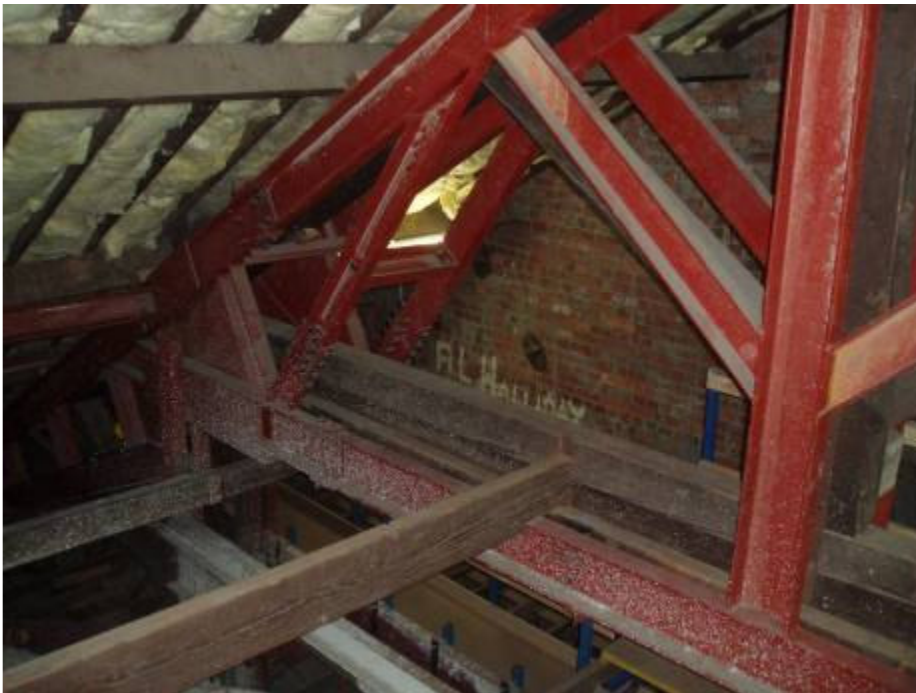
Photograph 21

Note steel truss supports under purlins and ceiling hanging beams as well as oregon trusses.

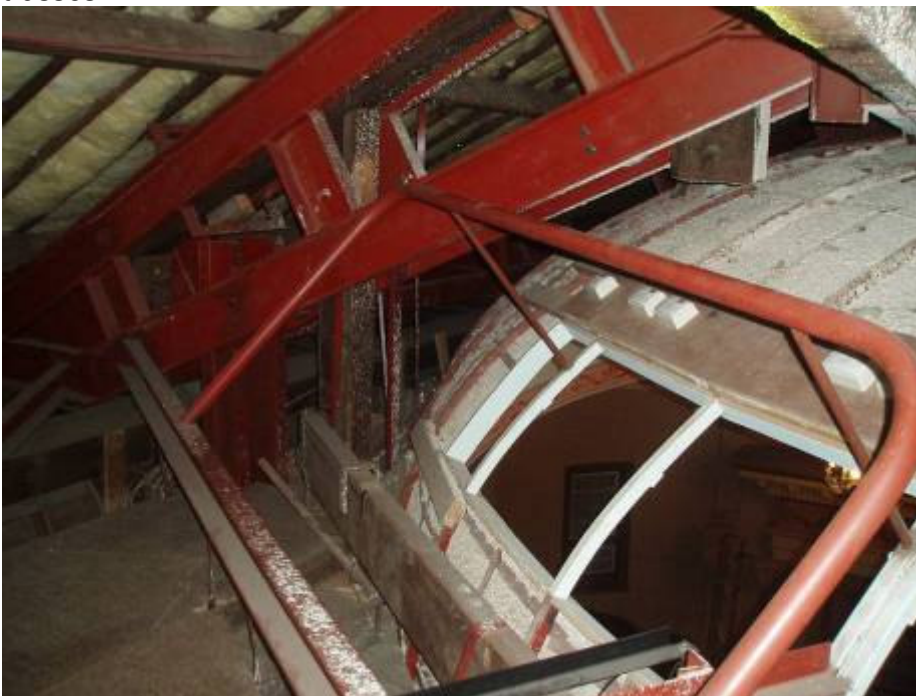
Photograph 22

Note dome is supported off new steel trusses and steel pipe handrails provide safety for access.

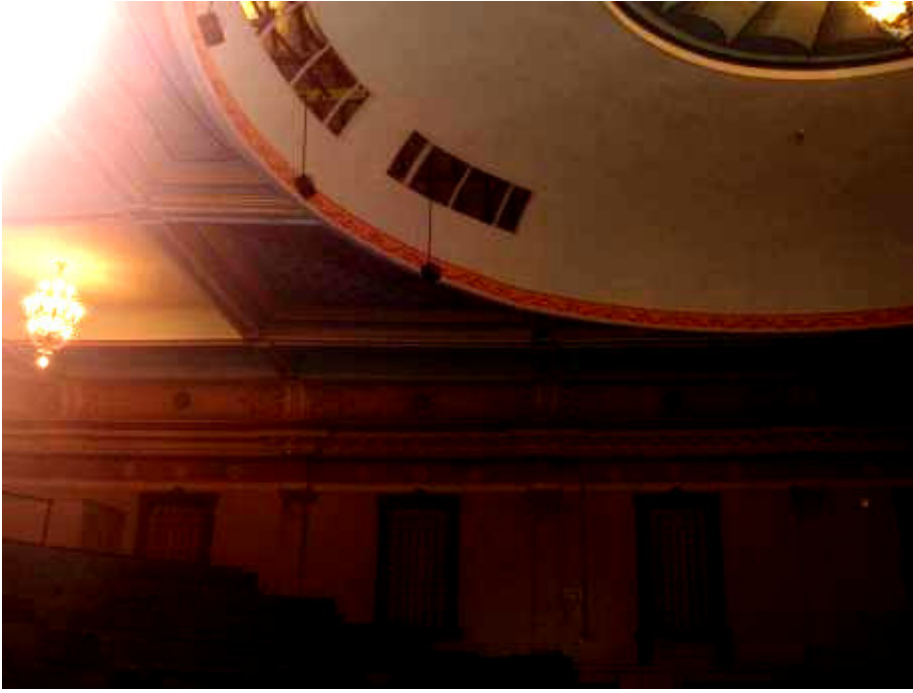
Photograph 23

Note coffered ceiling to west of dome clearly has sagged and settled over time but no evidence of current or ongoing deflection was apparent.

The dome is now stable and no new settlement is occurring.

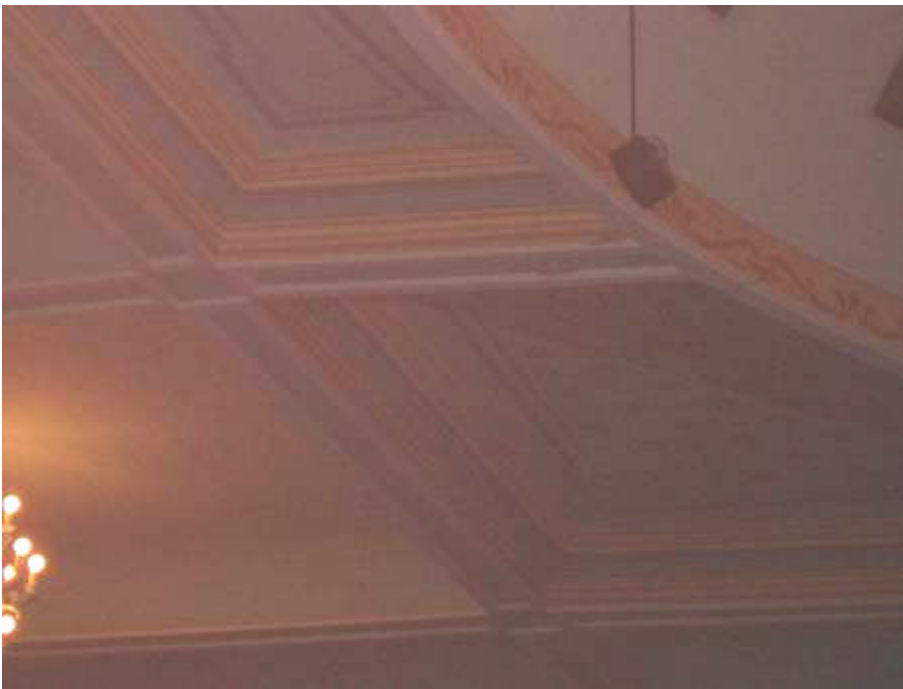
Photograph 24

Note settlement of dome relative to truss clearly evident but movement of steel trusses and no current deflection has occurred.

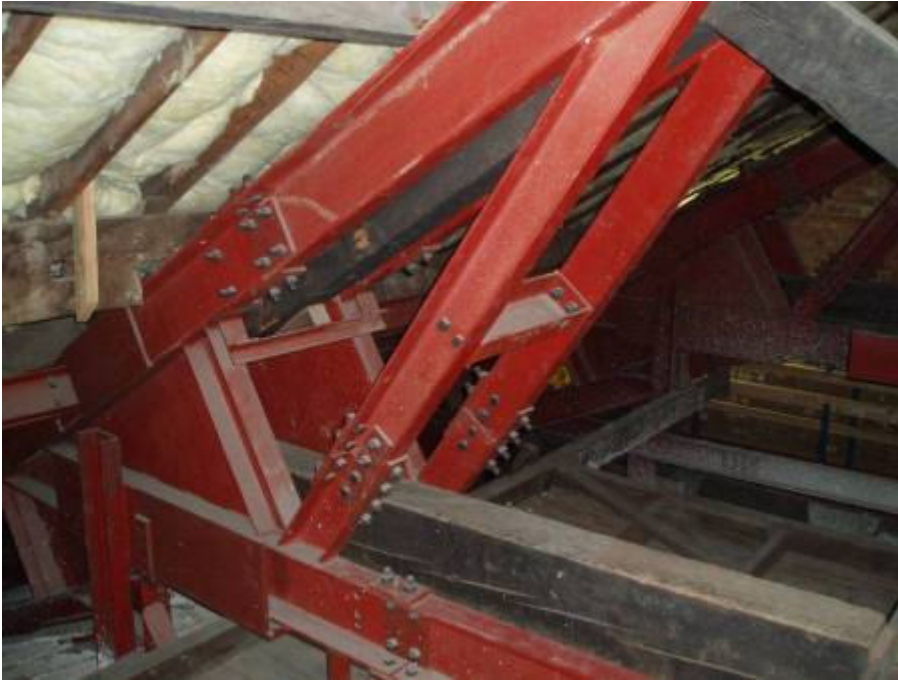
Photograph 25

Note bottom chord splitting of Oregon truss. Steel trusses are now providing support to all timber members.

Close inspection of the end supports of the new truncated steel scissor trusses on the external masonry walls indicates that no evidence exists of outward spread of the trusses where they sit on TEFLON sliding supports. The steel trusses are rigidly fixed with steel angle brackets fixed to the top of the brick 450 thick walls with 'chemset' anchors in such a way that if any settlement or spread of the trusses occurred then very visible distortion or shattering of the brickwork would be readily observable. This is not the case.

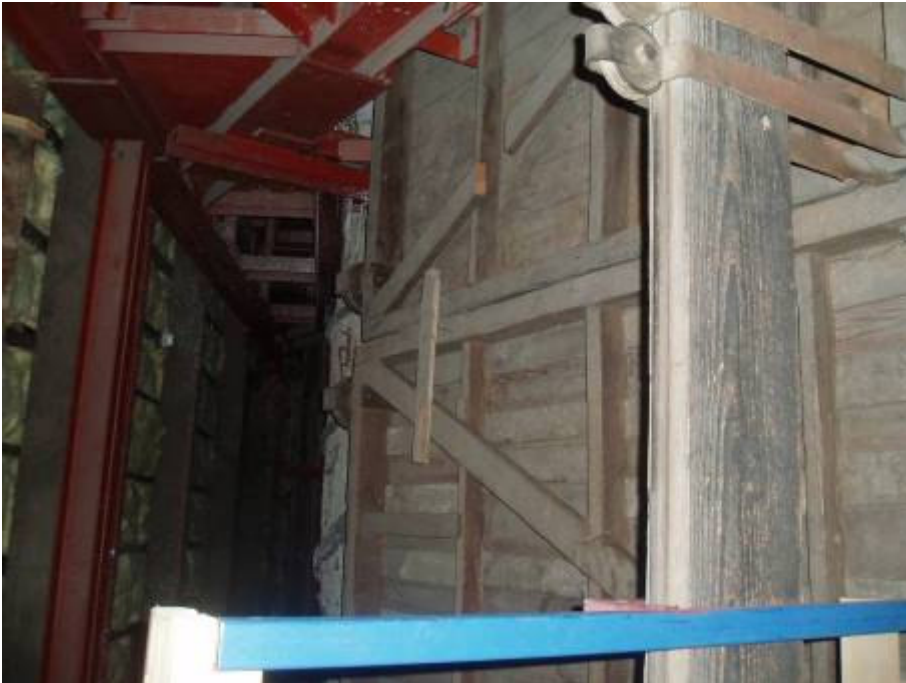
Photograph 26

Note timber panels to open up top of dome for ventilation run on metal rollers with hanger straps which run on steel rods on top of Oregon beams in foreground.

These are now fixed in position and supported off steel trusses.

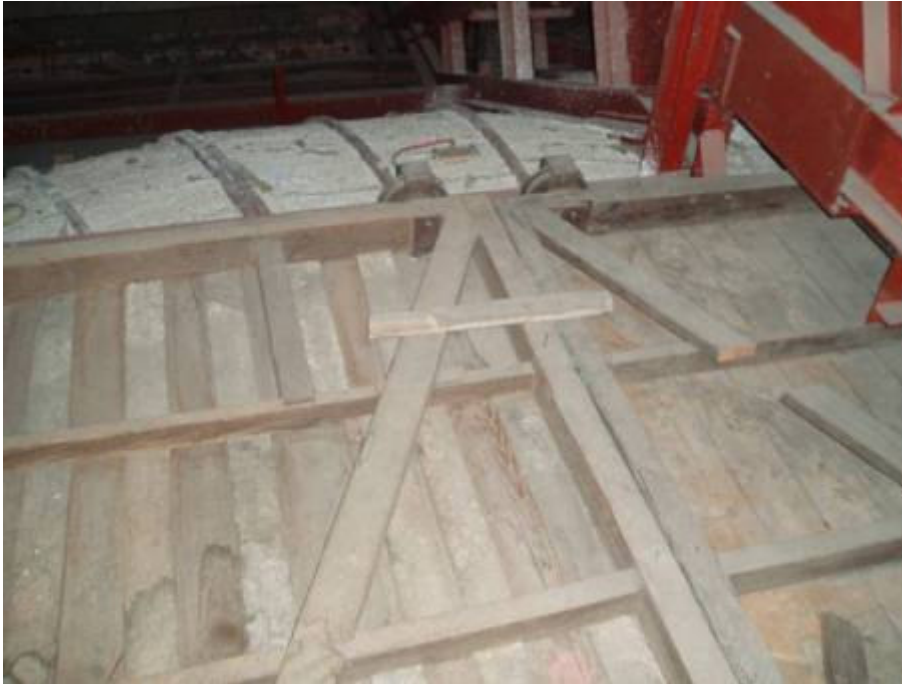
Photograph 27

Note timber panels on top of dome are now nailed together and are supported off steel hangers to truss.

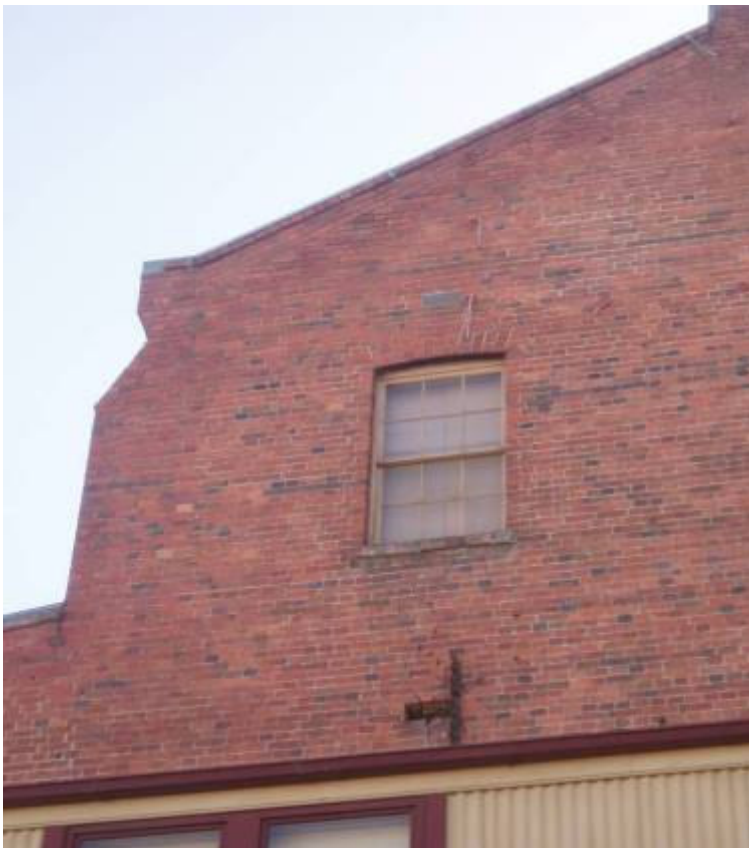
Photograph 29

Note that old former electrical services connections should be made good and re-bricked to stop water entry.

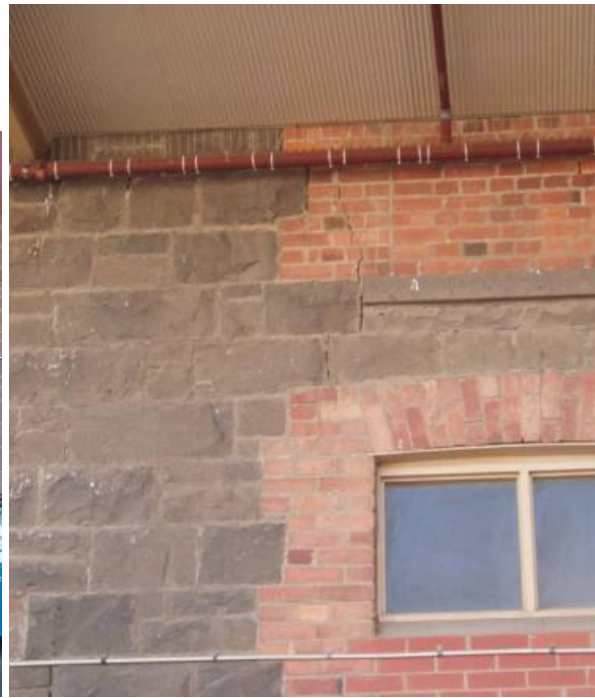
Photograph 30B

Note very old cracking due to differential movement of stone and brick (not of structural significance).

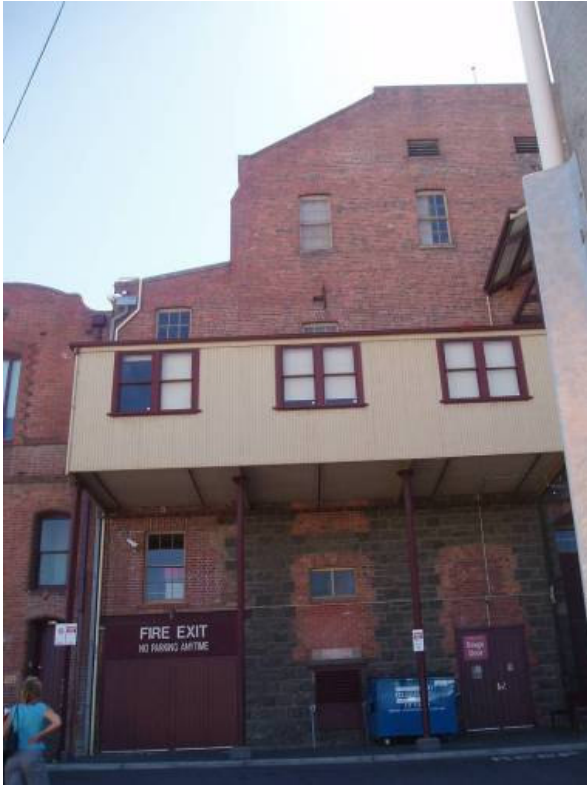
Photograph 31

Note rear (east) elevation has undergone various changes with time.

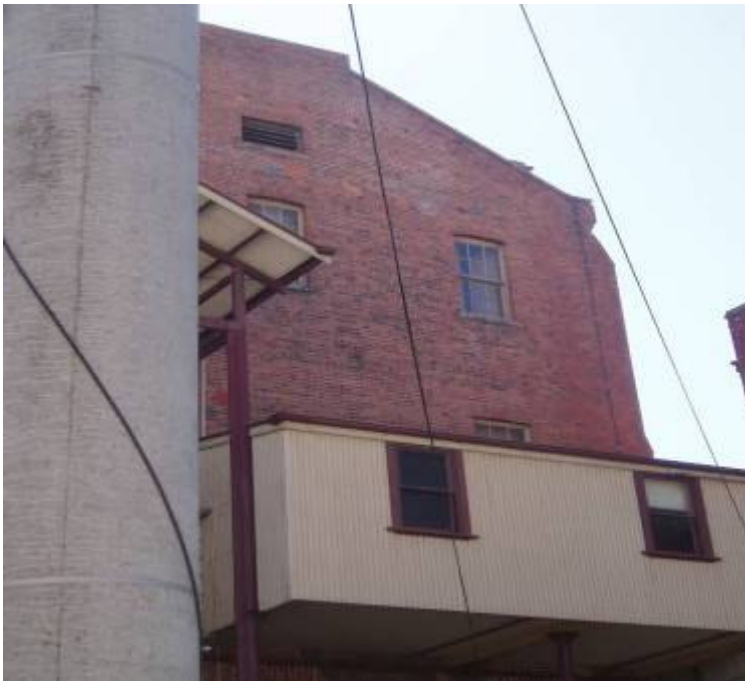
Photograph 32B

Note vertical brick growth crack to northeast corner of fly tower very visible to painted face of brickwork internally and less noticeable to unpainted face brick externally. Crack can be re-pointed if desired and would prevent further water entry into brick wall.

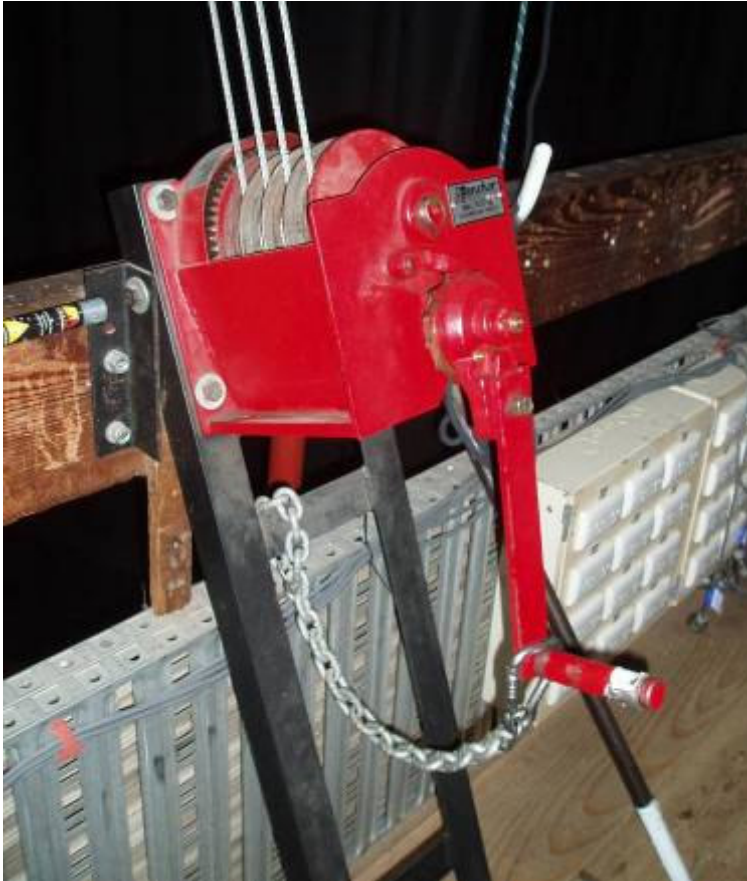
Photograph 35

Hand operated winch, fly tower gallery with ratchet lock and steel angle frame.

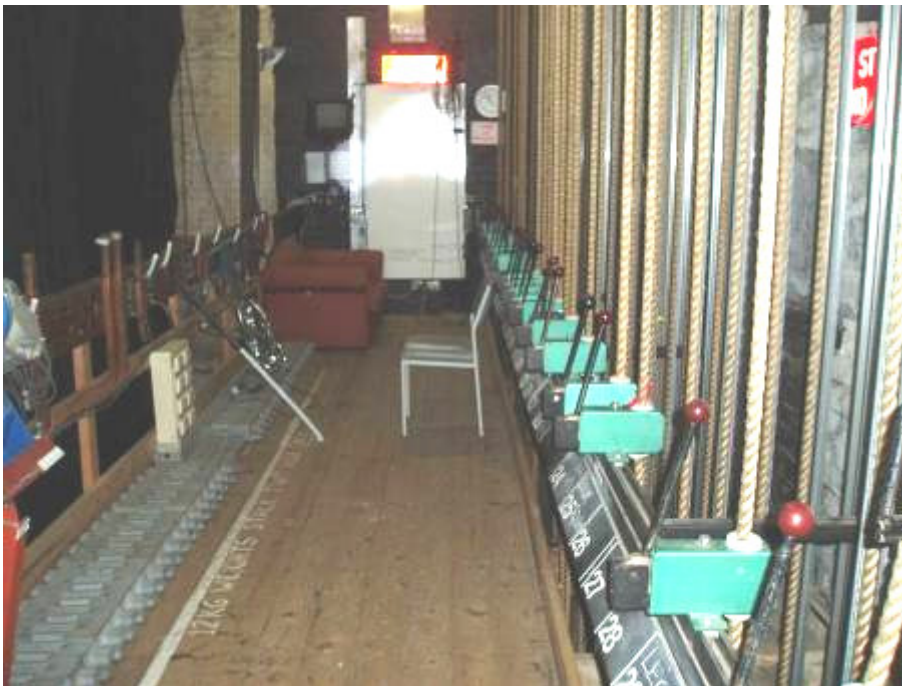
Photograph 42

Northern fly gallery showing counterweights stacked and spread appropriately to avoid overloading of floor and fly locks along north wall.

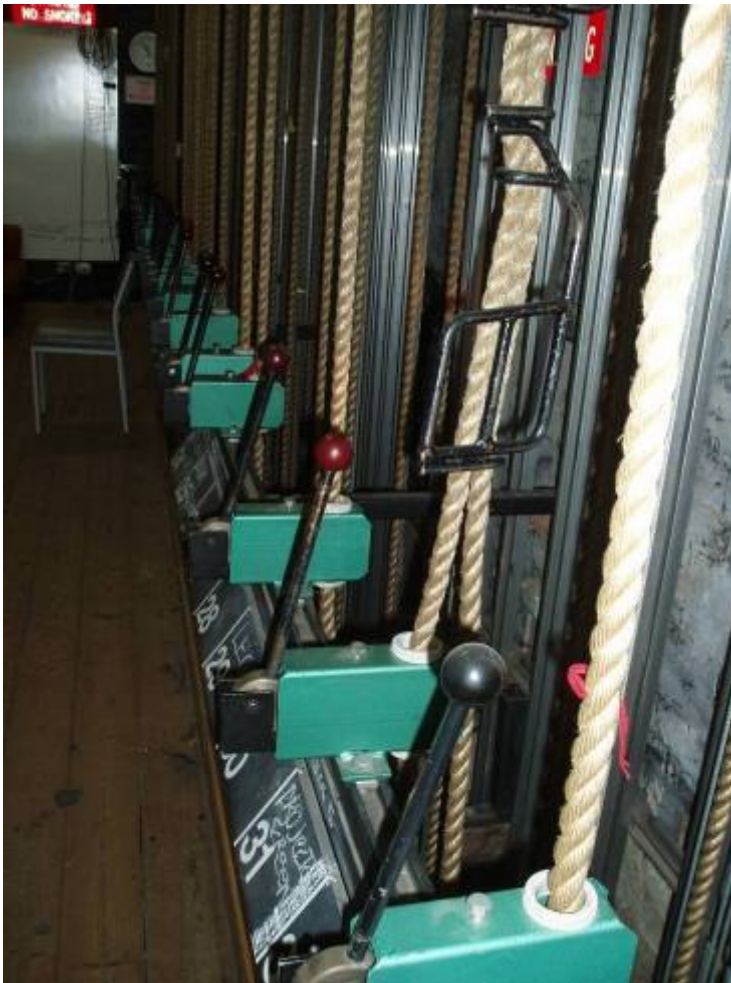
Photograph 43

Northern fly gallery, fly locks, all in very good order.

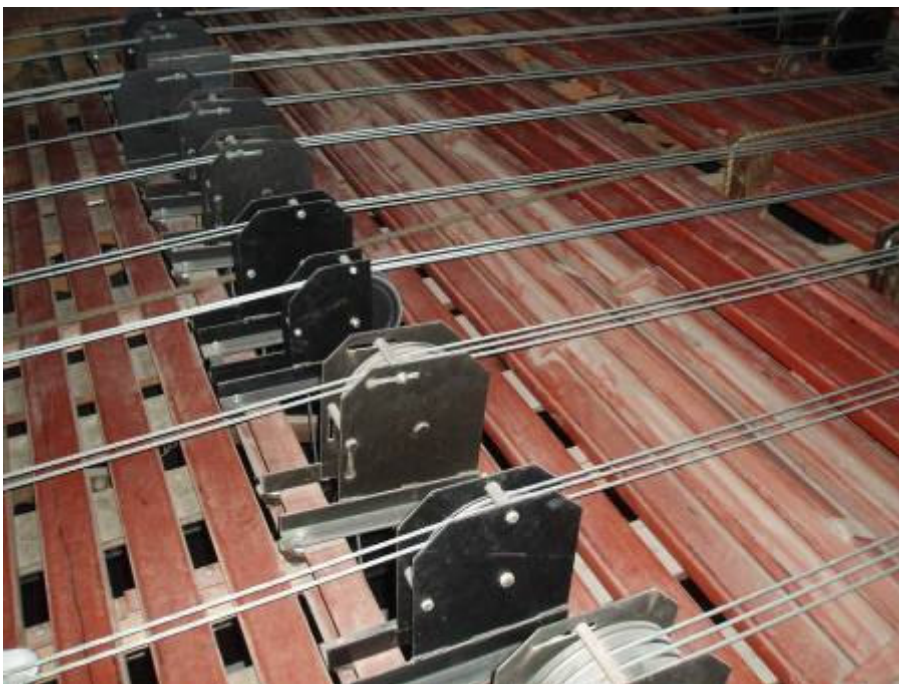
Photograph 44

Steel RHS slats on flat to the fly gallery provide a very good system.

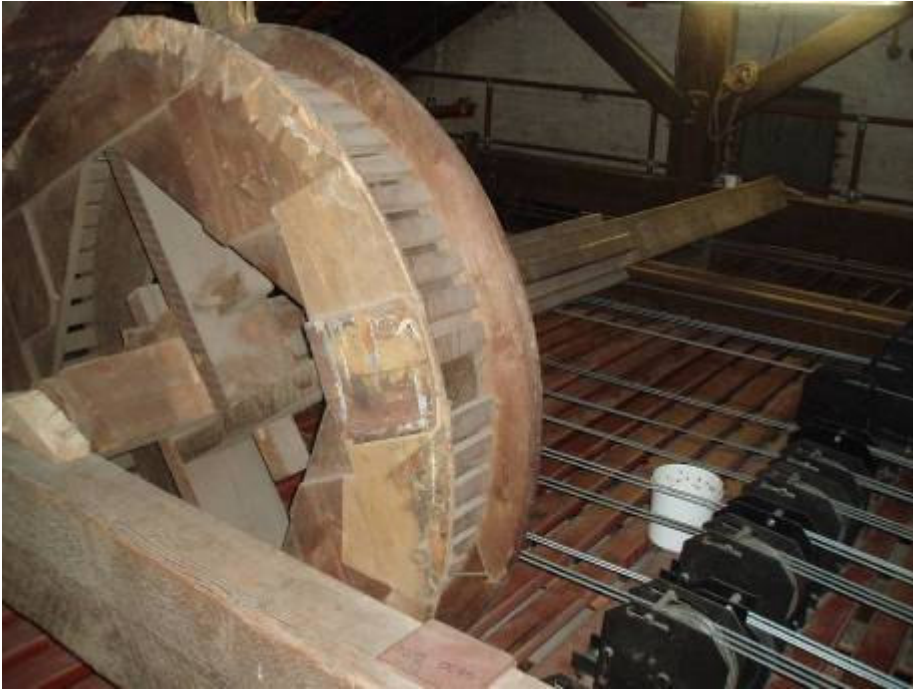
Photograph 45

Old timber lifting windlass over the fly grid retained but no longer in use.
