Her Majesty's Theatre Compliance, Facilities & Operational Upgrade

Feasibility Report – Stage 3 Works

17 Lydiard Street South, Ballarat VIC 3350

December 2019

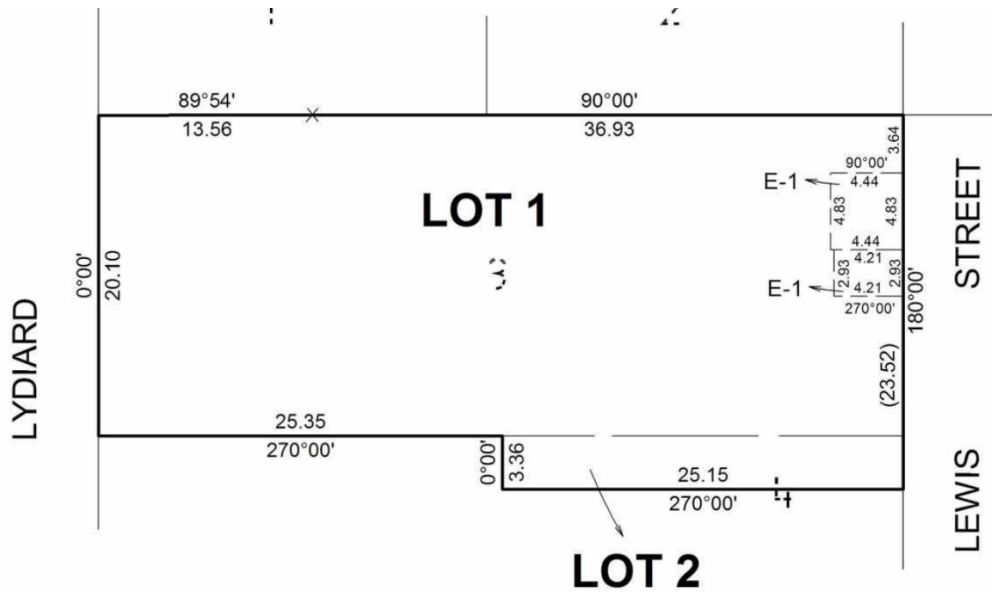
Figure 7 17 Lydiard Street, Ballarat Title Plan TP 893826Y showing that the north egress stair into Unicorn lane is not currently amalgamated into the title.
Source: LANDATA® Land Use Victoria accessed 02/12/2019

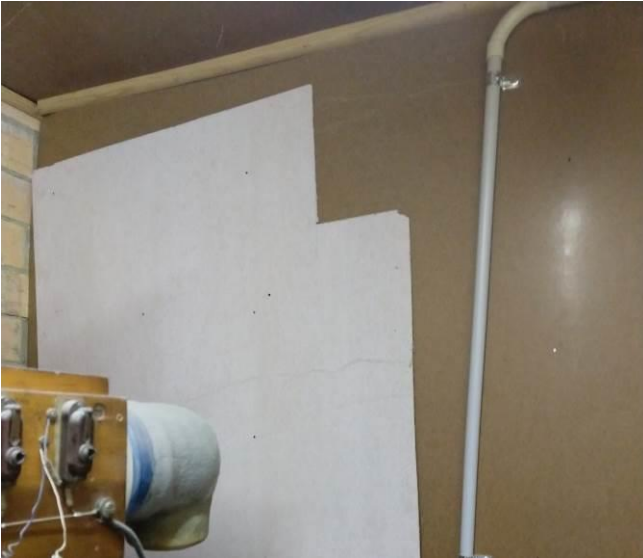
Photo 1 – Sub Basement Drum room fibro cement loose sheeting against wall

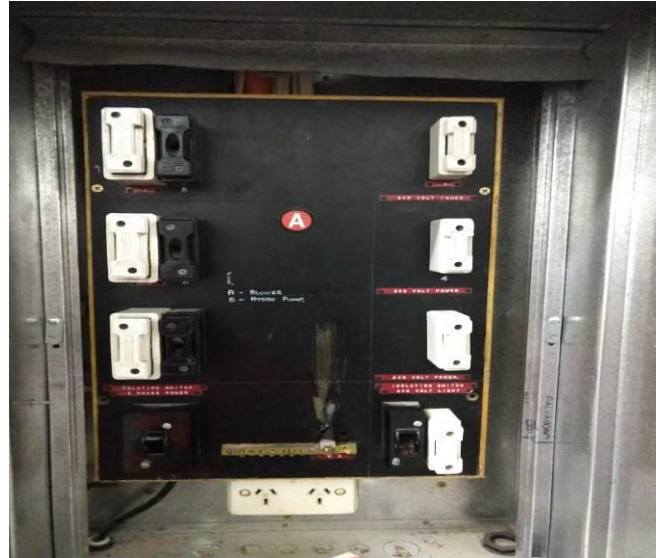
Photo 2 – Sub Basement Store 5 Zelemite switchboard

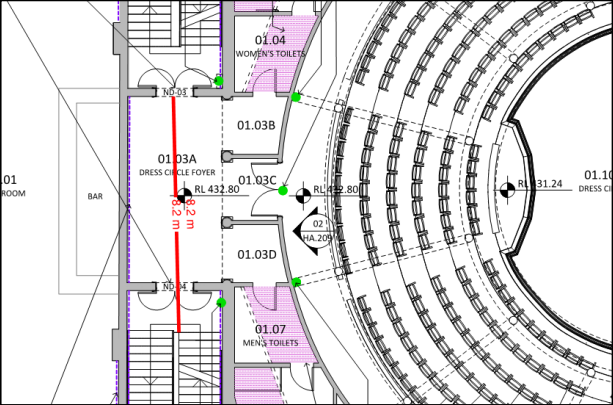
Item	Requirements	Location	Inspection Findings	Recommendation	Photo/Figure Reference
<p>D1.5 Separation of exits</p>	<p>For exits to be considered as alternatives to each other, they must be a minimum of 9m apart.</p>	<p>Northwest & Southwest stairs - Foyer</p>	<p>The separation of the Northwest and Southwest stairs connecting the auditorium to the foyer is less than 9m, thereby meaning that they are considered to be one and the same exit, although with a large exit width.</p>	<p>Note only. No action required. It is noted that the South stair in the foyer is proposed to be demolished as part of the Stage 2 works.</p>

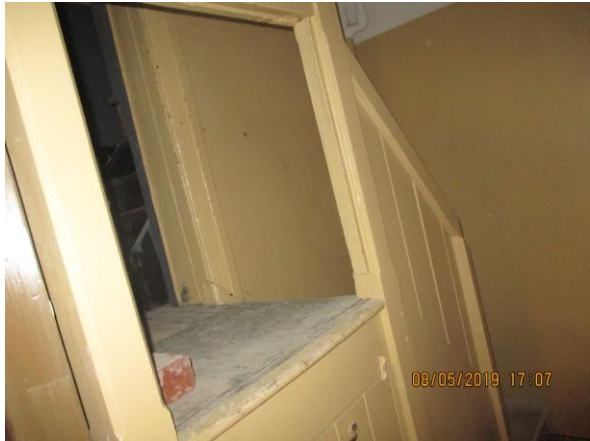
<p>D1.6 Dimensions of exits and paths of travel to exits</p>	<p>The unobstructed width of each exit or path of travel to an exit must be a minimum of 1m.</p> <p>The unobstructed height of each exit or path of travel to an exit must be a minimum of 2.4m, except for doorways which may be 1980mm.</p>	<p>Various</p>	<p>Corridor in switchroom (B1.42) has a clear width of 790mm in lieu of minimum required 1m.</p> <p>Clearance of 720mm between columns and adjacent walls in B1.25 organ area.</p> <p>External northern escape stair is only 940mm wide in parts.</p> <p>Stair serving Bio Box is only 635mm wide.</p> <p>Stair from stalls to stage is 770mm wide.</p> <p>Door at the top of Bio Box stair is only 1740mm high.</p>	<p>Verify the existing situation via fire engineering.</p> <p>This issue will be resolved through the Stage 2 works.</p> <p>This issue will be resolved through the Stage 2 works.</p> <p>This stair should be demolished and a compliant alternative constructed.</p> <p>The door should be altered to achieve the minimum required height.</p>

<p>Stair and door to BioBox</p>

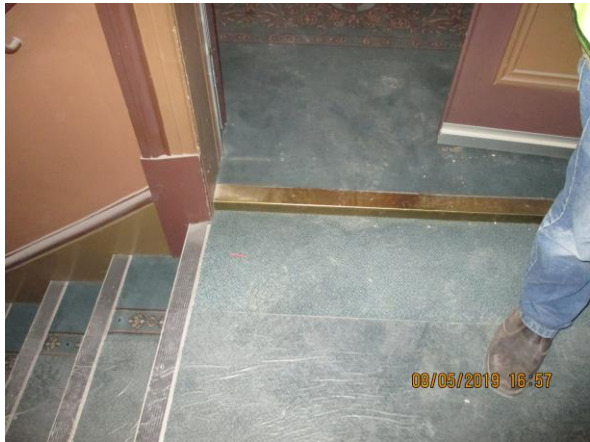
Item	Requirements	Location	Inspection Findings	Recommendation	Photo/Figure Reference
D1.7 Travel via fire-isolated exits	A door must not open directly to a fire-isolated stair unless it is from a public corridor / lobby, sanitary compartment or the like.	Long Room	The Long Room opens directly to the Northwest stair that is required to be fire-isolated. The auditorium opens directly to the south fire stair.	Validate the noted doors opening directly to the fire-isolated stairs through the fire engineering process.

Door from Long Room opening directly to stair
D1.7 Travel via fire-isolated exits	Fire-isolated exits are required to discharge directly, or by way of a dedicated fire-isolated corridor, to a road or open space.	Northwest stair	The northwest stair, which is considered to be a fire-isolated stair, discharges inside the building in lieu of discharging directly to a road or open space.	Address the discharge of northwest stair in the Stage 2 works utilising fire engineering.

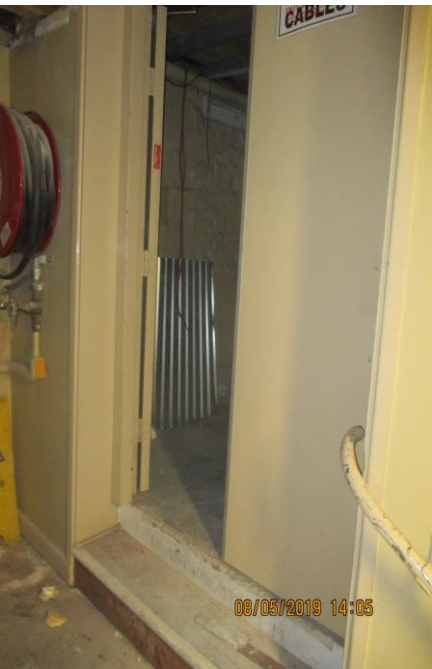
Item	Requirements	Location	Inspection Findings	Recommendation	Photo/Figure Reference
D2.15 Thresholds	The threshold of a doorway must not incorporate a step or ramp at any point closer to the doorway than the width of the door leaf.	Various	<p>Various doors throughout the building incorporate steps directly in the door thresholds, reflective of building techniques at the time of construction, including:</p> <ol style="list-style-type: none"> 1. Ground floor Audio Room (GF.108). 2. Doors from auditorium to south fire escape. 3. Organ rooms. 4. Archive room (B1.16). 5. Doors from Long Room (01.01). 6. Door to B1.21. 7. Door from B2.17 to B2.18. 8. Door from corridor to B1.25. <p>Landing of only 500mm is provided at the base of the stair between front-of-house and back-of-house in Basement 1, in lieu of landing of at least one door width.</p>	<p>Given the unique heritage nature of the building, and where the issues will not be resolved as a result of Stage 2 works, apply for a building surveyor dispensation to permit the retention of the steps in the door thresholds as part of Stage 2 building permit works.</p> <p>Rationalise the existing situation via dispensation / Performance Solution as part of the Stage 2 works.</p>

<p>Step incorporated in door threshold</p>

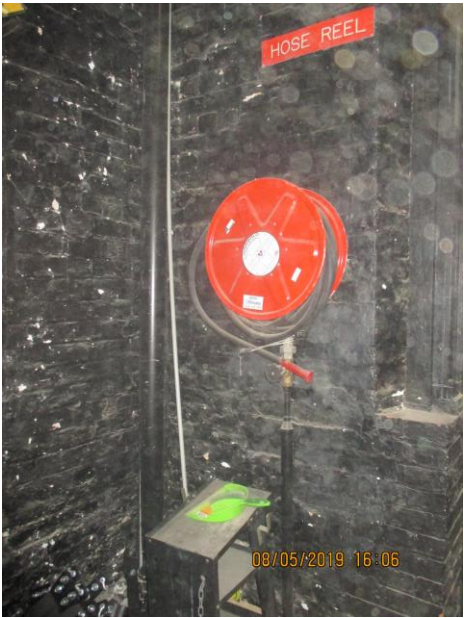
Item	Requirements	Location	Inspection Findings	Recommendation	Photo/Figure Reference
<p>E1.4 Fire hose reels</p>	<p>Where fire hose reels are required, they are not permitted to pass through fire or smoke doors to achieve coverage.</p> <p>Where fire hose reels are installed, as far as is practically possible, they should be within 4m of an exit.</p>	<p>Auditorium & Long Room</p> <p>Various</p>	<p>The introduction of the new fire-rated walls in Stage 1 to compartment the building has resulted in fire hose shortfalls to the main auditorium and the Long Room.</p> <p>Most fire hose reels in the building are located more than 4m from an exit, including ground floor foyer, stage area, stage door etc.</p>	<p>Install additional fire hose reels to cover the areas of shortfall or rationalise the shortfalls via fire engineering analysis as part of the Stage 2 works.</p> <p>Relocate fire hose reels to be within 4m of exits or address through fire engineering process.</p>

<p>Fire hose reel located more than 4m from an exit</p>

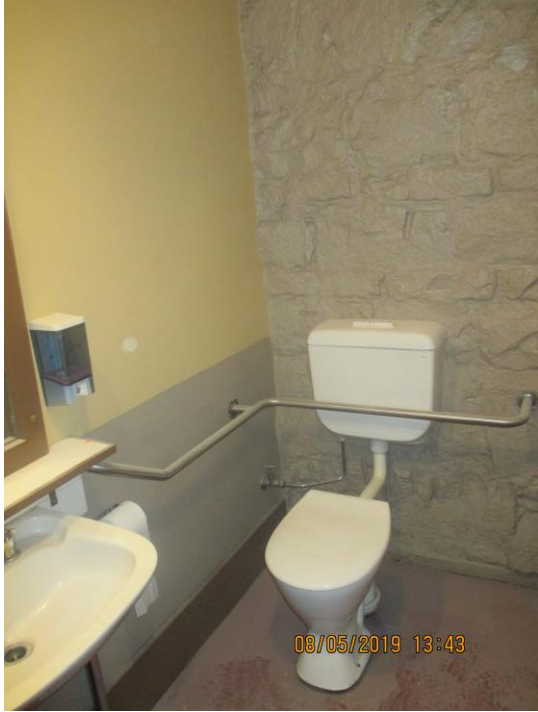
Item	Requirements	Location	Inspection Findings	Recommendation	Photo/Figure Reference
<p>F2.2</p> <p>Calculation of number of occupants and facilities</p>	<p>Class 9b theatres and sporting venues must be provided with one shower for every 10 participants or part thereof.</p>	<p>Back of house</p>	<p>The number of showers provided does not cater for the number of participants when strictly applying BCA requirements.</p>	<p>We note that it is proposed to increase the number of showers as part of the Stage 2 works.</p> <p>Performance Solution will likely be required to reduce the number from 25 showers due to space issues.</p>	
<p>F2.4</p> <p>Accessible sanitary facilities</p>	<p>Where accessible sanitary facilities are provided within a building, there are required to comply with AS 1428.1-2009 in respect of dimensions and features.</p>	<p>Basement 1</p>	<p>The sanitary facilities signed as accessible display multiple non-compliances with AS 1428.1-2009 including but not limited to:</p> <ol style="list-style-type: none"> 1. Non-conforming room dimensions. 2. No backrest provided. 3. No / non-compliant grabrails. 4. No coat hooks / shelf. 	<p>We understand that these toilets will be demolished and that new compliant accessible unisex sanitary facilities will be provided.</p>

<p>Non-compliant sanitary facility signed as being accessible</p>

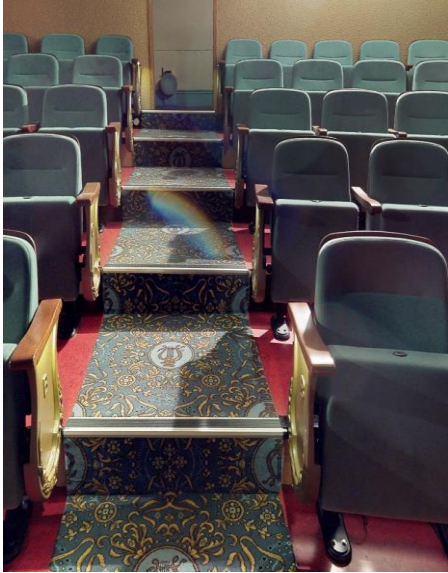
Item	Requirements	Location	Inspection Findings	Recommendation	Photo/Figure Reference
<p>H1.3 Seating area</p>	<p>Line between nosings in the seating area must be at a pitch of not more than 30° to the horizontal and the height of steps between rows of seating does not exceed 600mm.</p> <p>Where an aisle divides the stepped floors, any steps exceeding 230mm in height must be provided with intermediate steps.</p>	<p>Auditorium</p>	<p>The pitch of the nosings does not exceed 30° and is in fact less than this at 22° in parts.</p> <p>Steps in aisles exceed 230mm in various areas, thereby requiring intermediate steps.</p>	<p>Consider the installation of intermediate steps in the aisles, Heritage constraints permitting.</p> <p>Alternatively, obtain a dispensation to allow retention of existing arrangements under the Regulation 233 process associated with Stage 2 works.</p>

<p>Steps exceeding 230mm in height</p>

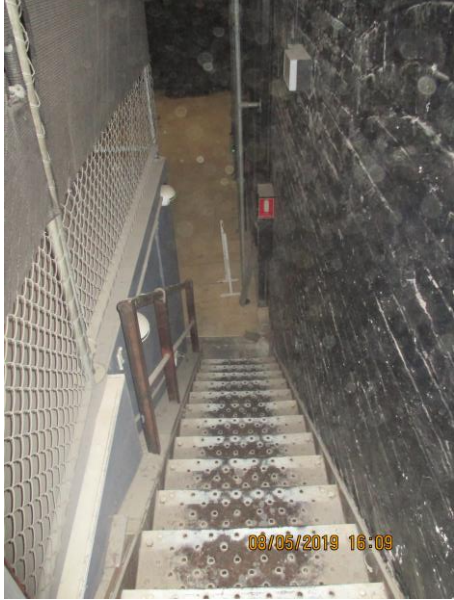
Item	Requirements	Location	Inspection Findings	Recommendation	Photo/Figure Reference
<p>H1.6 Access to platforms and lofts</p>	<p>A stairway that provides access to a service platform, rigging loft, or the like, must comply with AS 1657.</p>	<p>Backstage area</p>	<p>The stairs and platforms serving the back-of-house areas display multiple non-compliances with AS 1657 in respect of the features, such as no toeboards to landings,</p>	<p>Replace or carry out alterations to backstage stairs, platforms and walkways to achieve a greater level of compliance with AS 1657.</p>

<p>Non-conforming stair with non-continuous handrails and gate opening halfway up.</p>
<p>H1.7 Aisle lights</p>	<p>In an auditorium, where the floor is stepped, aisle lights must be provided to illuminate the full length of the aisle and tread of each step.</p>	<p>Auditorium</p>	<p>Lights are provided on the side of the chairs along the aisle. No lights are provided to the tread of each step.</p>	<p>Upgrade aisle lighting to comply with BCA H1.7 as part of future works.</p>

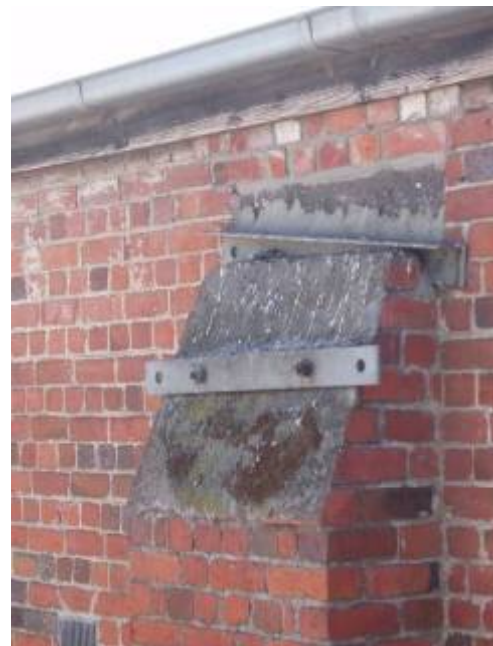
View of deterioration to pilaster
