MCDUGALL & VINES

**HER MAJESTY'S THEATRE
BALLARAT**

**CONSERVATION MANAGEMENT
PLAN
October 2006**

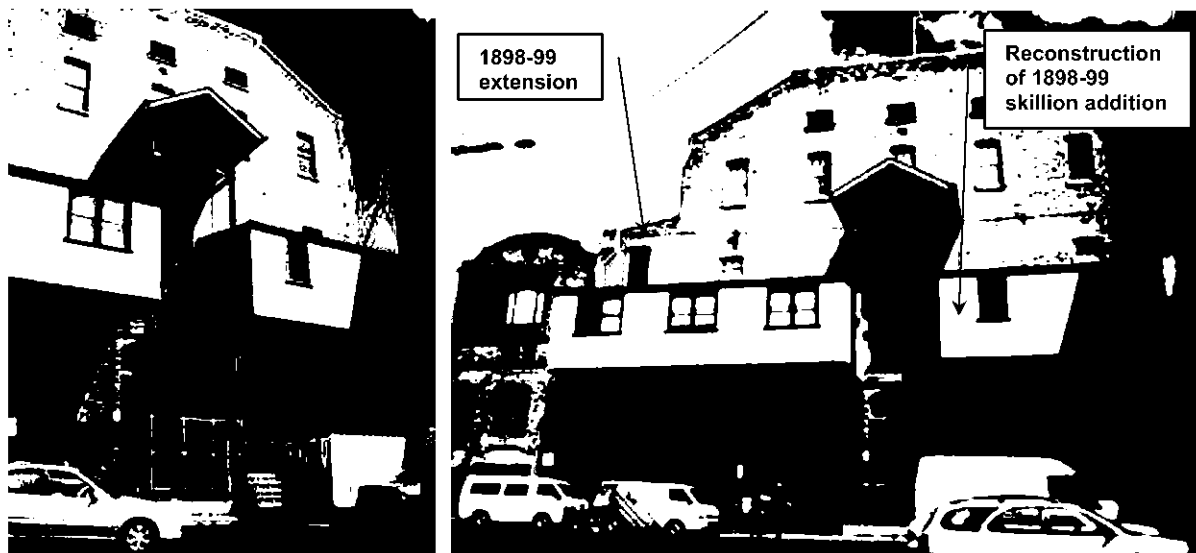
The east elevation is constructed in face red brick with bluestone to the lower levels. There have been a number of changes to this elevation. Generally it is in good condition, although there are areas of brickwork where mortar is missing, in particular below the upper southern window which corresponds to a crack which appears to travel down the building. This has resulted in missing mortar to the brickwork and bluestone at the lower levels.

- Continue to maintain this elevation.
- Re-point missing mortar to sections of brickwork and stonework.
- Opportunities to expand the theatre complex into the adjacent apartments, the Mechanics Institute or through the extension of the skillion addition should be investigated as part of the overall feasibility study.
- Surface mounted pipes are not considered appropriate and no further external piping or fittings should be permitted. In the long term, internal relocation of current surface mounted plumbing pipes is recommended.
