## **Central Victorian Livestock Exchange**

RLX Operating Company Pty Ltd

### **Expert Witness Statement**

IS110800-001 | FINAL

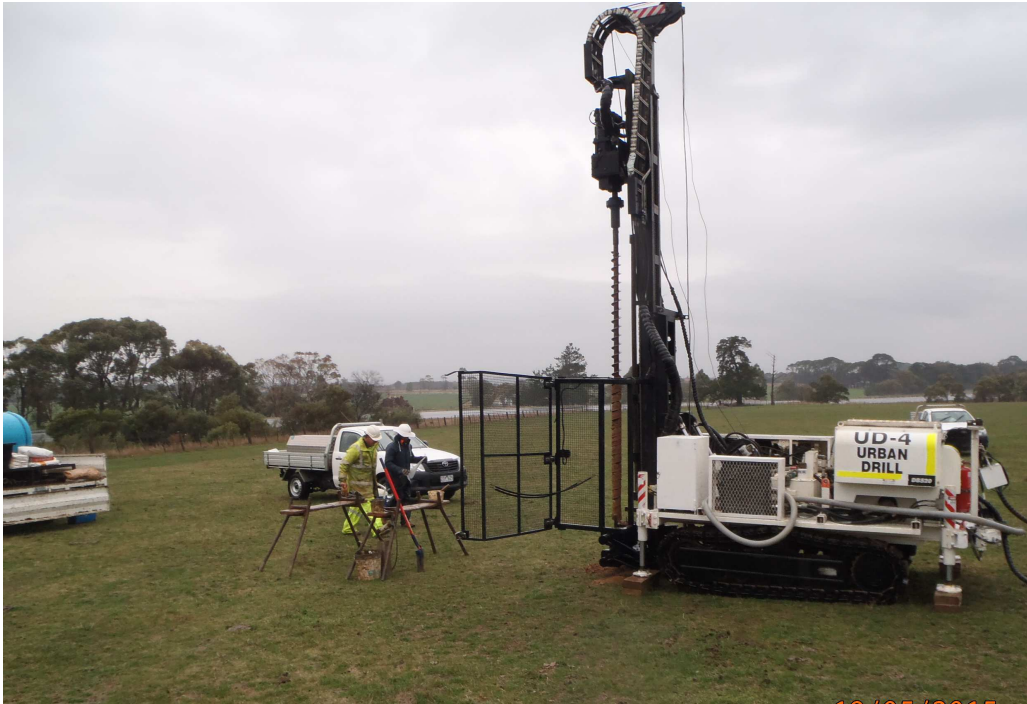
Photo 1 – Drilling borehole MW103.

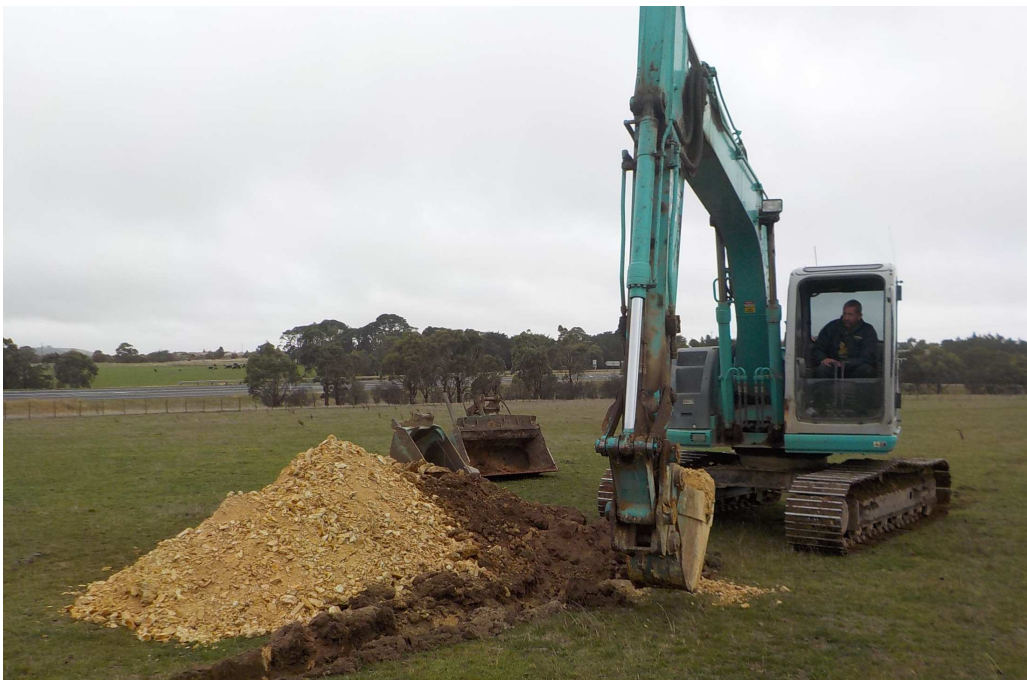
Photo 2 – Excavating test pit TP103, showing siltstone fragments.

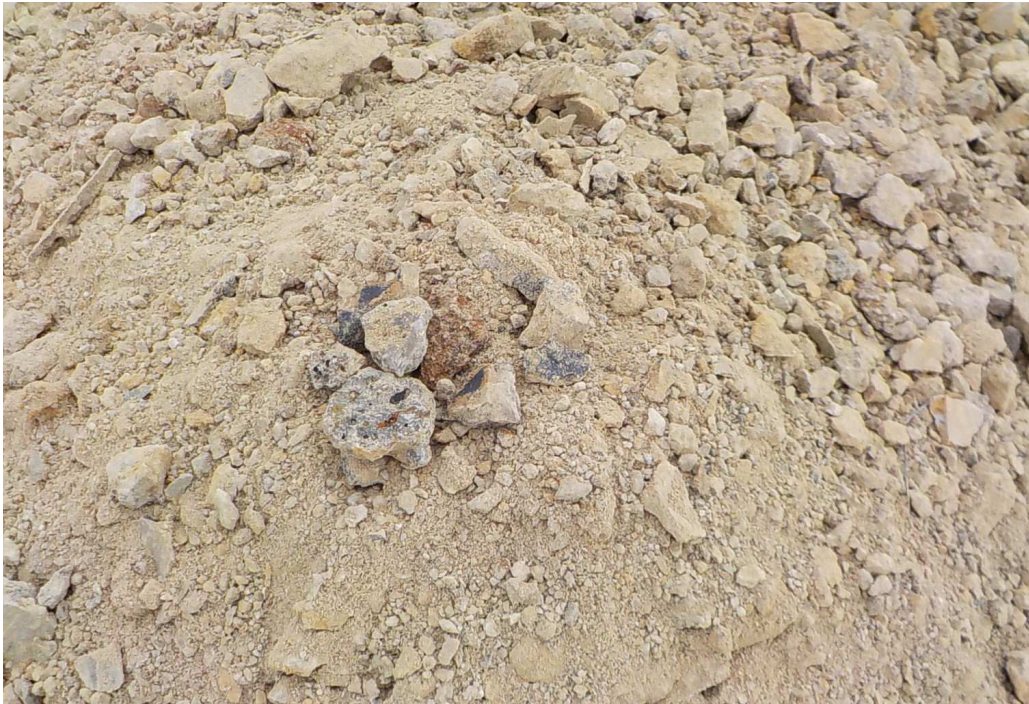
Photo 3 – Excavated spoil from TP121 showing basalt fragments.

Basalt was encountered beneath the high plasticity clay in the test pits noted above. Field observations of recovered fragments from the excavator bucket indicate the basalt to be typically highly weathered and low strength at the surface. The basalt encountered in MW102 was typically slightly weathered, high strength from its upper surface at 7.6 m to the base at 18.2 m depth.

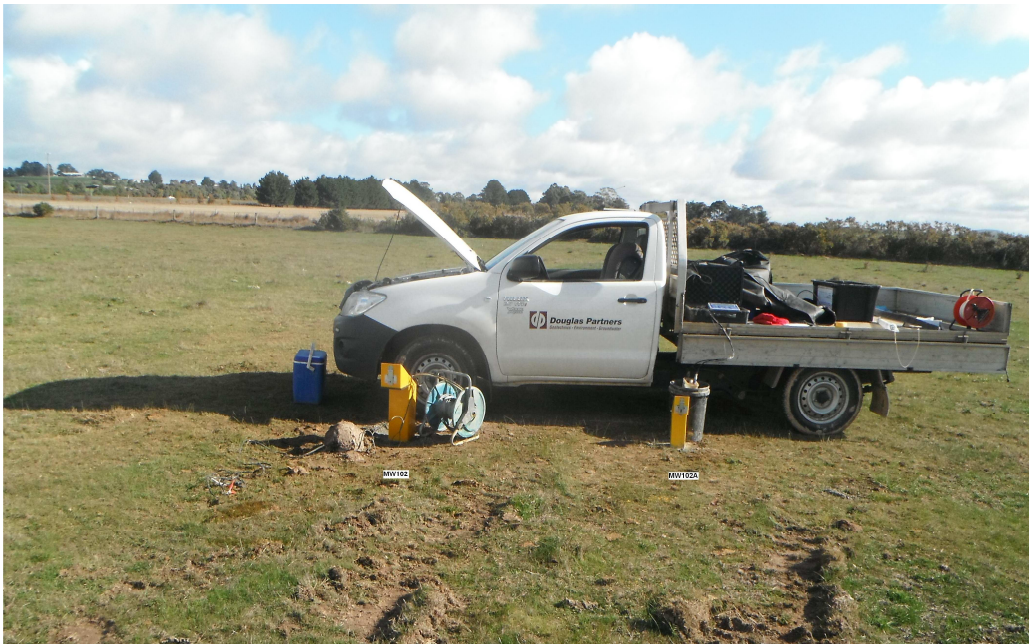
Photo 4 – Groundwater monitoring and sampling of boreholes MW102 and MW102A.

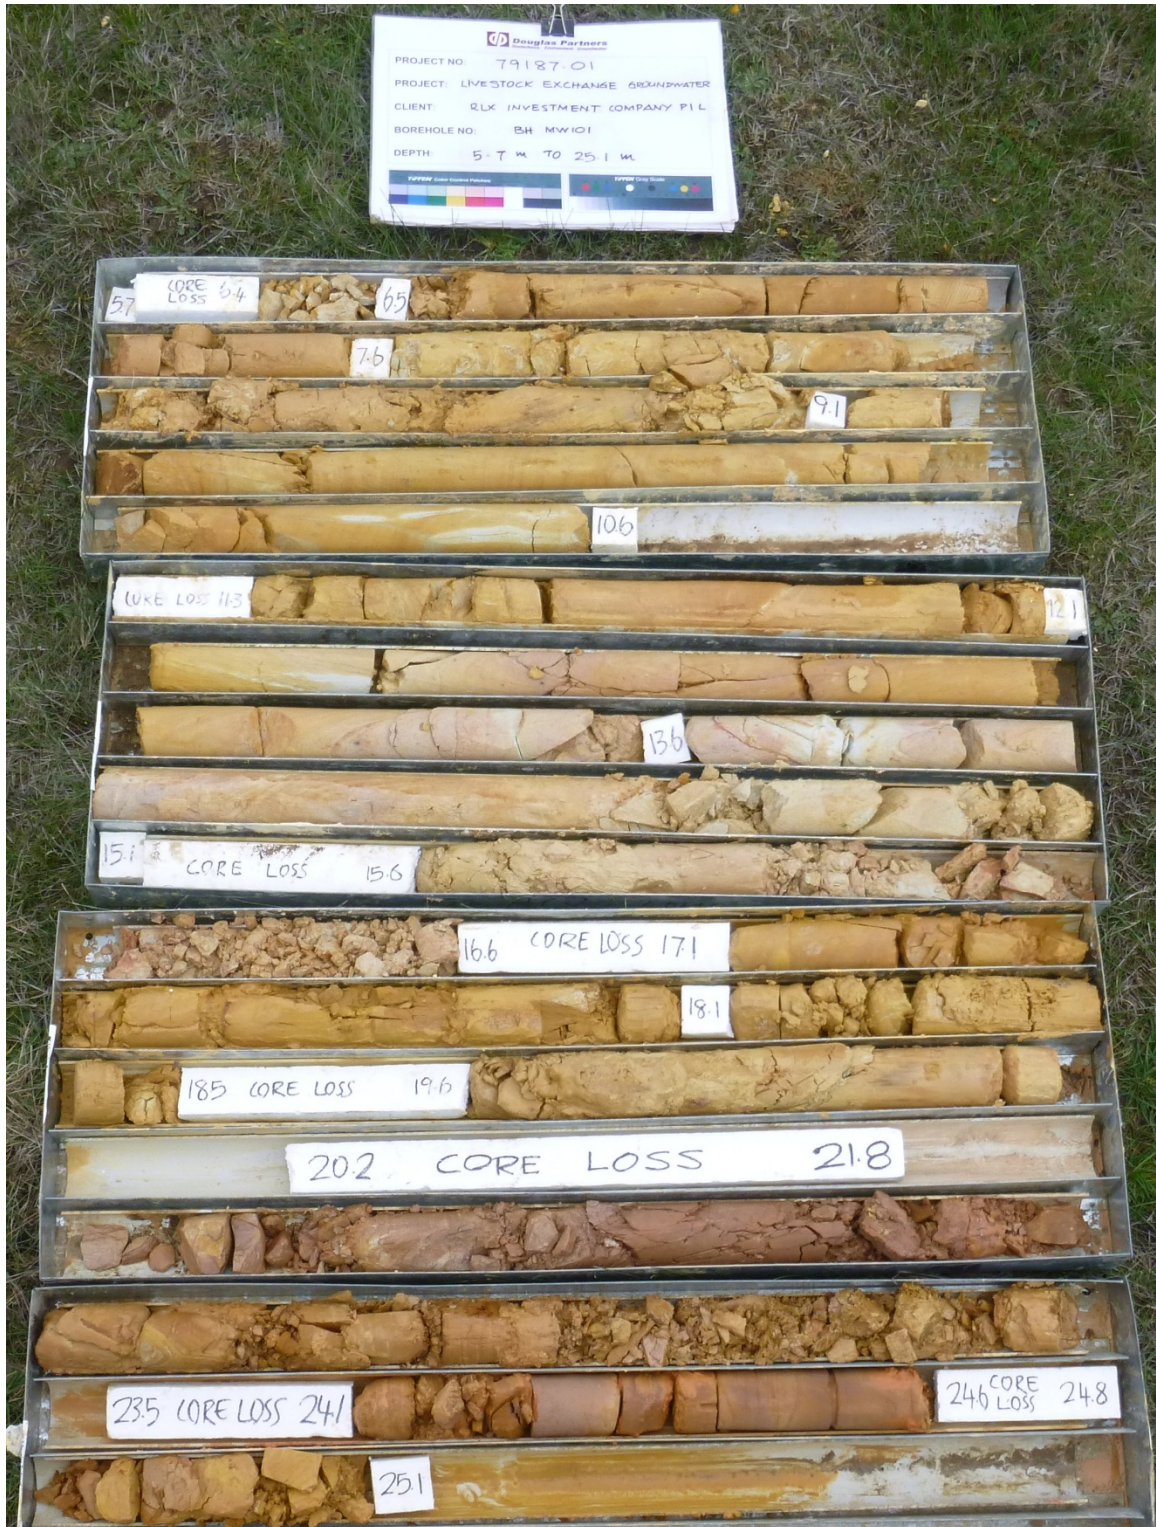
Core Photo 1: MW101, 5.7 m to 25.1 m.

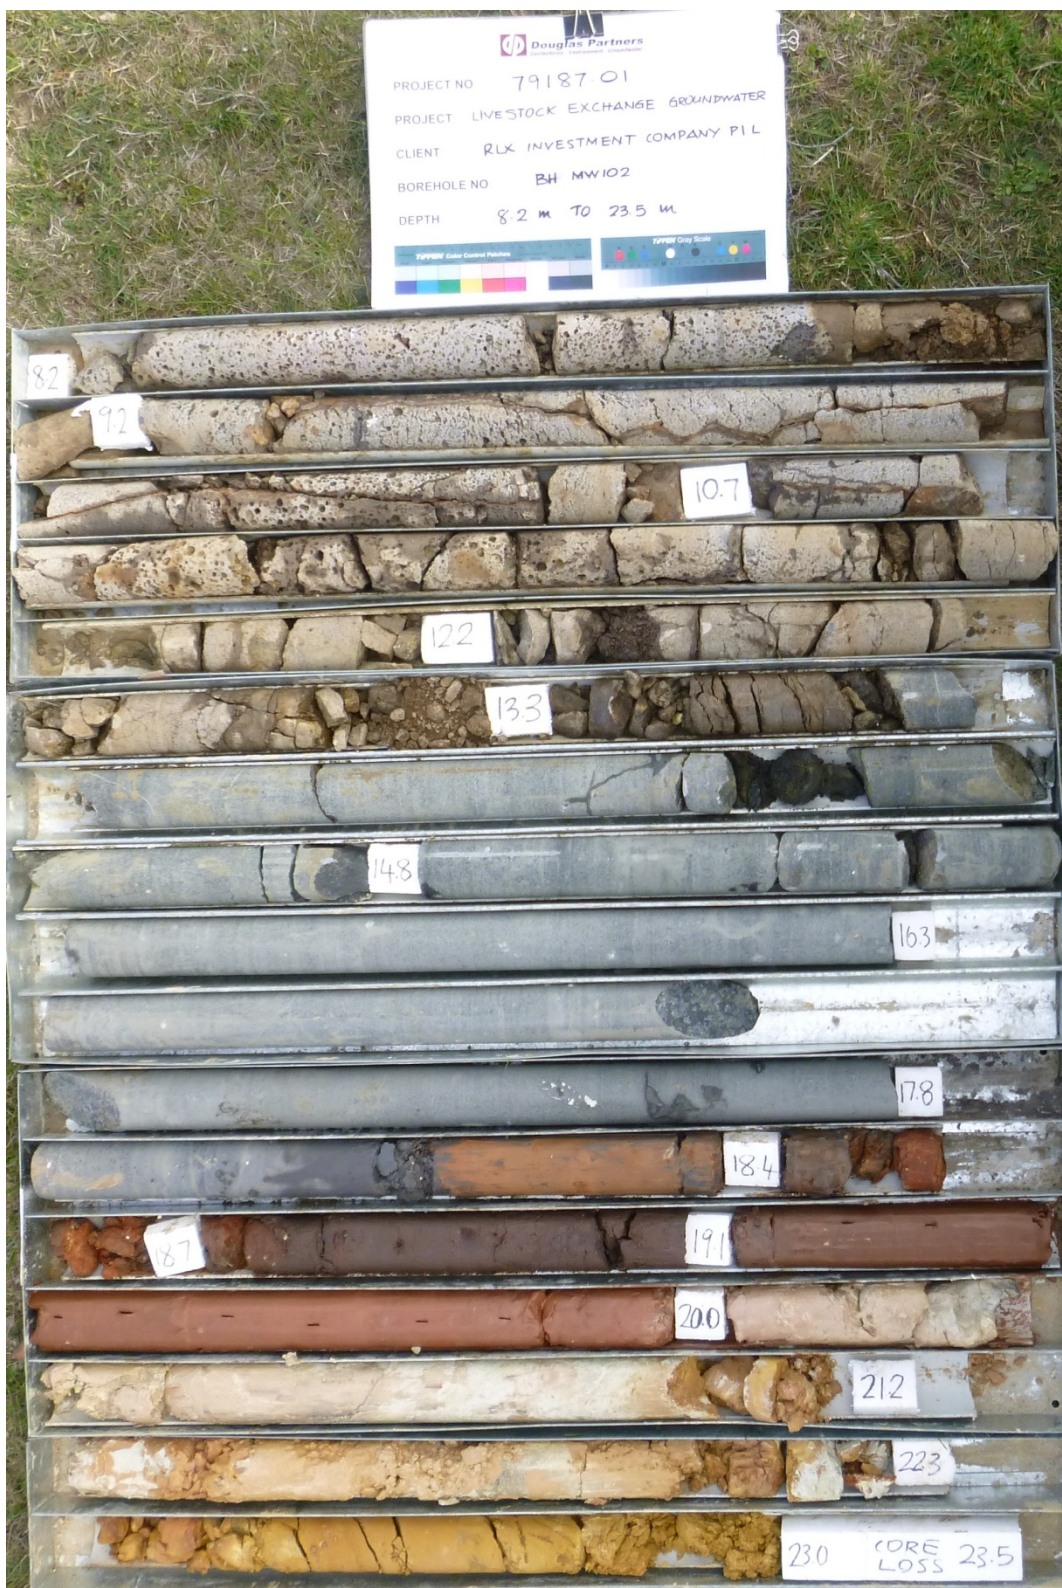
Core Photo 2: MW102, 8.2 m to 23.5 m.

| Groundwater Well | Hydrogeological Summary |
|---|---|
| MW102 | Starts in colluvial/alluvial sediments, intersects hard basalt at 8 metres below surface and then passes into bedrock at 22.3 metres below surface. This bore monitors groundwater in the bedrock aquifer.<br>Basalt encountered in drilling this bore was firm and had sections with little fracturing. No water inflow was noticed from the basalt. |

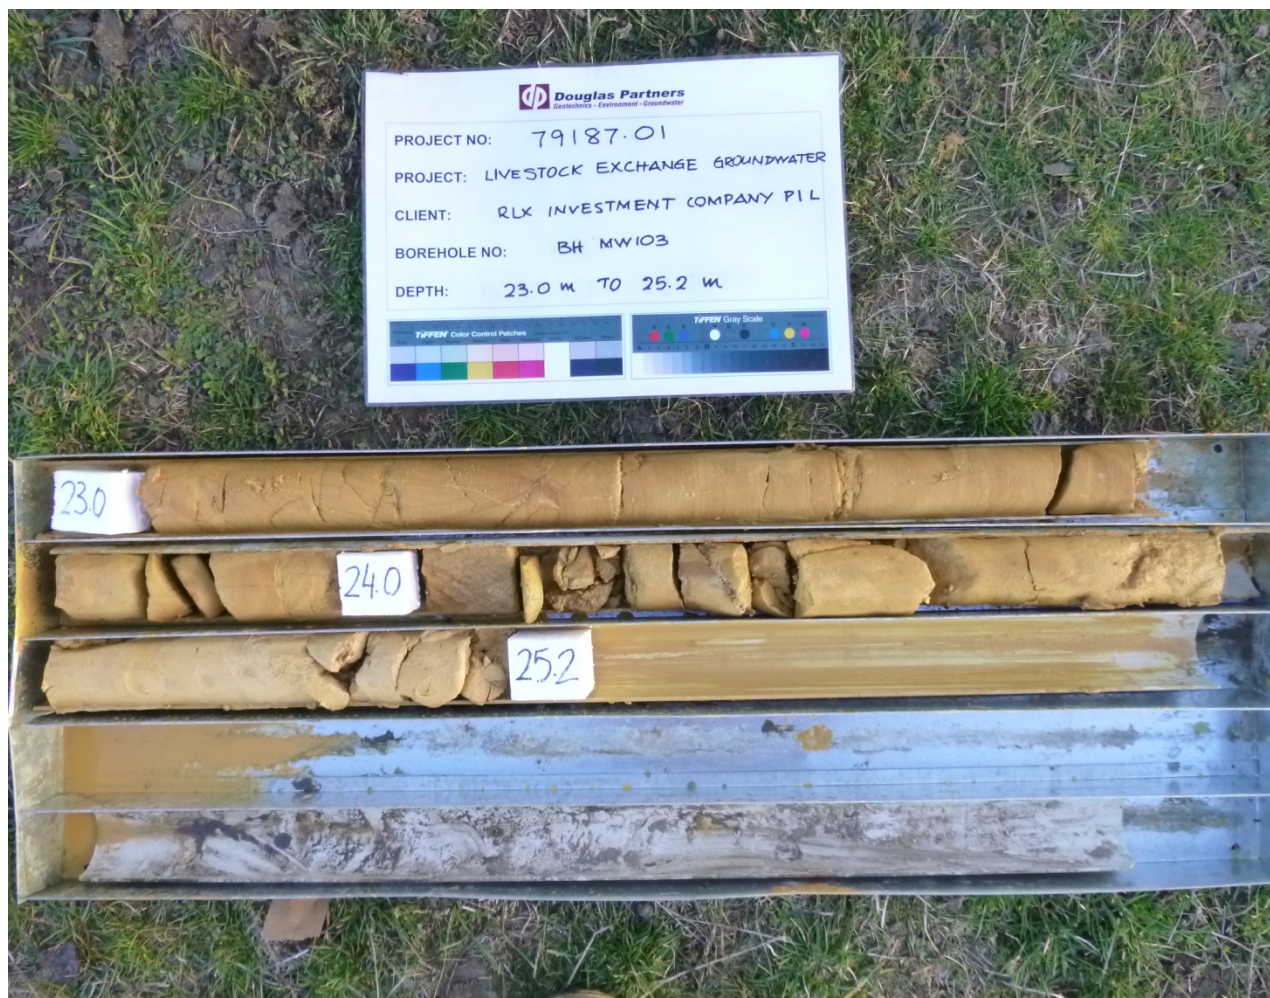
Core Photo 3: MW103, 23.0 m to 25.2 m.

| Groundwater Well | Hydrogeological Summary |
|---|---|
| MW103 | Starts and finishes in bedrock. The bore was stopped at 25 metres. This bore monitors the bedrock aquifer. |
