Arboricultural Impact Assessment and Report

**Steve Moneghetti Track
Lake Wendouree Foreshore
Ballarat, VIC**

20 March 2020

C91757

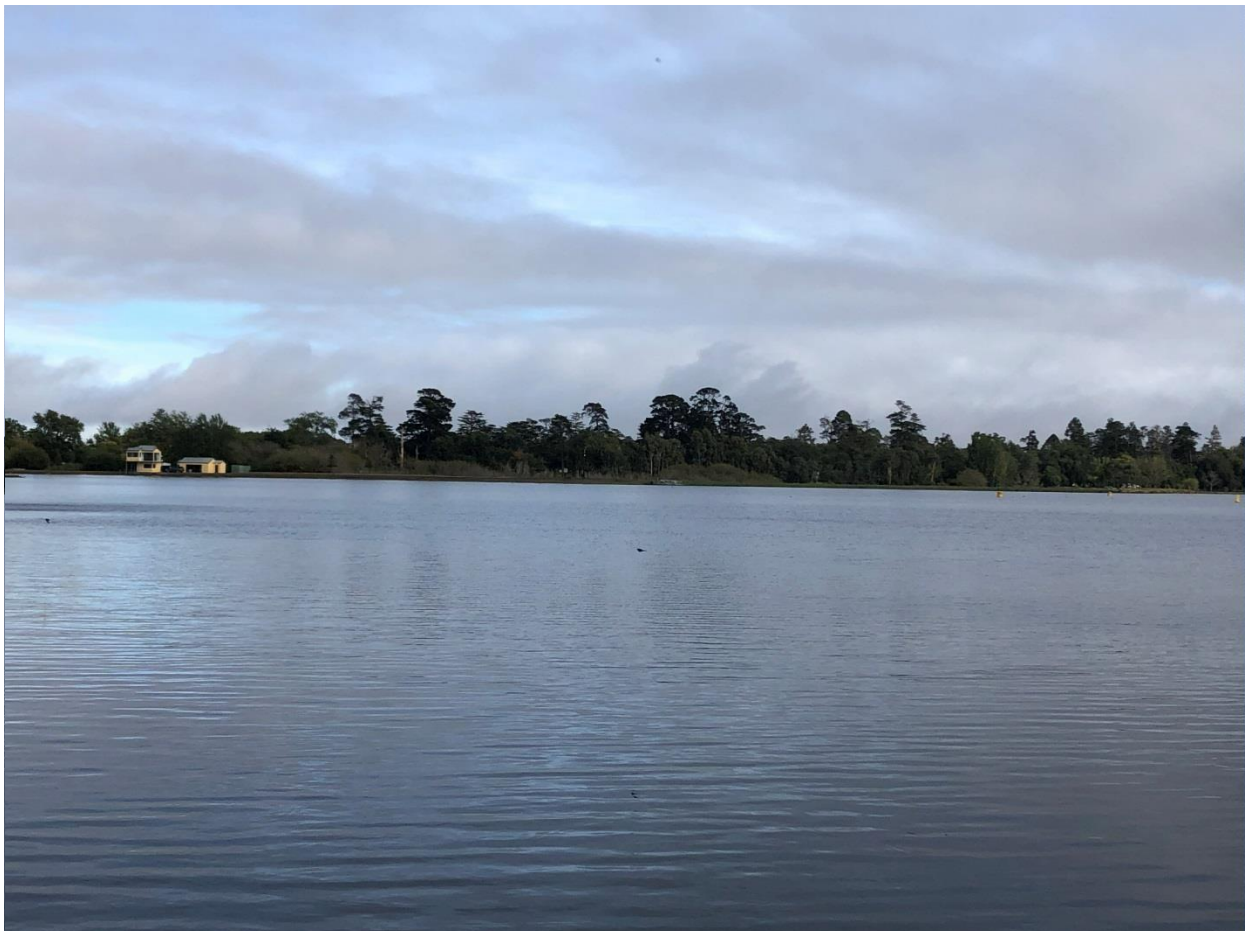
Figure 1. View of the tree canopy to the north-west, Lake Wendouree. (Lachlan Andrews, 28 February 2020).

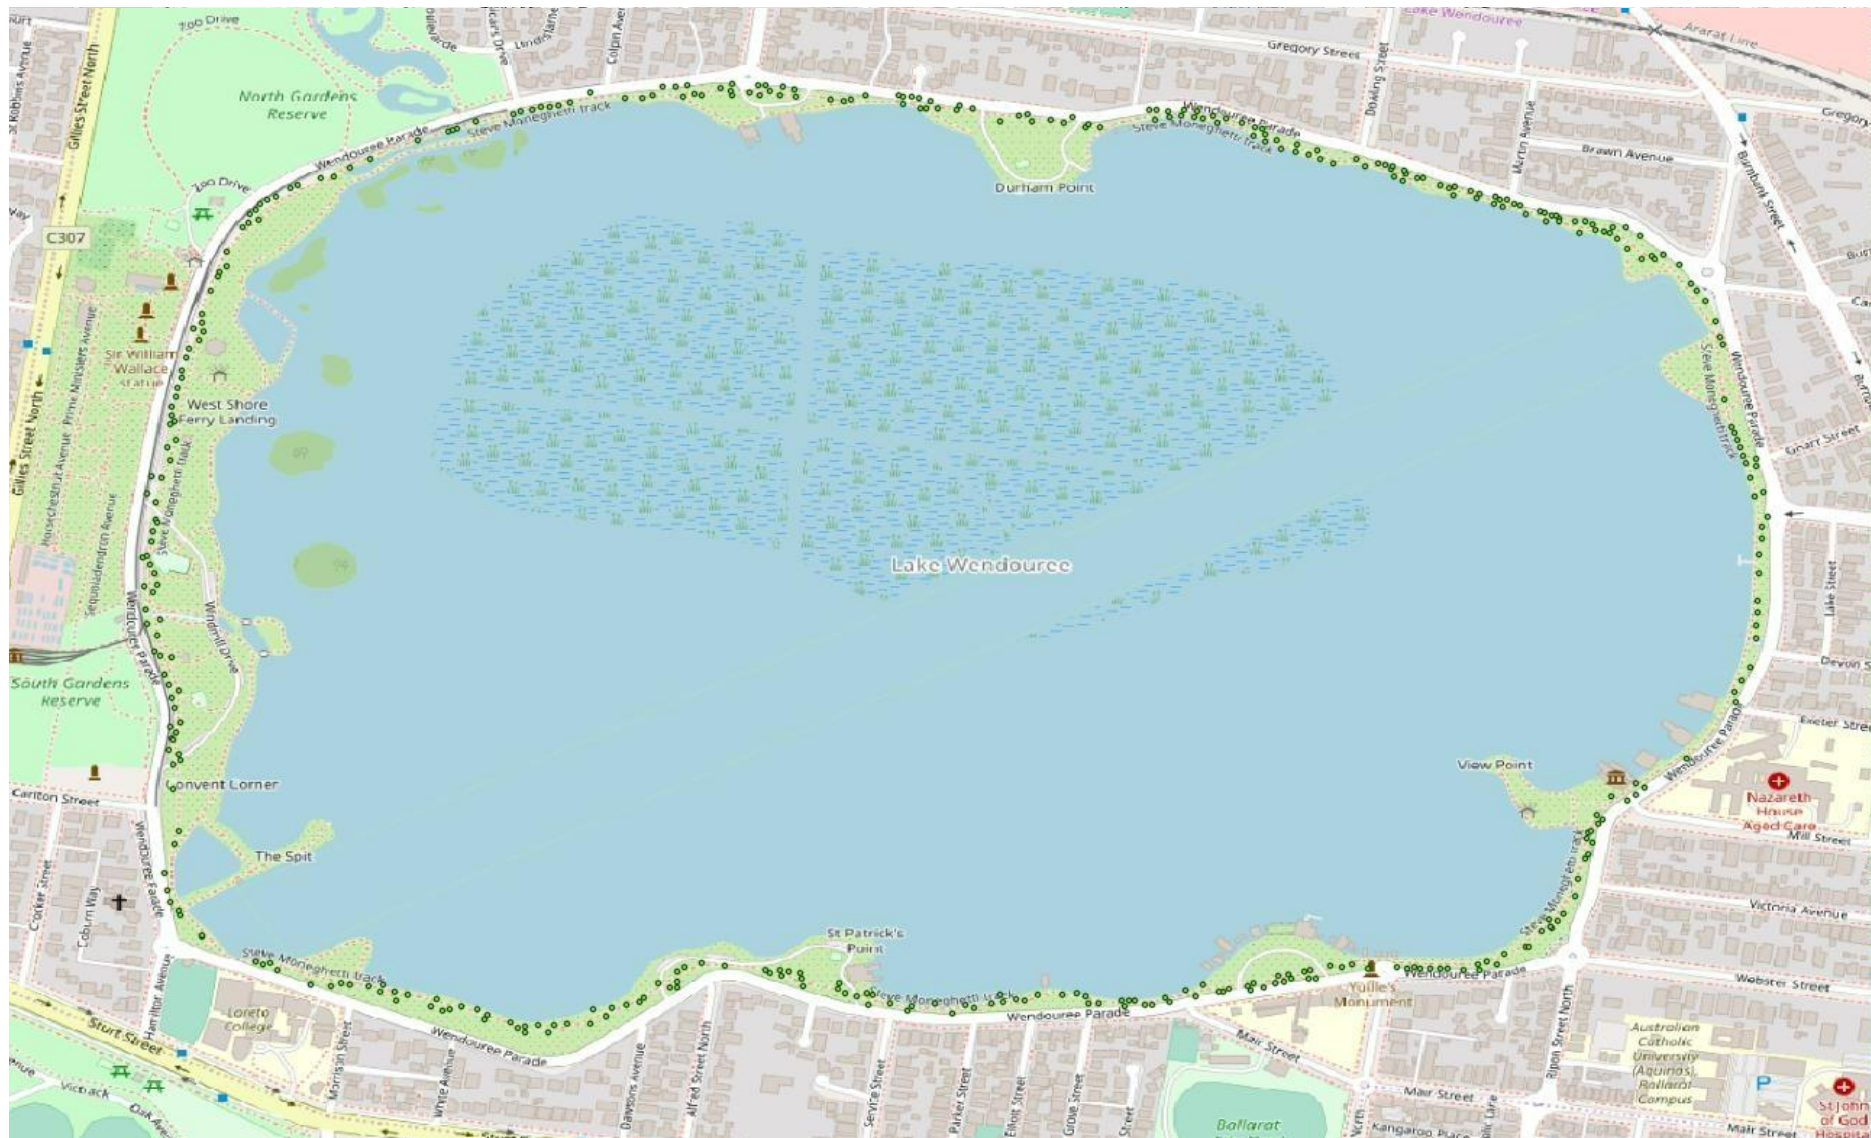
5.3.1 The four hundred (400) subject trees (Figure 2) assessed as part of this report were located around the entire length of the Steve Moneghetti Track and were by and large quite evenly spaced. They are indicated in Figure 2 by the green dots throughout the lake foreshore.

Figure 2. View of the location of the subject trees, Lake Wendouree. (City of Ballarat, 3 March 2020)
