HER MAJESTY'S THEATRE BALLARAT

FEASIBILITY REPORT

December 2006

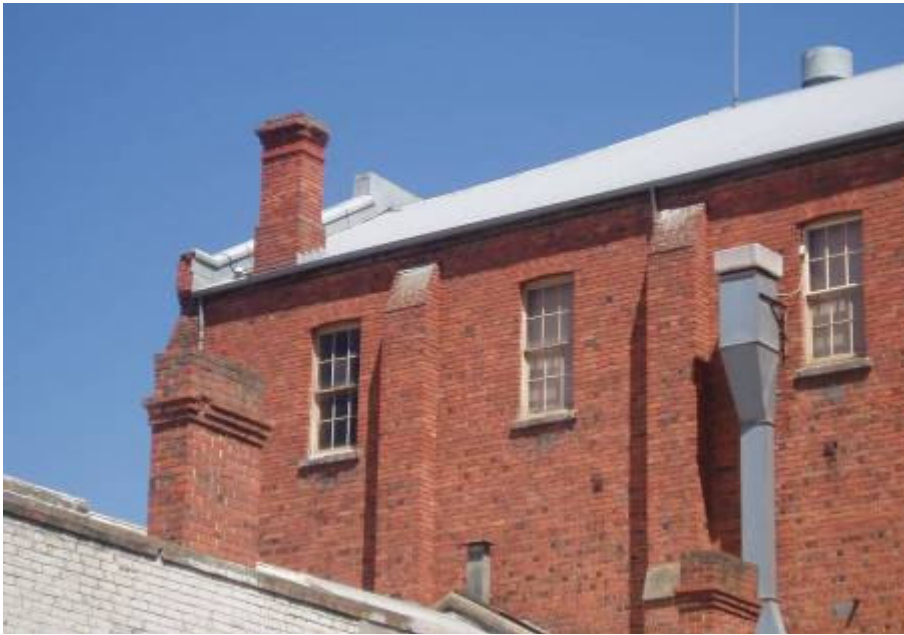
Photograph 1.

Note deflection of roof to the east of the Proscenium Arch brick firewall relative to the Auditorium.

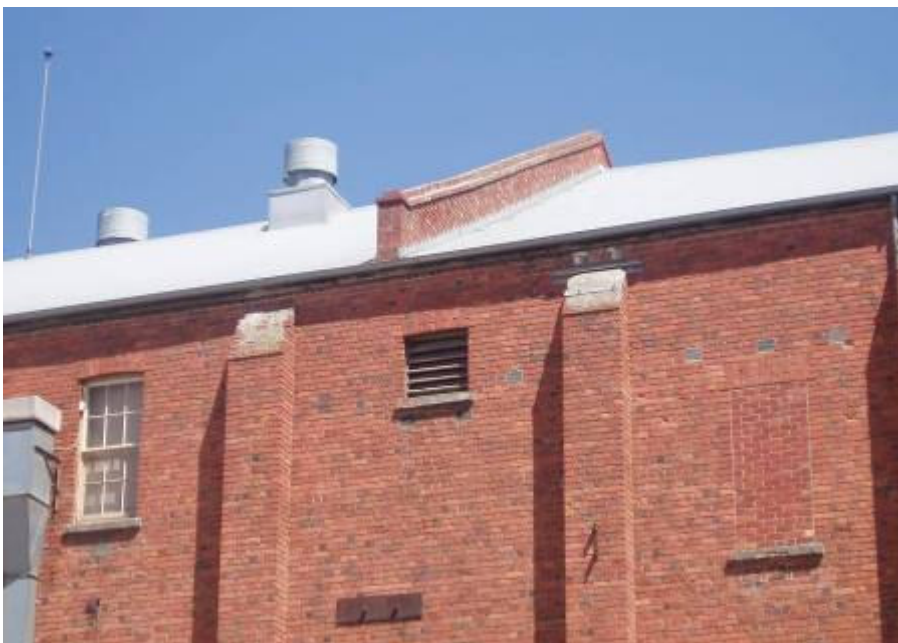
Photograph 2.

Note deflection of the ridge west of the Proscenium Arch brick parapet where the roof has settled over time in the vicinity of the internal ceiling dome.

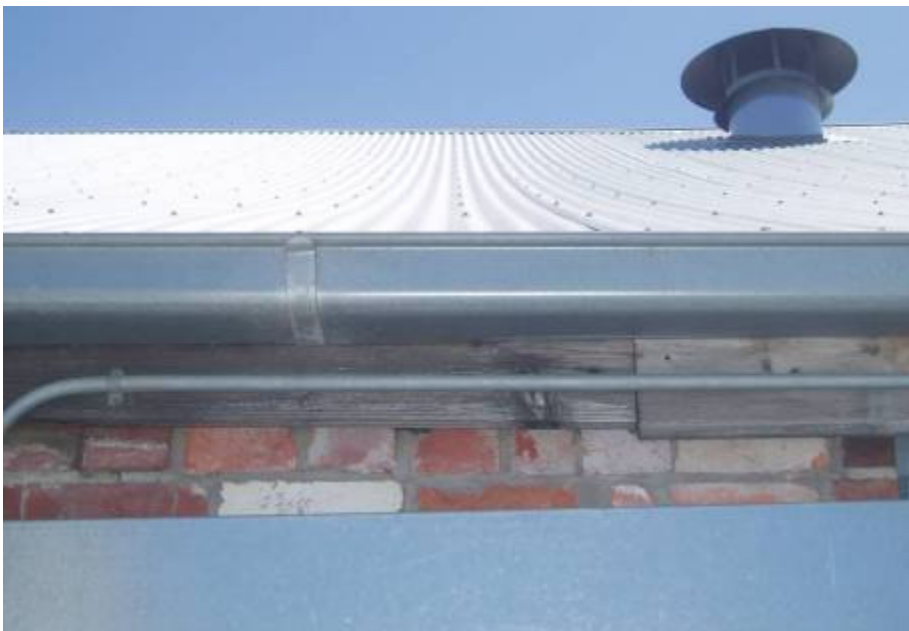
Photograph 4.

Note the deflection of the roof between the perimeter walls and the roof ridge line.

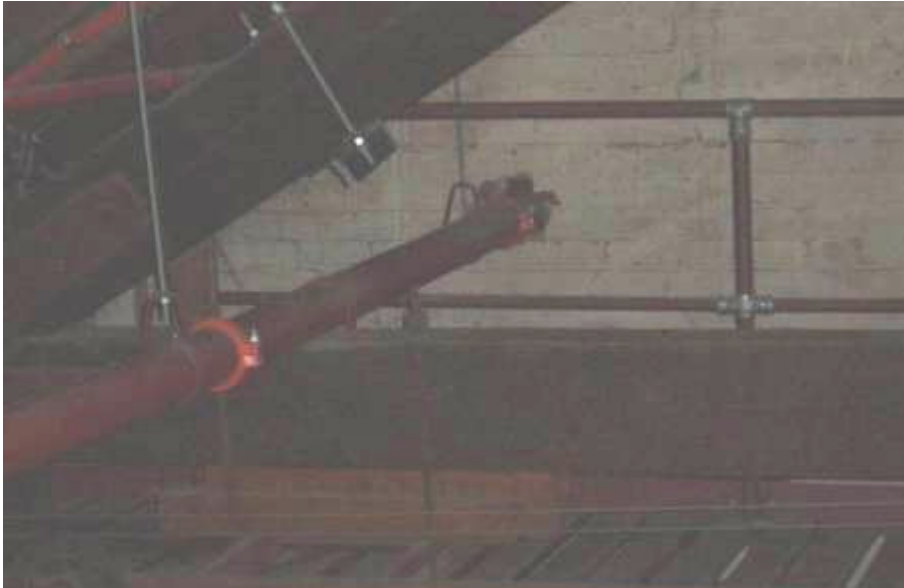
Photograph 6A.

Note large diameter steel fire service pipe passes straight through the 340 thick brick firewall making the compartmentalization of the front of house and back of house ineffective and allowing a fire to 'leap frog' from one compartment to another.

The compartmentalization of the front of house and back of house is ineffective as a service pipe penetrates the brick firewall to the Proscenium Arch and has not been sealed off. An expanding foam fire sealant such as 'White Frost' or similar could be employed to the void surrounding the pipe or alternatively the void could be mortared up with a near dry 1:1:10 Lime/cement/sand mortar mix. Note that the former recommendation is the quickest and simplest given the difficulty of working access.

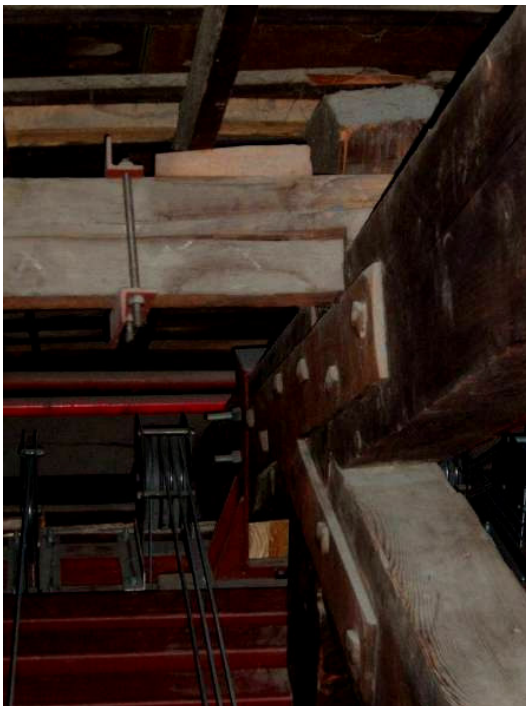
Photograph 8.

Note hardwood under-purlin has split longitudinally where it has been notched and supported on the top chord of the Oregon truss.

The steel angle and 'Allthread' rod clamps are structurally adequate to carry the loads.

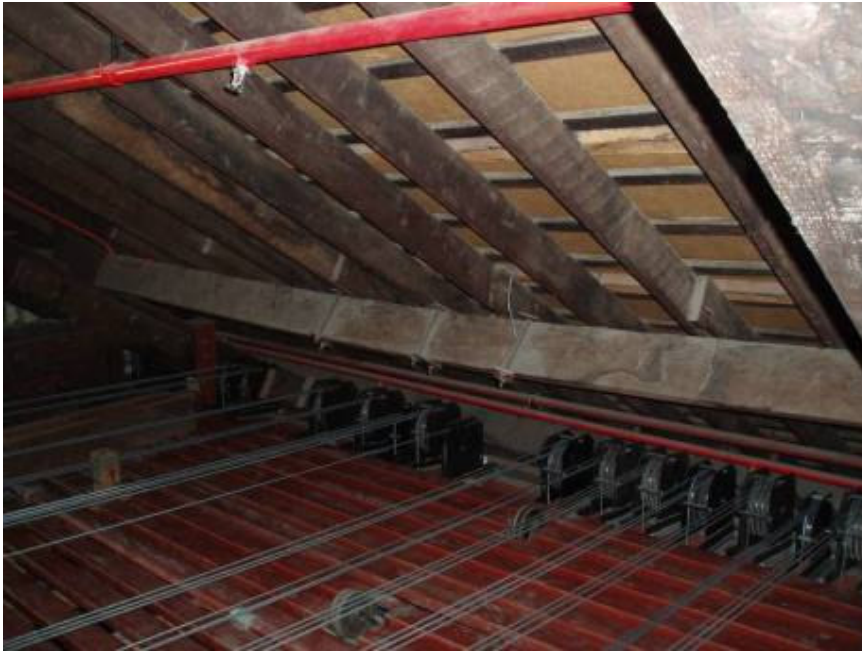
Photograph 9.

This under-purlin has deflected and split diagonally along the beam due to the sloping grain of the beam over the fly tower grid. Note the Caneite panel ceiling laid over the original roofing battens presumably for acoustic insulation against rain noise from the new corrugated iron roofing. This under-purlin strengthening is structurally satisfactory for the current roof loads.

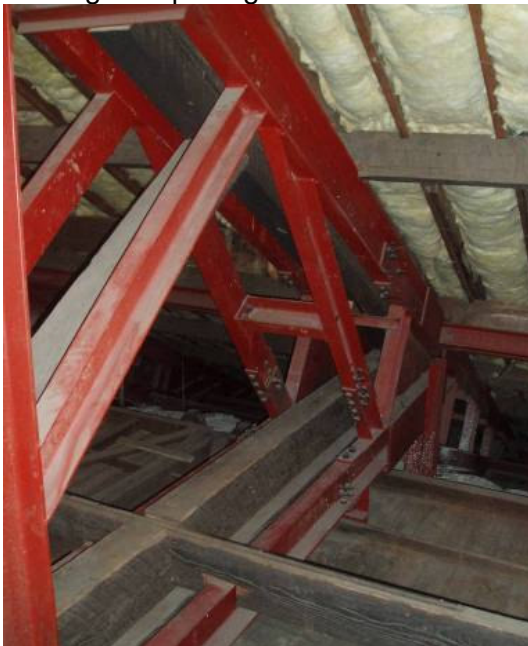
Photograph 20

The new steel trusses are performing precisely as intended and no current movement is occurring and no future deflection will occur beyond its present position. See photographs 20 to 25. Photographs 26, 27 and 28 show elements of the original opening mechanism for the dome.

Note steel truncated scissor trusses on each side of original oregon timber truss installed over dome preventing any future sag.

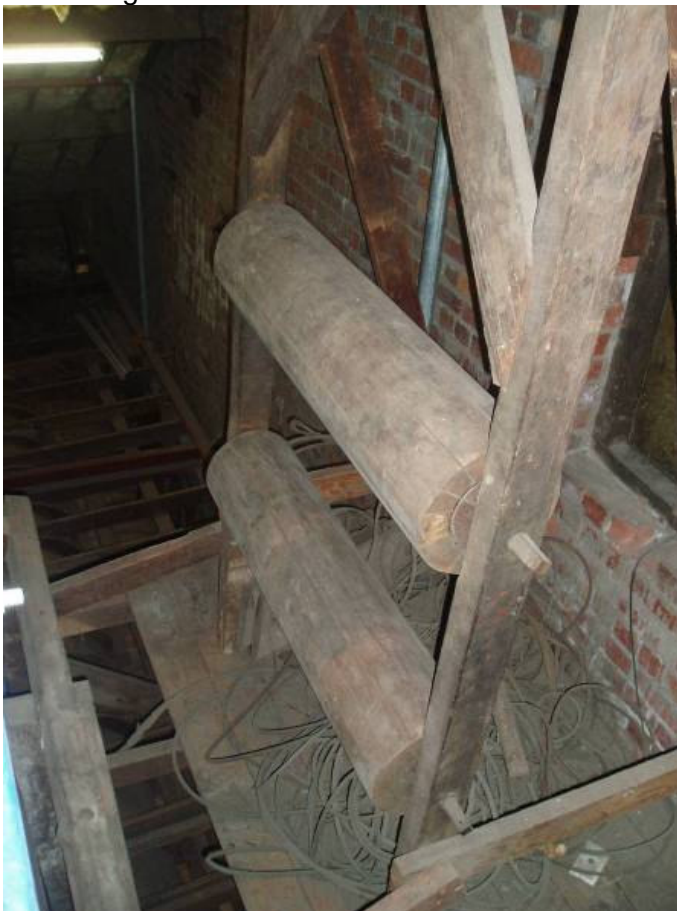
Photograph 28

Note former windlass structure to slide dome panels.

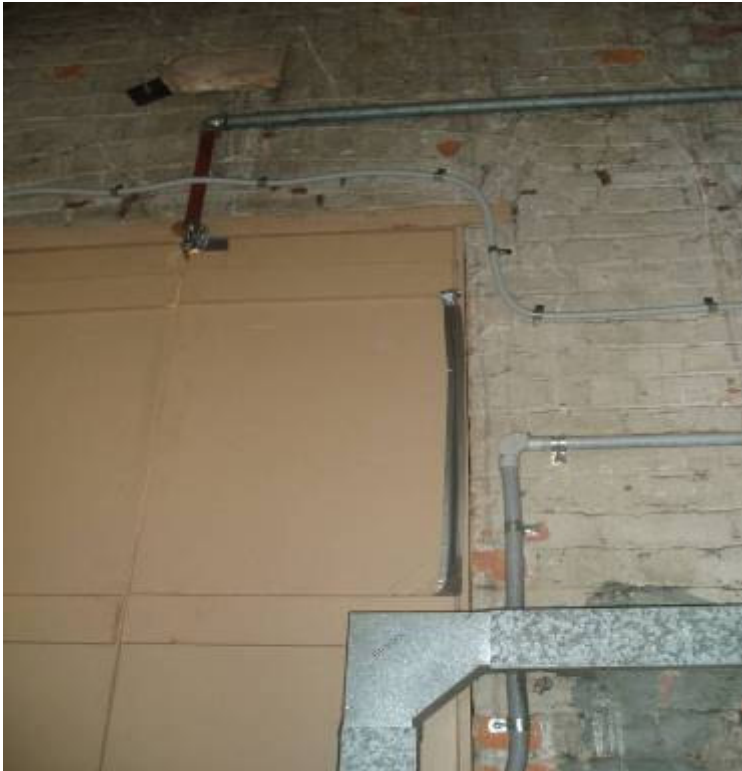
Photograph 32A

Note vertical brick growth crack to northeast corner of fly tower very visible to painted face of brickwork internally and less noticeable to unpainted face brick externally. Crack can be re-pointed if desired and would prevent further water entry into brick wall.

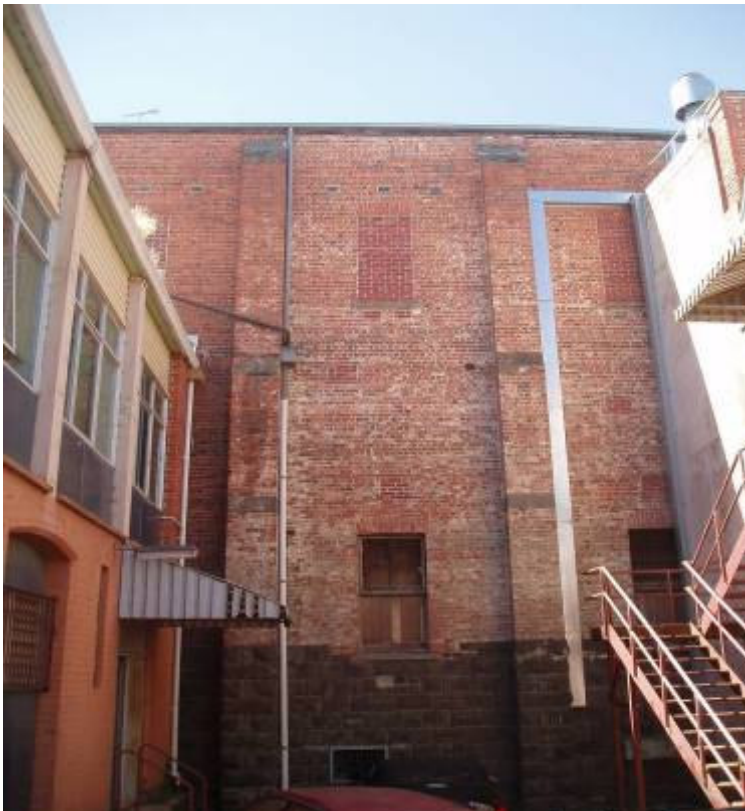
Photograph 33

Upper windows have been bricked and sealed, lower window has not been and has broken window sashes and opportunity for water entry. Opening should be water proofed against water entry to masonry.

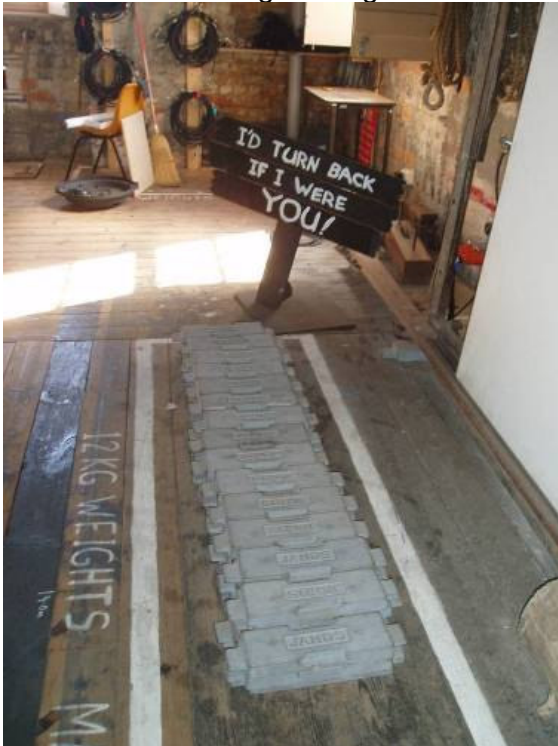
Photograph 34

The counterweights to the fly grid were spread over an area by limiting the height of the stacks (see photograph 34) and this is crucial to ensure heavy concentrated dead loads are not exerted on the light timber floors in the future.

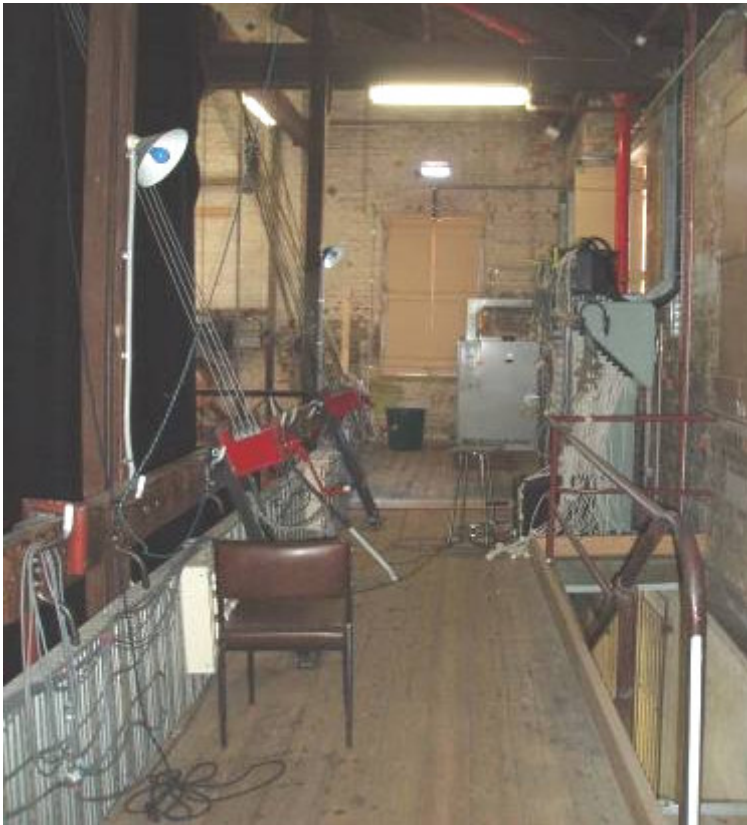
Photograph 36

Southern fly gallery

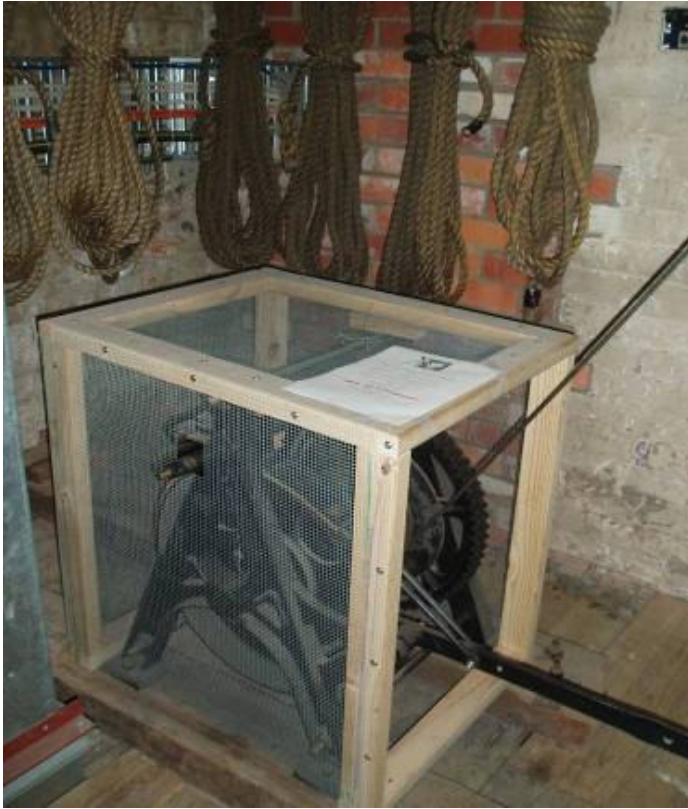
Photograph 37

Safety cage to lifting winch south fly tower gallery.

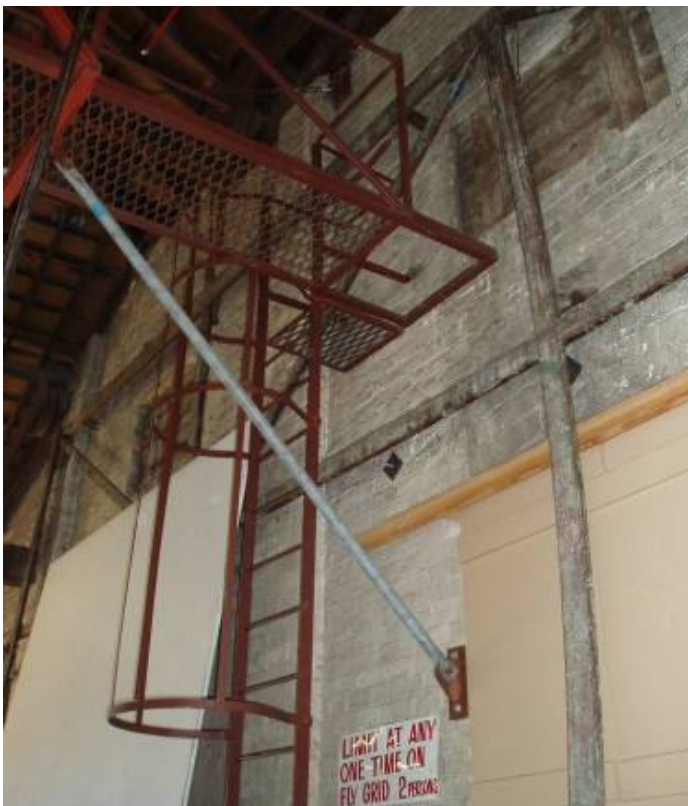
Photograph 38

Steel access ladder and catwalk to rear (east) wall of fly tower. Note old timber set frame that could be raised and lowered through a slot in the rear of the fly tower floor for set painting and preparation.

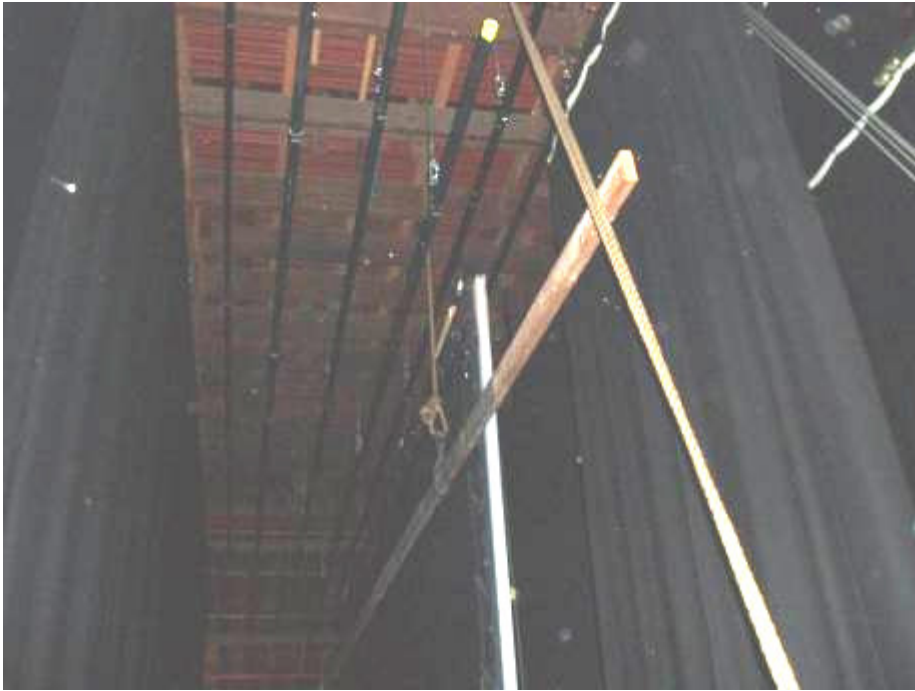
Photograph 40

Rear of fly tower with timber hip half trusses.
