Her Majesty's Theatre Compliance, Facilities & Operational Upgrade

Feasibility Report – Stage 3 Works

17 Lydiard Street South, Ballarat VIC 3350

December 2019

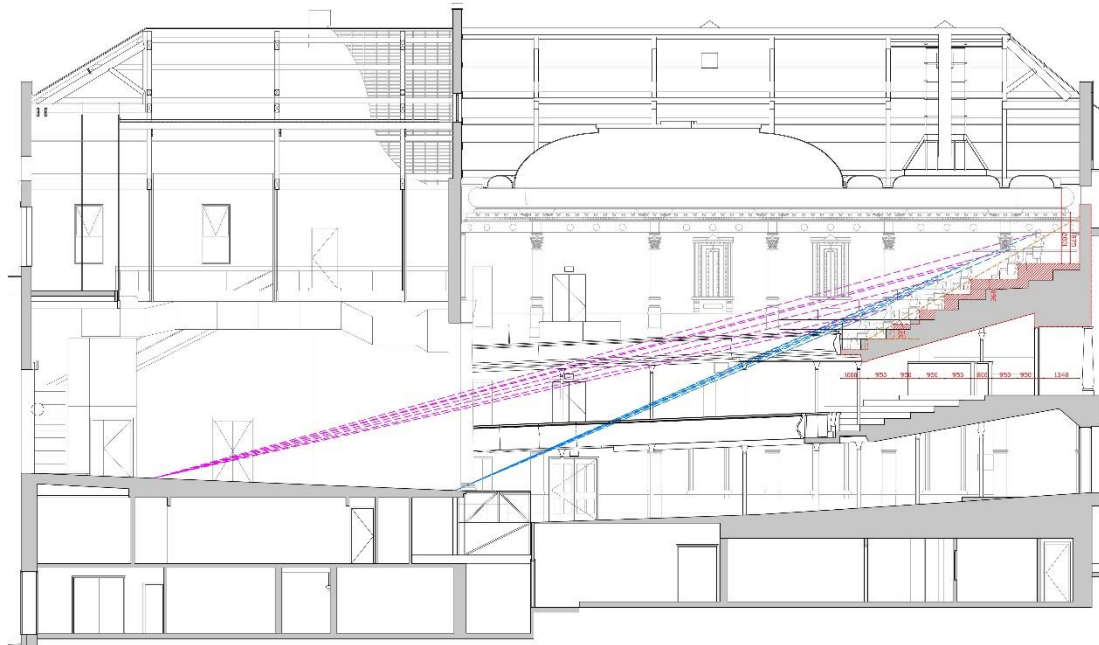
Figure 6 Sectional study of the re-raking of the balcony level to improve sight lines. Note that two rows of seats are removed to re arrange the plats for improved sight lines.

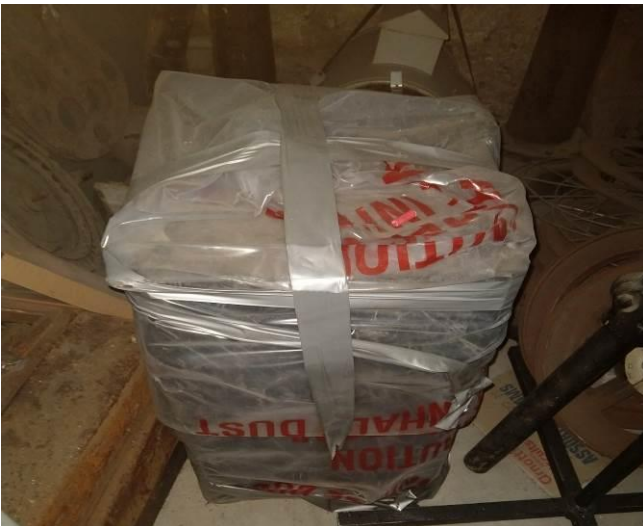
Photo 3 – Sub Basement Switch room wrapped asbestos labelled item

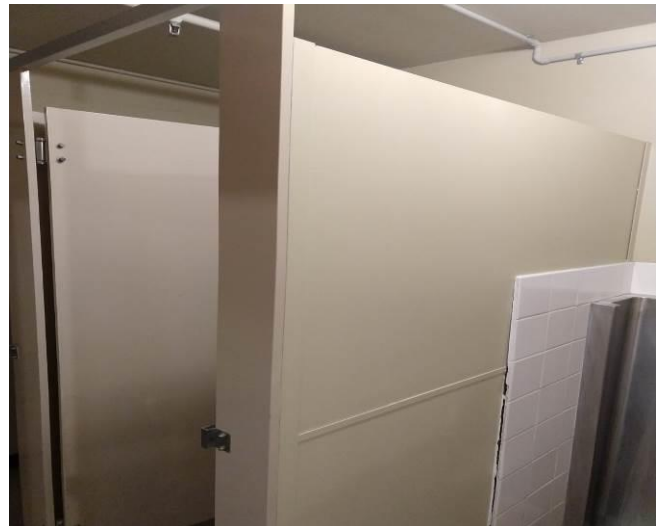
Photo 4 – Sub Basement Male WC 2 fibro cement urinal surround

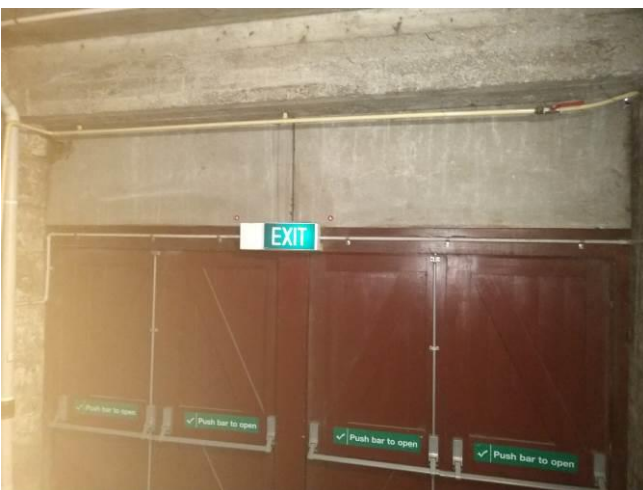
Photo 5 – Basement Auditorium fire escape fibro cement infill panels above exit doors

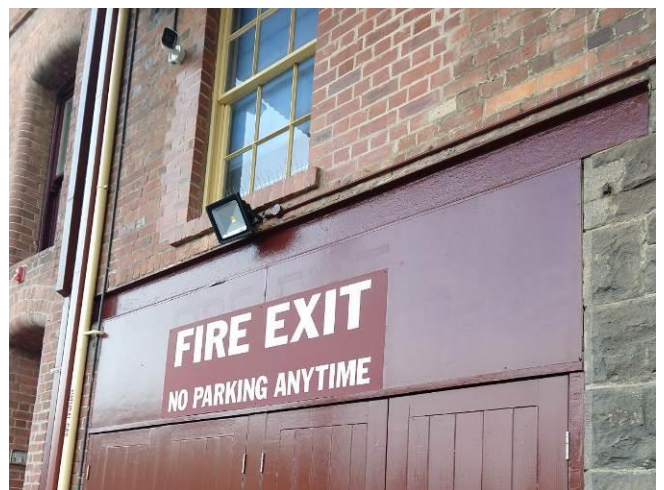
Photo 6 – Externals Auditorium fire escape fibro cement infill panels above exit doors

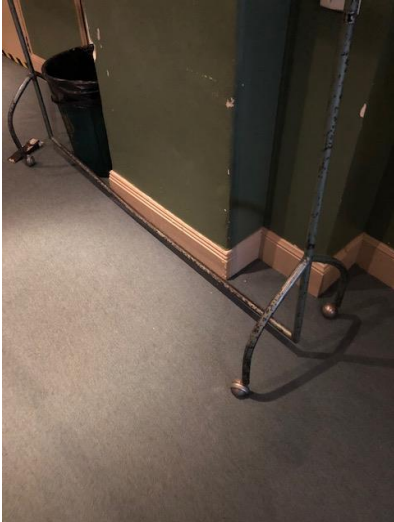
Photo 7 – Green room floor skirting has lead containing paint

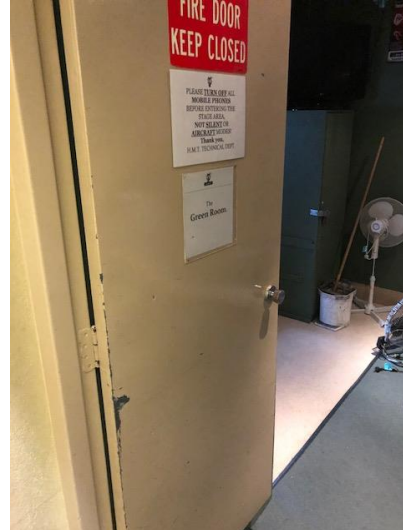
Photo 8 – Green room metal door has lead containing paint

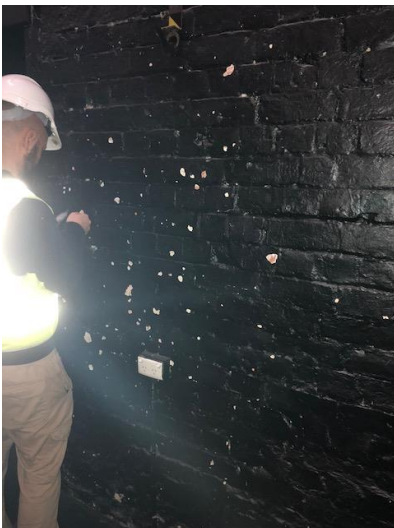
Photo 9 – Stage wall does NOT have lead paint

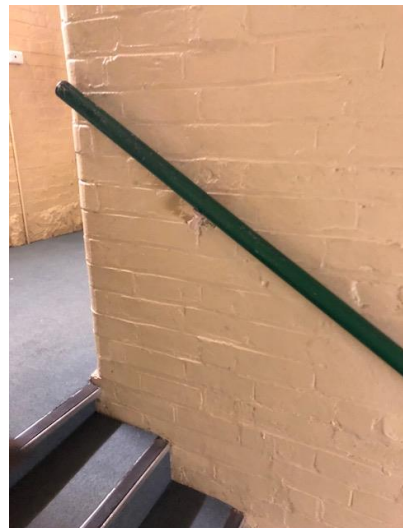
Photo 10 – Stage stairs do NOT have lead paint

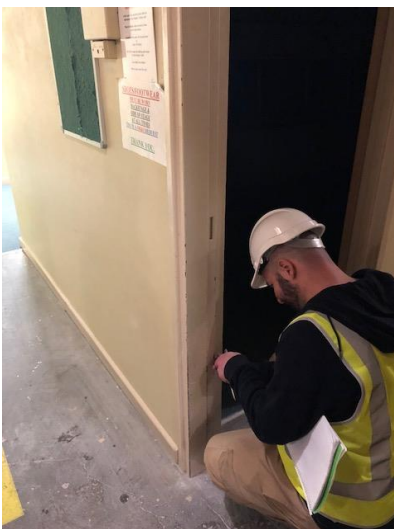
Photo 11 – Basement dresser door frame has lead coated paint

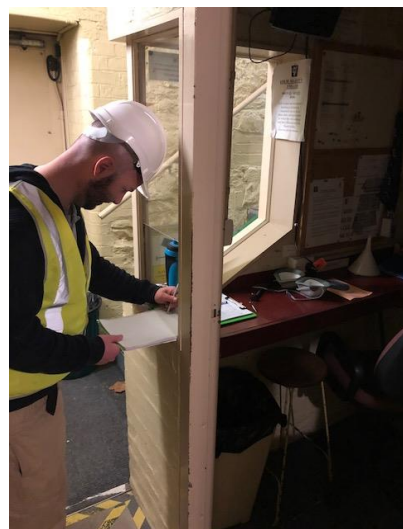
Photo 12 – Sub basement ticket booth door frame does NOT have lead coated paint

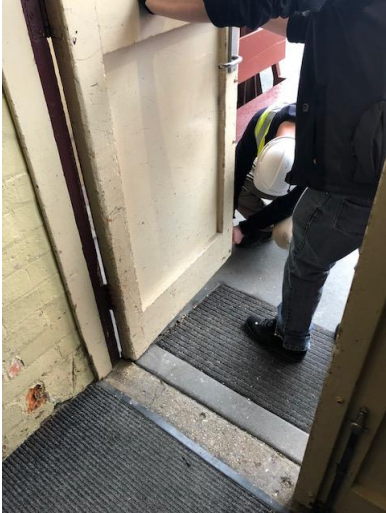
Photo 13 – Sub basement stage door does NOT have lead containing paint

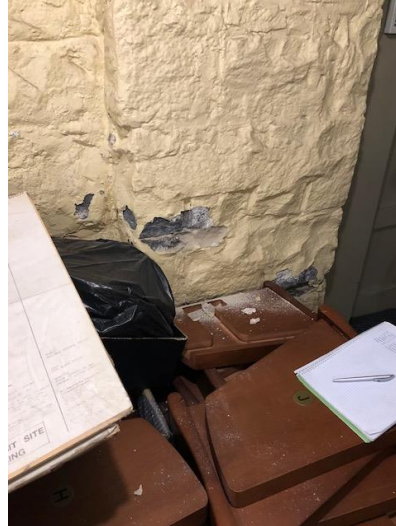
Photo 14 – Offices foyer wall does NOT have lead containing paint

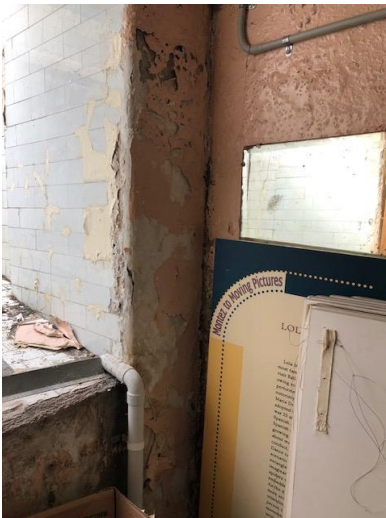
Photo 15 – Candy bar store wall has lead containing paint

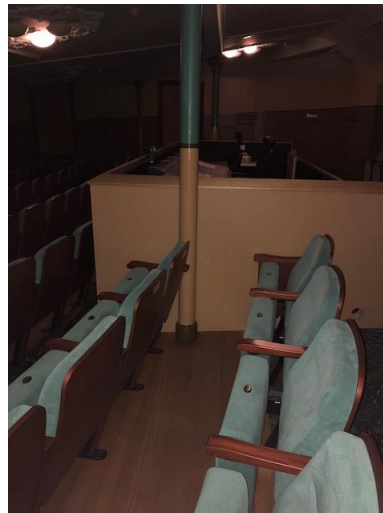
Photo 16 – Stalls pillars have lead containing paint

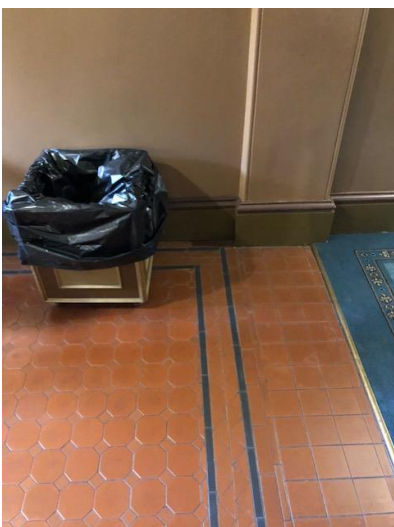
Photo 17 – North entrance lower skirting Has lead containing paint

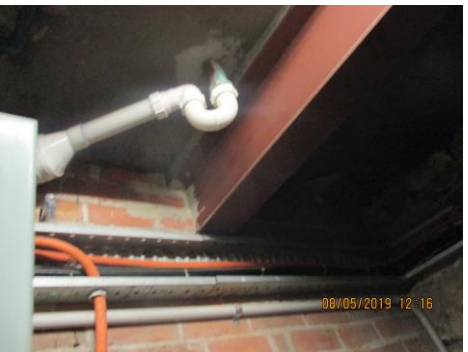
Item	Requirements	Location	Inspection Findings	Recommendation	Photo/Figure Reference
C1.1 Fire-resisting construction	For a Class 9b building with a rise in storeys of 4 (see item C1.2), the building is required to be of Type A construction (the most fire-resisting construction methodology noted in the BCA) with the following requirements: 1. Floors to achieve 120 minute FRL. 2. Fire walls to achieve 120 minute FRL. 3. Beams, columns, trusses etc. to achieve 120 minute FRL.	Throughout	There were several issues in respect of fire-ratings, including: 1. Unprotected timber columns in various areas. 2. Unprotected steel beams supporting floors above. 3. Non-fire-rated timber floor structures in various areas. 4. Unprotected steel columns and floor structure at the east side (Lewis Street). 5. Unprotected steel columns in the auditorium.	Since the trigger for full upgrades per Regulation 233 will be activated, fire engineering analysis of retaining the existing structure in its current form will be required, possibly subject to some upgrades (Heritage constraints permitting). We do note the long-term intent to increase the height of the Green Room area which would increase the load on the existing Lewis Street columns. This would need to be included in the fire engineering and structural analysis.

Unprotected steel beam

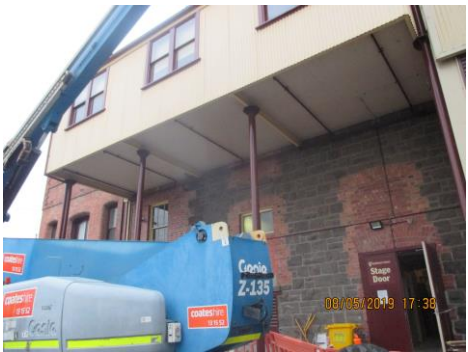
Non-fire-rated structural columns

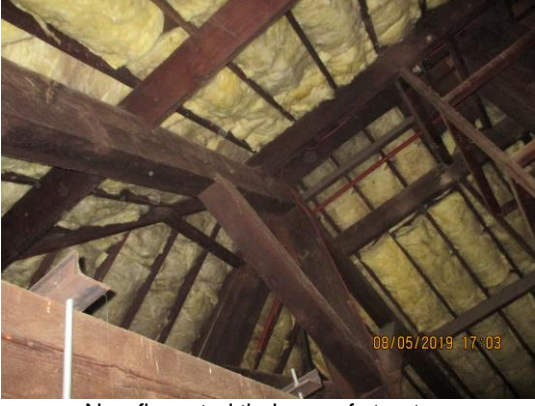
Exposure of external walls to adjacent building
C1.1 Fire-resisting construction	In a Type A building, the roof must achieve an FRL of 120/60/30, unless one of the following conditions are satisfied: 1. Sprinkler system installed throughout the building. 2. The building has a rise in storeys of 3 or less. 3. The building is Class 2 or Class 3. 4. The building has an effective height of less than 25m and the ceilings are treated to achieve a 60 minute FRL.	Roof space.	The original roof is constructed from timber beams and trusses which will not achieve the required fire-ratings, despite one of the conditions noted being satisfied. We do however note that some new steel trusses have been installed as part of the rectification works process.	Rationalise the lack of fire-rating to the roof as part of the fire engineering process associated the Stage 2 works. We note that the roof space itself is sprinkler-protected so this should be relatively easy to justify.

Non-fire-rated timber roof structure

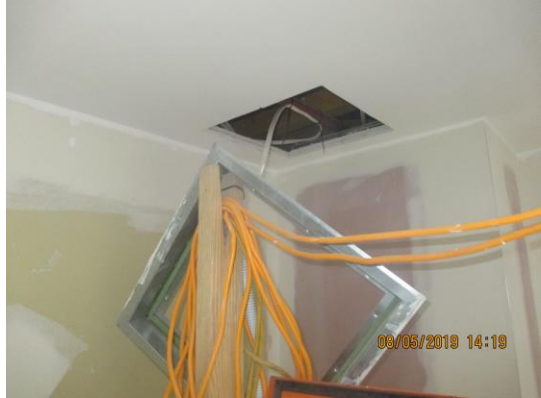
Item	Requirements	Location	Inspection Findings	Recommendation	Photo/Figure Reference
C3.15 Openings for service installations	The fire engineering report prepared for the Stage 1 works required the provision of 1 x 13mm fire-rated plasterboard to the underside of the basement floor structure including protecting any openings in accordance with C3.15.	Basement	It was noted during our inspection that access panels have been installed in the fire-rated ceilings. It was further noted that holes for downlights have been drilled into the fire-rated ceiling.	Although the current architectural drawings specify fire-rated access panels, verify that the access panels installed are tested systems that do not impair the FRL of the plasterboard linings and are installed in accordance with the manufacturer's specifications. Verify that the downlights proposed to be installed will be protected with tested systems.

Verify FRLs of proposed access panels

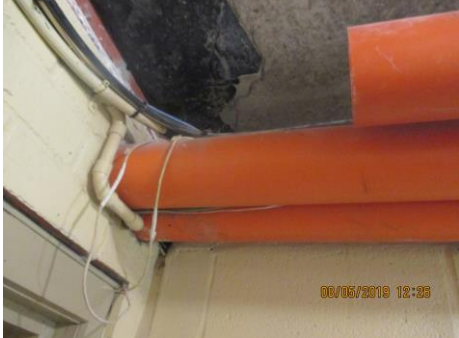
C3.15 Openings for service installations	Where fire-rated building elements are penetrated by services, those penetrations must be treated in accordance with this Clause so as not to detrimentally affect the fire-rating of the element concerned.	Various	Multiple unprotected penetrations were observed throughout the building, including: 1. Walls between switchroom (B1.42) and substation (B1.43). 2. PVC pipe and other penetrations through the Basement 1 fire wall between backstage and auditorium fire compartments.	A passive fire services contractor should be engaged to audit the building and prepare a matrix of tested fire-stopping systems for installation. Installation of the systems should then be carried out as part of the scope of a building permit; either an amendment to the Stage 1 building permit or as part of Stage 2.

Unprotected PVC pipe penetrations

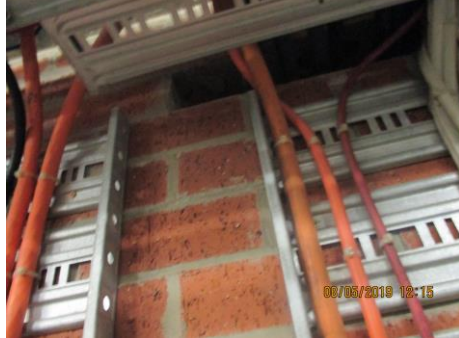
Unprotected opening in fire-rated wall

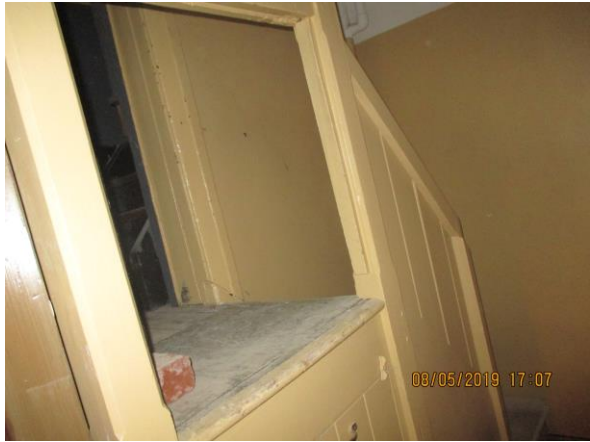
D2.3 Non-fire-isolated stairs and ramps	Required non-fire-isolated stairs and ramps are required to be of concrete, 6mm steel or timber with specific characteristics.	Stair to Bio Box	The stair to the Bio Box is timber and will very likely not satisfy the requirements of this Clause.	Reconstruct the stair to fully comply with current requirements.

Timber stair to Bio Box
D2.4 Separation of rising and descending flights	If a stairway is required to be fire-isolated, there must be no direct connection between flights serving storeys above ground level and flights serving storey below ground level.	Northwest stair	The northwest stair, which connects 4 storeys, is required to be fire-isolated and connects storeys above and below ground level at the Lydiard Street side.	As part of the Stage 2 works, rationalise the existing situation with fire engineering analysis.

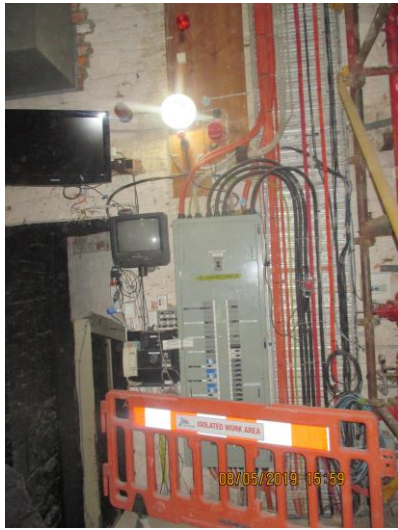
Item	Requirements	Location	Inspection Findings	Recommendation	Photo/Figure Reference
D2.7 Installations in exits and paths of travel	If switchboards are installed in paths of travel to exits, they must be enclosed in non-combustible construction and have doors fitted with smoke seals.	Stage	Switchboard in Stage area does not have doors or smoke seals.	Replace the switchboard with a compliant alternative or install a door fitted with smoke seals. Verify that all other switchboards in the building meet this requirement.

Non-conforming switchboard located on path of travel
D2.8 Enclosure of space under stairs and ramps	For a required, non-fire-isolated stairway, the space underneath must not be enclosed to form a cupboard unless 60 minute fire-rated construction is provided.	Unicorn Lane Fire Escape Room B1.46 GF.078 Stair serving Bio Box	The space underneath the Unicorn Lane fire escape has been enclosed to form the entrance lobby to Basement 1 but the construction is not fire-rated as required to be. The space beneath the southeast stair has been enclosed to form Room B1.46 and the mechanical plant area. The space beneath the South Stairs has been enclosed to form a lift shaft. The space beneath the stair serving the Bio Box has been enclosed to form a cupboard.	We do note the long term intention to construct a new fire-isolated stair to the north elevation, which would resolve the Unicorn Lane issue. Rationalise the enclosure of the space beneath the other stairs using fire engineering analysis. We understand that it is proposed to demolish the South Stair and lift as part of the Stage 2 works, thereby resolving this issue. This stair should be demolished and a compliant alternative constructed in its place, without storage beneath.

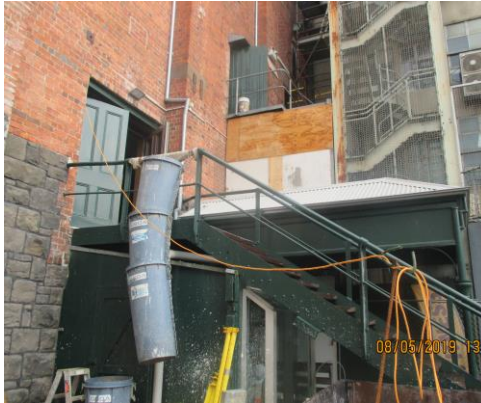
Enclosure of space under required non-fire-isolated stair

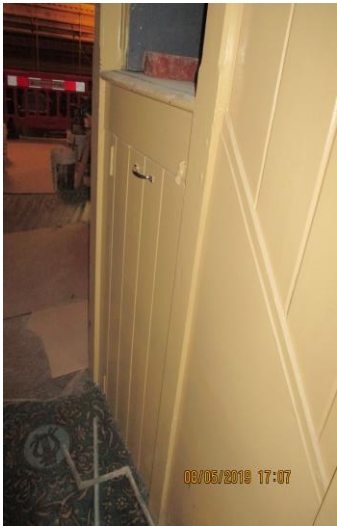
Enclosure of space under Bio Box stair

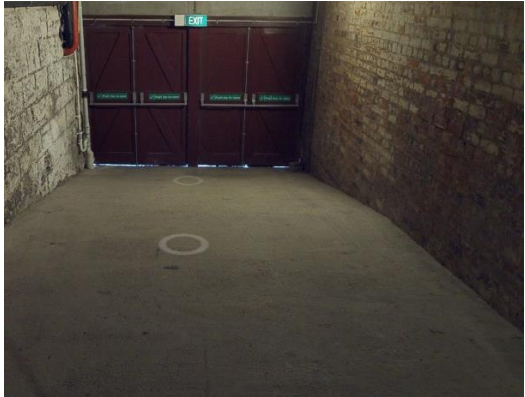
D2.10 Pedestrian ramps	Where a ramp is serving as a required exit, such as a fire-isolated ramp, it must have a gradient no steeper than 1:8.	South fire escape	The south fire escape stair discharges into a fire-isolated corridor at Basement 1 level which is connected to the exit door by a ramp. The gradient of the ramp is inconsistent and feels very steep in parts.	Verify the gradient of the ramp and, where found to be steeper than 1:8, carry out alterations to even out the surface to have a consistent gradient of not more than 1:8 at any point.

Verify ramp gradient

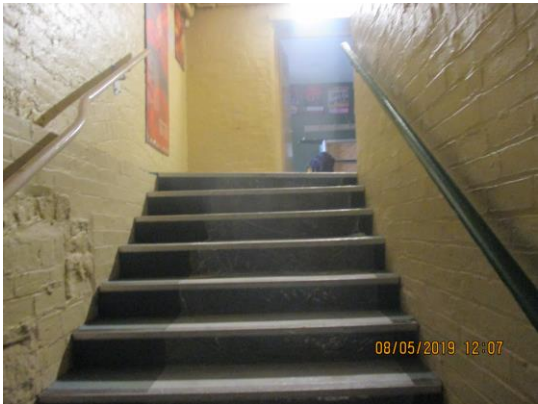
Item	Requirements	Location	Inspection Findings	Recommendation	Photo/Figure Reference
D2.13 Goings and risers	Stairs must satisfy BCA requirements in respect of dimensions, namely: <ul style="list-style-type: none"> Riser heights between 115mm and 190mm. Going dimensions between 250mm and 355mm (public stairs). In addition, a stair must have consistent dimensions throughout the same flight.	All stairs	The dimensions of individual stair components were found to vary significantly within the same component; for example, riser height 170mm at one end and 190mm at the opposite end. In addition, multiple stair flights within the building had inconsistent dimensions throughout the same flight.	Carry out remedial works to stairs where possible to achieve greater consistency of dimensions.

Top riser show significant variance
D2.13 Goings and risers	Stairs must satisfy BCA requirements in respect of dimensions, namely: <ul style="list-style-type: none"> Riser heights between 115mm and 190mm. Going dimensions between 250mm and 355mm (public stairs). In addition, a stair must have consistent dimensions throughout the same flight.	Bio Box	The stair serving the Bio Box is non-compliant in most aspects.	It is noted from review of the Stage 2 documentation that the stair serving the Bio Box is not proposed to be altered. We would strongly recommend that, as a minimum, the installation of a compliant AS 1657 arrangement be considered for this area.

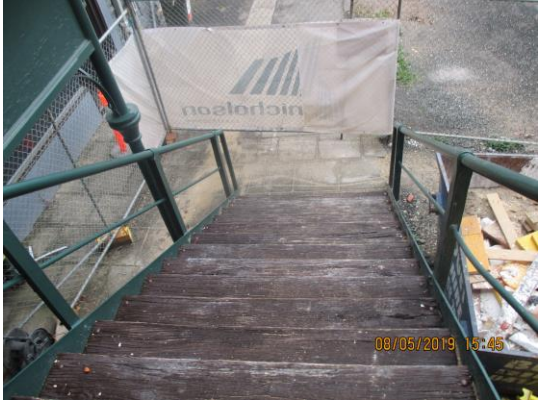
D2.14 Landings	Stair treads and landings must satisfy minimum BCA slip resistance requirements.	Unicorn Lane fire escape	Unicorn Lane fire escape stair treads were observed to be in poor condition.	Although it is noted that the stairs to the north of the building are proposed to be demolished as part of the Stage 2 scope, we recommend that non-slip nosing strips are provided in the interim.

Stair treads in poor condition

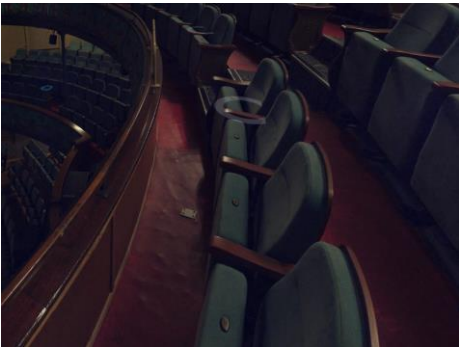
D2.16 Barriers to prevent falls	<p>Where a person could fall 1m or more, suitable barriers to prevent falls must be installed.</p> <p>Required barriers must have a minimum height of 1m above level surfaces and 865mm above the line of stair nosings.</p> <p>Where installed in front of fixed rows of seating, barrier height can be 700mm provided there is a horizontal projection of 1m from the top of the balustrade.</p> <p>Barriers must also contain no openings that are greater than 125mm in size.</p>	<p>Auditorium – Gallery & Dress Circle</p> <p>Northwest corner of Gallery</p>	<p>Barriers provided along the front edge of the Gallery and Dress Circle, preventing significant falls, were measured to be approximately 690mm in height in lieu of the minimum required 1m.</p> <p>It is possible to fall more than 1m from the top level of seating, thereby requiring a balustrade. Currently only a handrail is provided.</p>	<p>In tandem with the line of sight issues noted, formulate a solution to increasing the safety levels of the balustrade. One potential option could be to install a horizontal projection in lieu of increasing the height. This would increase safety levels whilst preserving sightlines.</p> <p>Consider the provision of a BCA-compliant balustrade to this area.</p>

<p>Low balustrade in sight line</p>

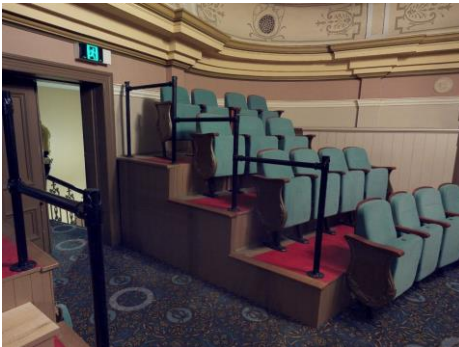
<p>Barrier required to prevent falls</p>

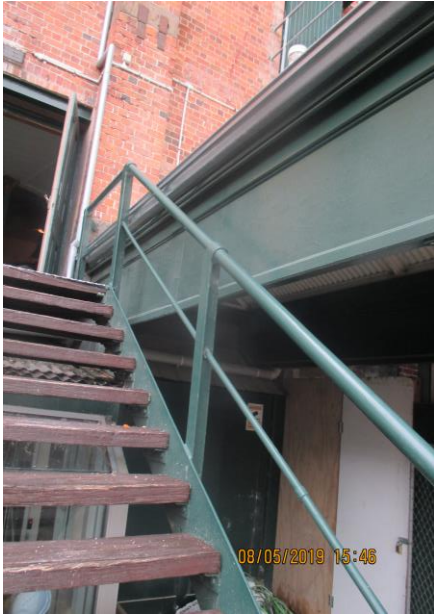
D2.16 Barriers to prevent falls	<p>Where a person could fall 1m or more, suitable barriers to prevent falls must be installed.</p> <p>Required barriers must have a minimum height of 1m above level surfaces and 865mm above the line of stair nosings.</p> <p>Barriers must also contain no openings that are greater than 125mm in size.</p> <p>Where a person could fall 4m or more, the barriers must not have any horizontal elements that could facilitate climbing.</p>	<p>Unicorn Lane Fire Escape</p> <p>North External Fire Escape</p>	<p>The balustrade provided to the Unicorn Lane fire escape is 940mm in height in lieu of the minimum required 1m and has openings that exceed the maximum 125mm permitted by the BCA.</p> <p>The openings to the external north fire escape balustrade, at 460mm, exceed the maximum 125mm permitted by the BCA.</p>	<p>Whilst we understand that the Stage 2 aim is to demolish this stair, consideration should be given to augmenting the balustrade in the interim.</p> <p>Whilst we understand that the Stage 2 aim is to demolish this stair, consideration should be given to augmenting the balustrade in the interim.</p>

<p>Balustrade to Unicorn Lane fire escape</p>

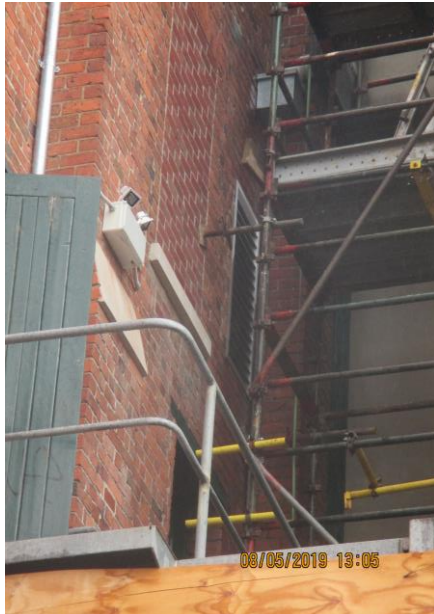
<p>North external fire escape</p>

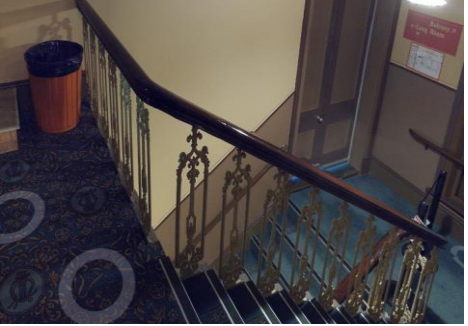
Item	Requirements	Location	Inspection Findings	Recommendation	Photo/Figure Reference
D2.16 Barriers to prevent falls	<p>Where a person could fall 1m or more, suitable barriers to prevent falls must be installed.</p> <p>Required barriers must have a minimum height of 1m above level surfaces and 865mm above the line of stair nosings.</p> <p>Barriers must also contain no openings that are greater than 125mm in size.</p> <p>Where a person could fall 4m or more, the barriers must not have any horizontal elements that could facilitate climbing.</p>	Northwest Stair (02.02)	The balustrade at the top of the internal northwest stair is only 820mm in height in lieu of the minimum required 1m.	Increase the height of the balustrade to be a minimum of 1m from FFL in line with BCA requirements.

820mm balustrade to north stair
		Stair serving Bio Box	There is effectively no balustrade provided to the stair serving the Bio Box on the northwest stair side, rather only a handrail mounted at 860mm. The section of balustrade on the inside of the Bio Box is too low.	This stair should be demolished, and a compliant alternative constructed including balustrades as required.

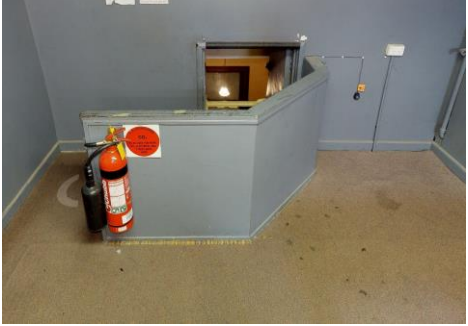
Balustrade to inside of Bio Box

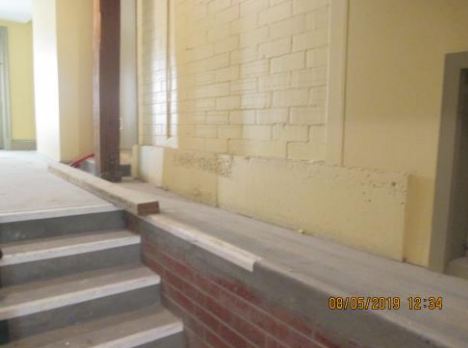
Basement 1 stair	It is possible to walk along a ledge on one side of the stair in the Basement 1 E-W corridor with no barrier to falls.	Erect a barrier to prevent people walking along the side of the stair in the corridor. We do note that this stair will not be present once Stage 2 works are implemented.

Possible to walk along ledge with no barrier
D2.17 Handrails	<p>A handrail must be provided along at least one side of every ramp or stairway.</p> <p>Handrail terminations must comply with AS 1428.1-2009.</p>	South fire escape	The stair discharges to a ramp which leads to the outside. No handrails are provided to either side of the ramp.	Install a handrail to at least one side of the ramp.

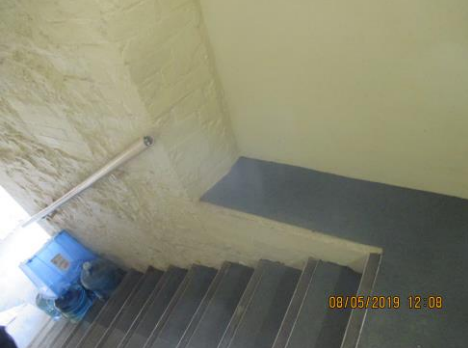
Handrail not continuous for full stair flight
		Rear stairwell	Handrail to the bottom flight is not continuous.	Extend the handrail to be continuous for the full stair flight.

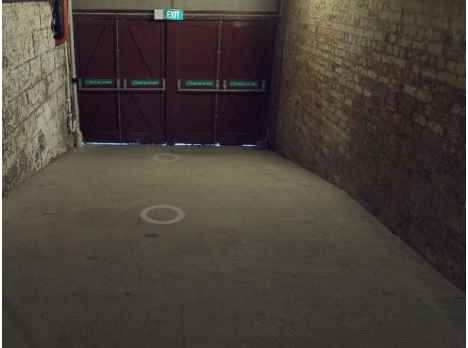
No handrails to steep ramp

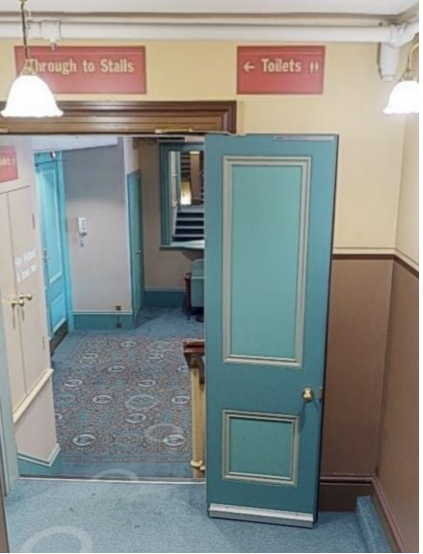
Door swing against egress direction
D2.21 Operation of latch	Hardware to doors is required to be downward lever action mounted between 900mm and 1100mm from floor level.	Throughout	Multiple doors throughout the building are provided with old style knob-type hardware.	As part of Stage 2 scope, and Heritage constraints permitting, upgrade door hardware throughout the building as required. We note that this is in the feasibility report as being part of Stage 2 scope.

Upgrade knob type hardware

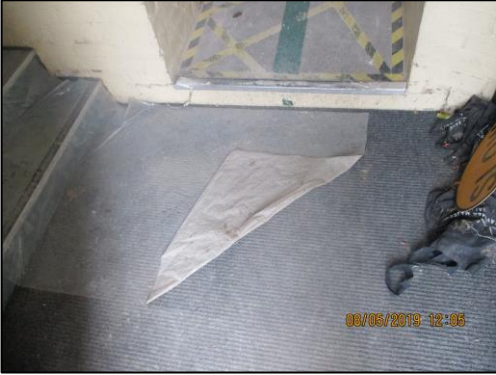
Item	Requirements	Location	Inspection Findings	Recommendation	Photo/Figure Reference
<p>D3.1</p> <p>General building access requirements</p>	<p>For Class 9b buildings, access for persons with disabilities must be provided to and within all areas normally used by the occupants.</p> <p>AS 1428.1-2009 requires accessways within a building to be level with no steps or other impediments.</p>	Various	<p>Numerous areas in the building are not accessible due to varying floor levels, including but not limited to:</p> <ol style="list-style-type: none"> 1. A 125mm step exists in the Basement 1 back of house corridor outside B1.46. 2. B2.18 and B2.19 are only accessible by stairs. 	<p>In conjunction with the access consultant, and considering the Stage 2 works, formulate a holistic strategy for access within the building.</p>

<p>125mm step in path of travel</p>
<p>D3.3</p> <p>Parts of buildings to be accessible</p>	<p>For Class 9b buildings, access for persons with disabilities must be provided to and within all areas normally used by the occupants.</p> <p>All stairs in buildings required to be accessible must comply with AS 1428.1-2009 in respect of accessibility features.</p>	All internal stairs.	<p>No internal stairs are provided with complying handrails to both sides of the flight, tactile ground surface indicators (TGSIs) at the top and bottom or highlighted, non-slip nosing strips.</p>	<p>Considering the Heritage constraints of the building, and in conjunction with an access consultant, formulate a holistic solution to the provision of access for persons with disabilities with appropriate Performance Solutions being ratified by a building permit.</p> <p>We note from the Stage 1 Feasibility Report that this is a long term project aim.</p> <p>The stair from GF.06 to GF.05 can only be provided with a single handrail because of the fire hydrant and fire hose reel cupboard.</p> <p>The stair to B2.14 will not be able to have compliant handrail terminations at the bottom since it adjoins a corridor.</p>

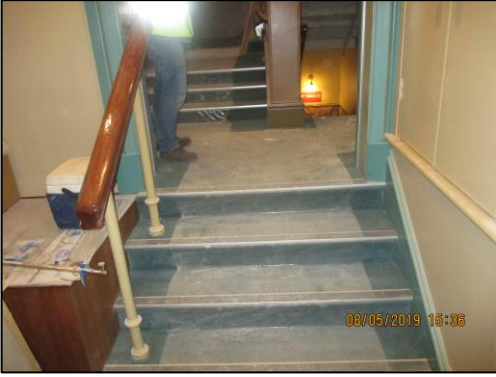
<p>Cupboard on stair and exmaple of non-conforming hadnrail</p>

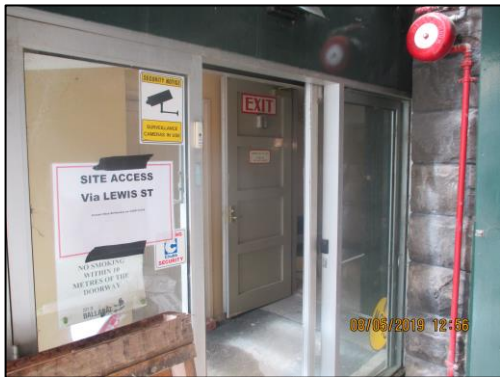
D3.12 Glazing on an accessway	On an accessway, fully glazed walls and doors must be clearly marked in accordance with AS 1428.1. AS 1428.1 requires that glazing capable of being mistaken for an opening be provided with solid band visual decals of minimum thickness 75mm with the bottom edge at a height between 900mm and 1000mm from floor level.	Northern Basement 1 entrance lobby area	No visual decals provided to full height glazed panels comprising Basement 1 entrance lobby. We do note however that this area is scheduled for demolition as part of the future upgrade works.	Until the area is demolished, provide visual manifestation in accordance with AS 1428.1-2009 to these partitions.

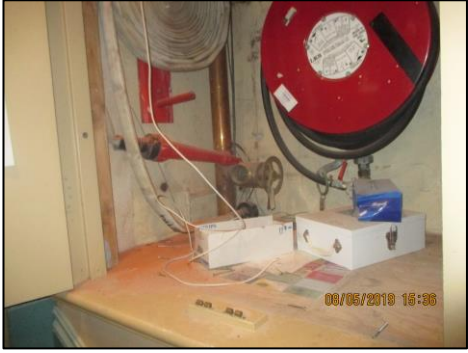
Item	Requirements	Location	Inspection Findings	Recommendation	Photo/Figure Reference
<p>E1.3 Fire hydrants</p>	<p>Since the size of the building exceeds 500m², full coverage from a compliant fire hydrant system is required.</p>	<p>Throughout</p>	<p>All the existing fire hydrants were observed to have the following defects:</p> <ol style="list-style-type: none"> 1. Threaded connections and lay flat hoses in lieu of Storz connections. 2. 80mm pipe size in lieu of current required 100mm. 3. The outlets point directly down to the ground in lieu of being angled at 35 degrees to the horizontal. 4. Being located more than 4m from an exit. <p>Some of the internal hydrants were noted to have accessibility issues, being:</p> <ol style="list-style-type: none"> 5. Level 2 hydrant in auditorium is obstructed by wooden panelling, making access difficult. 6. Ground floor fire hydrant and hose reel cabinet is located adjacent a stair flight, meaning that operators of this equipment would need to be standing on the stair. 	<ol style="list-style-type: none"> 1. Replace the threaded connections with Storz connections. 2. Rotate hydrant outlets to be maximum 35 degrees from the horizontal. 3. Obtain fire brigade consent for the undersized hydrant main and the non-compliant locations. 4. Alter the timber panelling in the Level 2 auditorium to provide unencumbered access to the fire hydrant and hose reel. 5. Obtain fire brigade consent to retain the ground floor fire hydrant in its current position. 	<div style="display: flex; justify-content: space-around;"> <div data-bbox="1970 191 2407 520">

<p data-bbox="1970 520 2407 548">Fire hydrant installation obstructed access</p> </div> <div data-bbox="2427 191 2864 520">

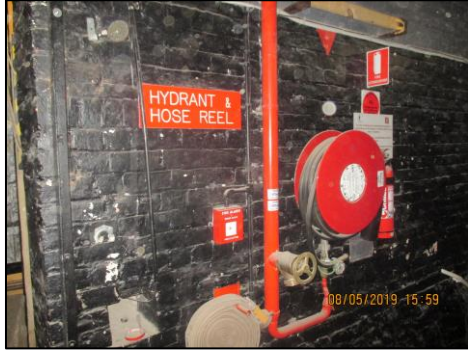
<p data-bbox="2427 520 2864 548">Fire hydrant more than 4m from an exit</p> </div> </div>

<p>E1.3 Fire hydrants</p>	<p>Since the size of the building exceeds 500m², full coverage from a compliant fire hydrant system is required.</p> <p>Since the building is divided into fire compartments between 1000m² and 5000m² in area, 2 fire hydrants are required to flow simultaneously with a residual pressure in the system of 350kPa.</p>	<p>Throughout</p>	<p>Despite the information noted on the block plan at the booster assembly, test results from February 2018 show that the residual pressure when 2 hydrants are operating as required is 310kPa in lieu of the current minimum required 350kPa.</p> <p>It is however noted that previous editions of the AS 2419.1 permitted a pressure of 300kPa.</p>	<p>As part of the engagement process with the CFA for the major upgrade works, obtain report and consent for reduced pressure and flows, pursuant to Regulation 129 of the Building Regulation 2018.</p>

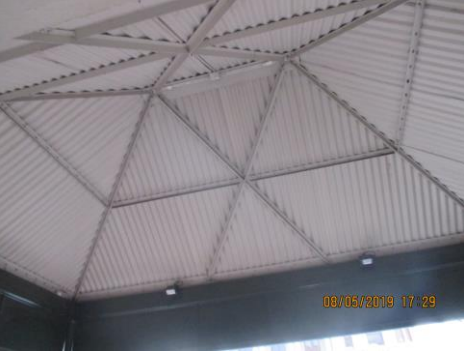
<p>E1.5 Sprinklers</p>	<p>Where some areas of buildings are protected by sprinklers and others are not, the areas must be separated from each other by construction having an FRL of 120/120/120.</p>	<p>Various</p>	<p>There were several areas with sprinklers missing that were not provided with fire-separating construction, including:</p> <ol style="list-style-type: none"> 1. Level 2 storage cupboard in south stairs. 2. Ground floor Audio Room (GF.108). 3. Ground floor Piano Store (GF.13). 4. Canopy at Lydiard Street entrance. 5. Cupboard adjacent and north of B1.18 and B1.19. 6. Various concealed spaces. 7. Sprinklers obstructed in 02.06 plant room. 	<p>Since the fire engineering report for Stage 1 requires sprinkler protection throughout with the exception of the auditorium, ensure that sprinklers are provided to all noted areas that do not currently have them.</p> <p>Where sprinklers are obstructed, rectify to ensure no obstructions.</p> <p>Ensure also that sprinklers are provided to all doors rationalised by the Stage 1 fire engineering report to be smoke doors in lieu of fire doors are provided with the sprinklers stipulated in the report.</p> <p>It is also noted that the sprinkler installation is to the 1982 version of the AS 2118.1 in lieu of current editions. That said, recent test results confirm that the system is operational and functioning as required. Fire engineering verification of the retention of the outdated system will be required as part of the Stage 2 scope.</p>

<p>No sprinklers to external canopy</p>

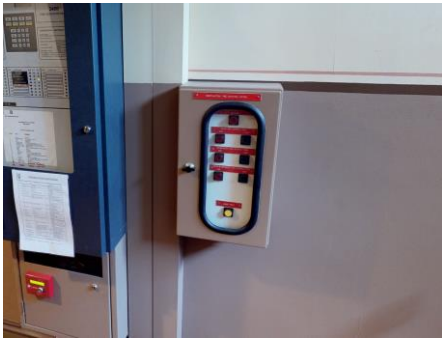
Item	Requirements	Location	Inspection Findings	Recommendation	Photo/Figure Reference
E2.2 Smoke hazard management	A Class 9b building having a rise in storeys of more than 3 must be provided with one of the following: 1. Stair pressurisation system to fire-isolated exits. 2. Zone smoke control system complying with AS 1668.1. 3. Smoke detection and alarm system. 4. Sprinkler system throughout.	Throughout	Rather than specifically being provided with one of the options, the building is actually provided with a hybrid mixture of sprinklers and smoke detection system.	As part of the fire engineering associated with the Stage 2 component of the upgrade works, rationalise the provision of an approach to satisfying this clause.	
E2.2 Smoke hazard management	A theatre that has a stage and associated rigging loft must be provided with an automatic smoke exhaust system if the building has more than one storey.	Throughout	During the inspection, it was noted that a fire fan control panel (FFCP) exists at the fire indicator panel (FIP). However, it was not immediately clear whether a fully compliant automatic smoke exhaust system exists in the building.	Since it is highly unlikely that any installed automatic smoke exhaust system would comply with current requirements, we would recommend that this be assessed by fire engineering in Stage 2, noting the restrictions around a building that has such onerous Heritage implications.

Fire fan control panel

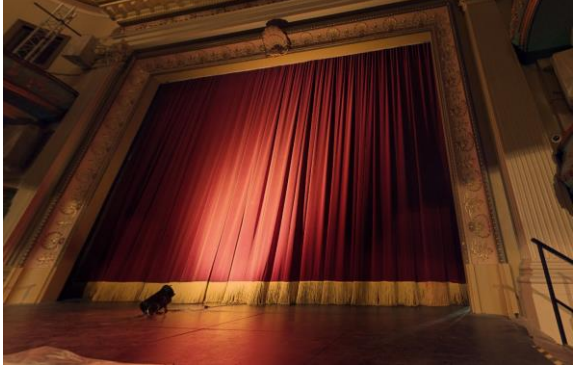
<p>H1.2 Separation</p> <p>H1.3 Proscenium</p>	<p>Where a theatre does not have a sprinkler system, the stage, backstage and accessible under stage area must be separated from the audience by a proscenium wall complying with Specification H1.3.</p>	<p>Stage</p>	<p>A proscenium wall exists but we were unable to determine the levels of compliance during our audit.</p>	<p>As part of the Regulation 233 process associated with the Stage 2 works, the fire engineer will need to verify the compliance levels of the existing proscenium curtain.</p>

<p>Proscenium curtain required</p>

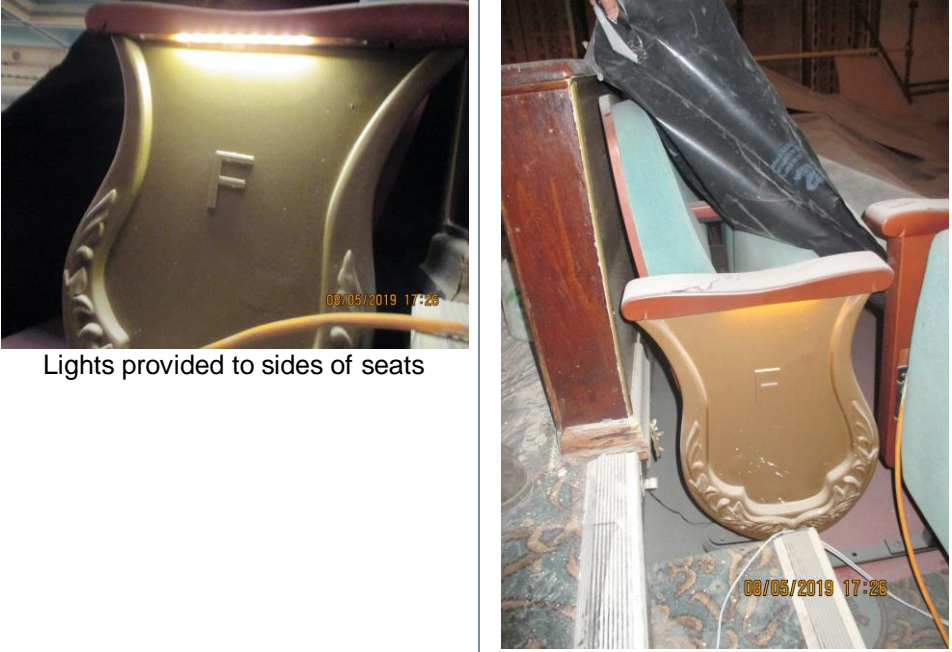
<p>Non-conforming stair with non-continuous handrails and gate opening halfway up.</p>
<p>H1.7 Aisle lights</p>	<p>In an auditorium, where the floor is stepped, aisle lights must be provided to illuminate the full length of the aisle and tread of each step.</p>	<p>Auditorium</p>	<p>Lights are provided on the side of the chairs along the aisle. No lights are provided to the tread of each step.</p>	<p>Upgrade aisle lighting to comply with BCA H1.7 as part of future works.</p>

<p>Lights provided to sides of seats</p> <p>No lighting to aisle treads</p>

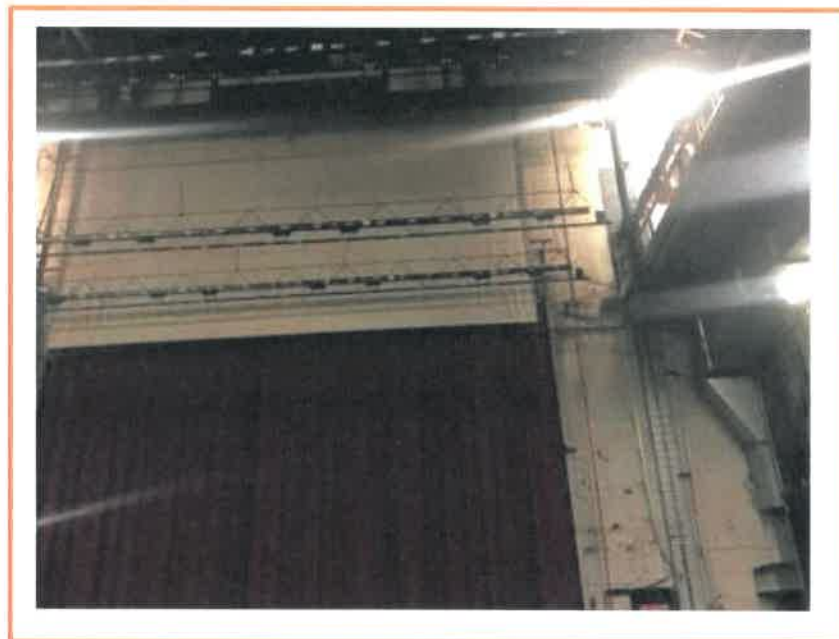
The building is provided with 2-off pre-existing walls that can form the basis for fire walls, one of which is provided with a proscenium curtain to separate the stage/back stage areas from the auditorium.

Figure 1: Proscenium Curtain (from stage side)

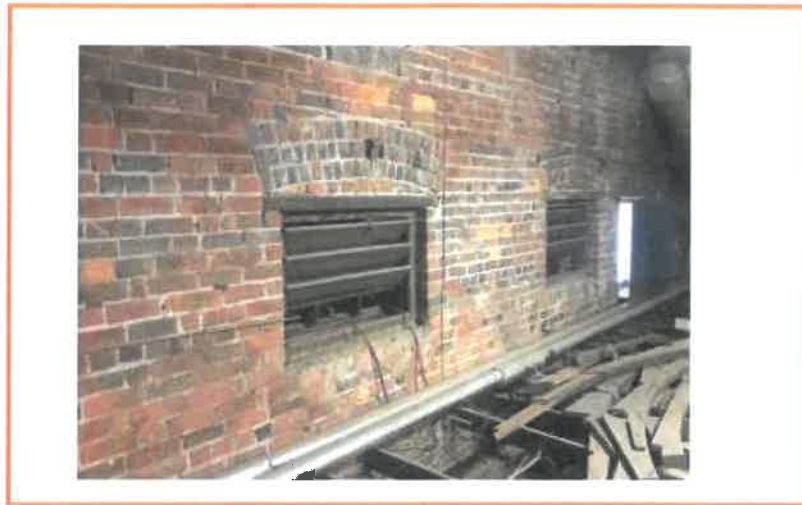
Figure 2: Existing West Wall Proposed Fire Wall in roof space (typical required upgrades)

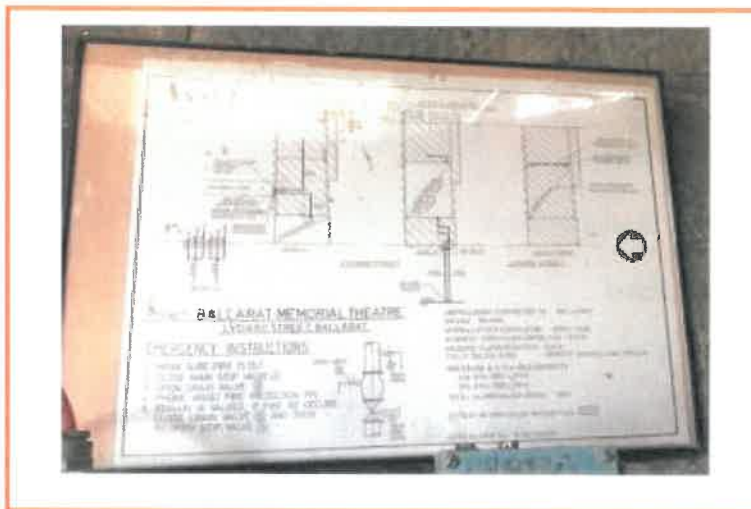
Figure 10: Sprinkler block Plan

The building is provided with automatic sprinkler protection in general accordance with AS 2118 throughout the building with the exception of the auditorium and minor areas in the basement associated with the organ areas (that connect back to the auditorium space).

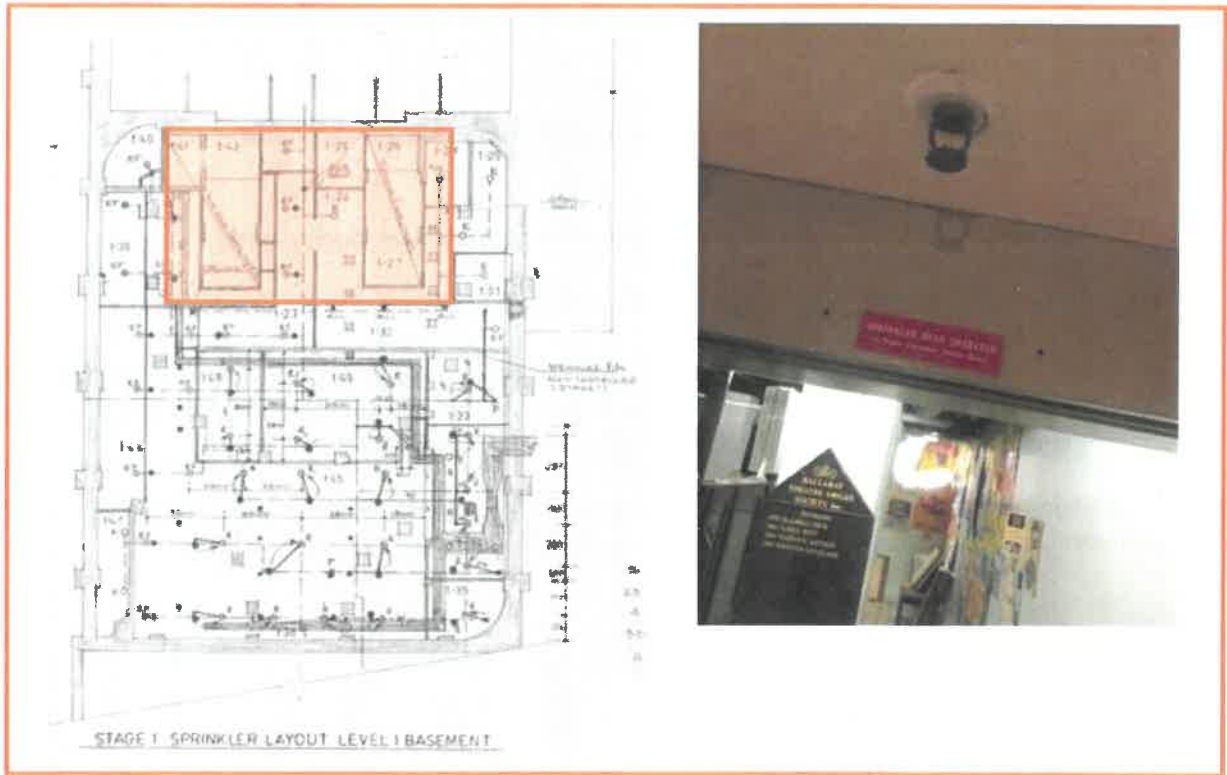
The organ rooms are provided with MJC sprinkler heads immediately outside, which drain back to an open head, to identify the location of a fire in the organ areas. The open/deluge heads are likely to wet down the immediate area and provide a water curtain between sprinkler protected and non sprinkler protected areas.

Figure 11: Non sprinkler protected area (organ areas)

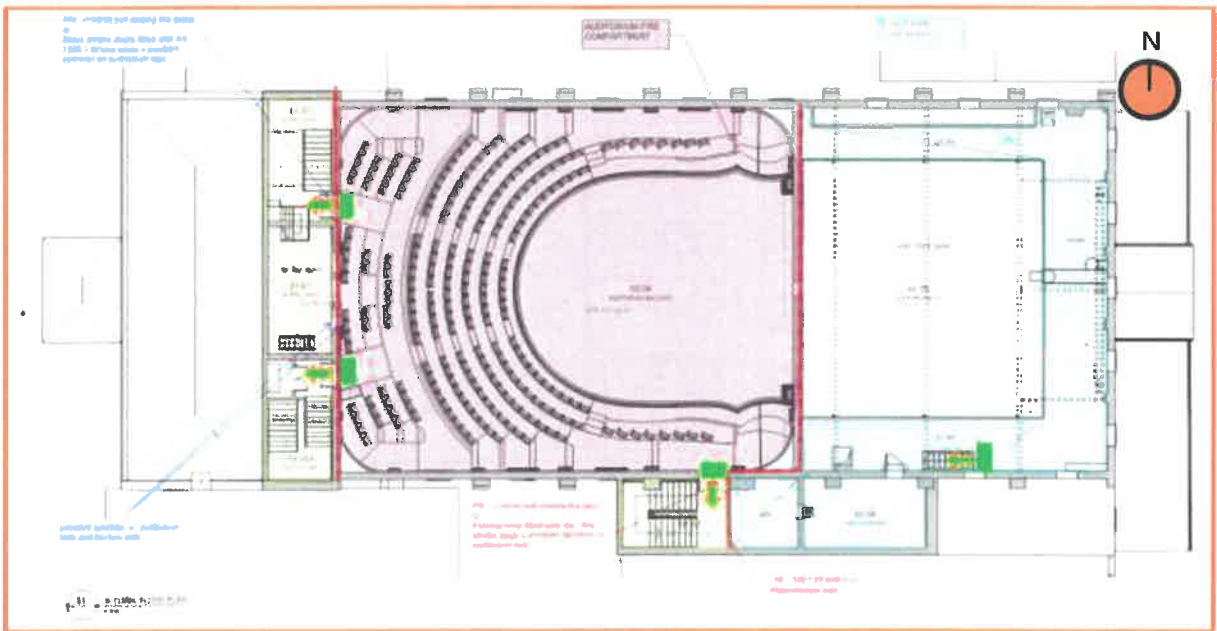
Second Floor Egress is provided with distances of travel to exits that are >20m to a single exit in the platform area stage side (30m). Bio Box adjoins the auditorium via glazed/operable openings in the existing fire wall.

Figure 18: Egress via Second Floor

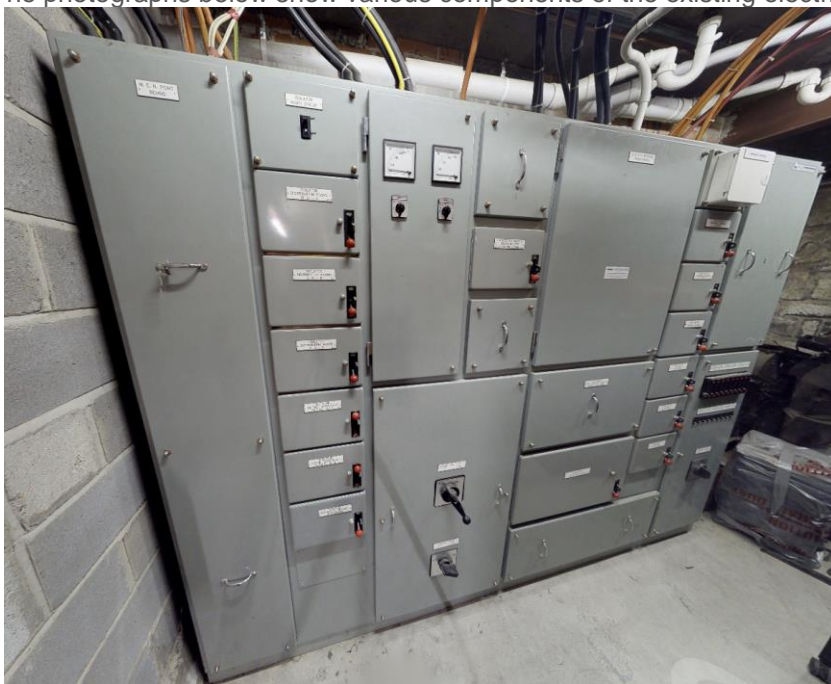
Main Switchboard – Basement Level 1

- Essential services on the MSB are not segregated and there is no means to isolate the incoming supply via a main switch. Therefore, the MSB is non-compliant. Further investigation would be needed to determine if the existing MSB can be modified to achieve compliance.

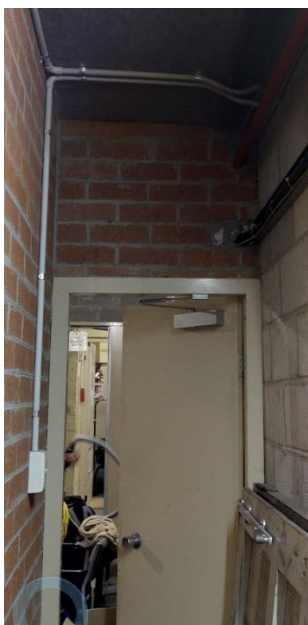
- Existing switchroom egress doorway is smaller in width and height than that required by AS3000:2018. Risk the doorway is required to be larger to achieve compliance.

Switchroom Egress Door – Basement Level 1
