Her Majesty's Theatre Compliance, Facilities & Operational Upgrade

Feasibility Report – Stage 3 Works

17 Lydiard Street South, Ballarat VIC 3350

December 2019

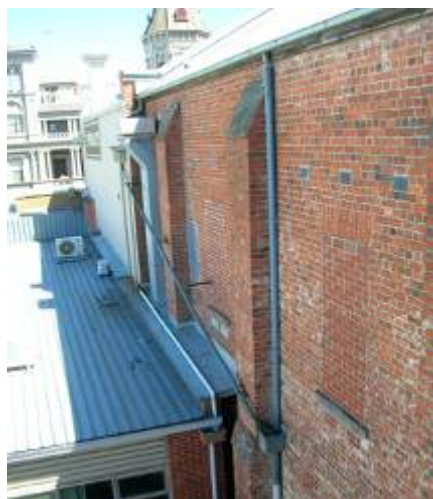
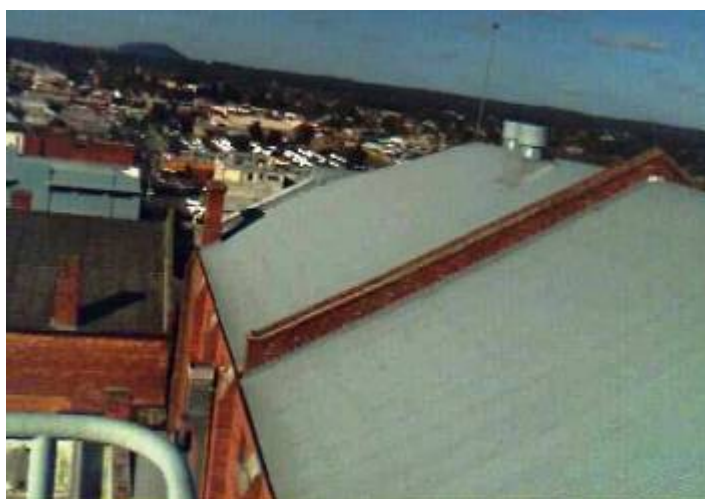
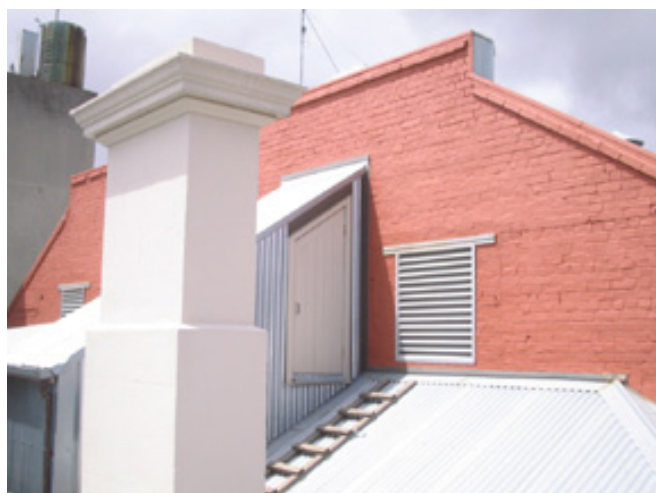
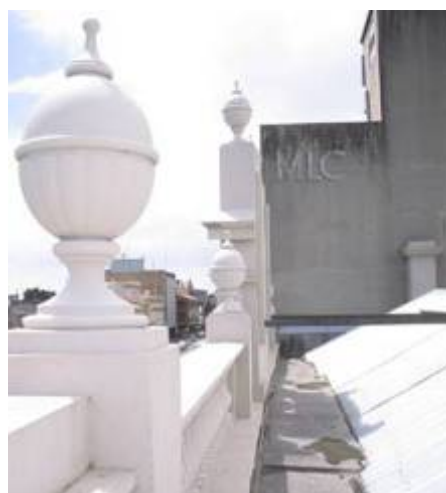
6.2.1 Roof and Stormwater

The original roof of the theatre was of slate and has since been replaced with corrugated iron and is currently in good condition. Box gutters have been well lined and are clean of debris.

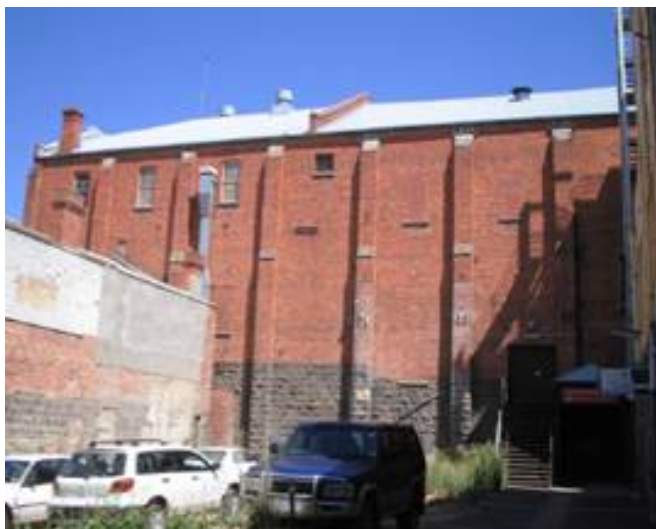
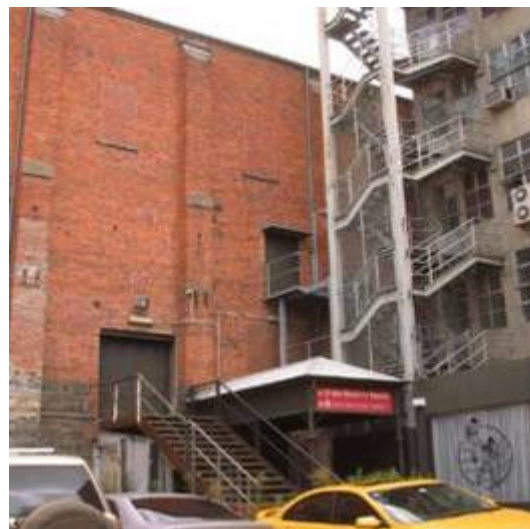
6.2.3 North Elevation (Unicorn Lane)

Constructed in bluestone to the lower levels and red brick to the upper levels, the north elevation has been temporarily revealed due to the demolition of the building to the rear of the Unicorn Hotel.

- Continue to maintain this elevation, if left as it is the fabric of the building will deteriorate to this elevation.
- Window joinery requires re-painting.
- Window sills require re-rendering and general repairs.
- The tops of the brick buttresses also require re-rendering to ensure that water does not penetrate down through the brickwork causing deterioration below.
- This elevation requires some urgent maintenance work including the re-pointing and repairs to the brick chimneys and the projecting brick proscenium arch wall.
- Check that the fire escape meets relevant building codes and repair or replace defective timber treads.
- Clean the roof to the entrance of debris and continue to monitor.

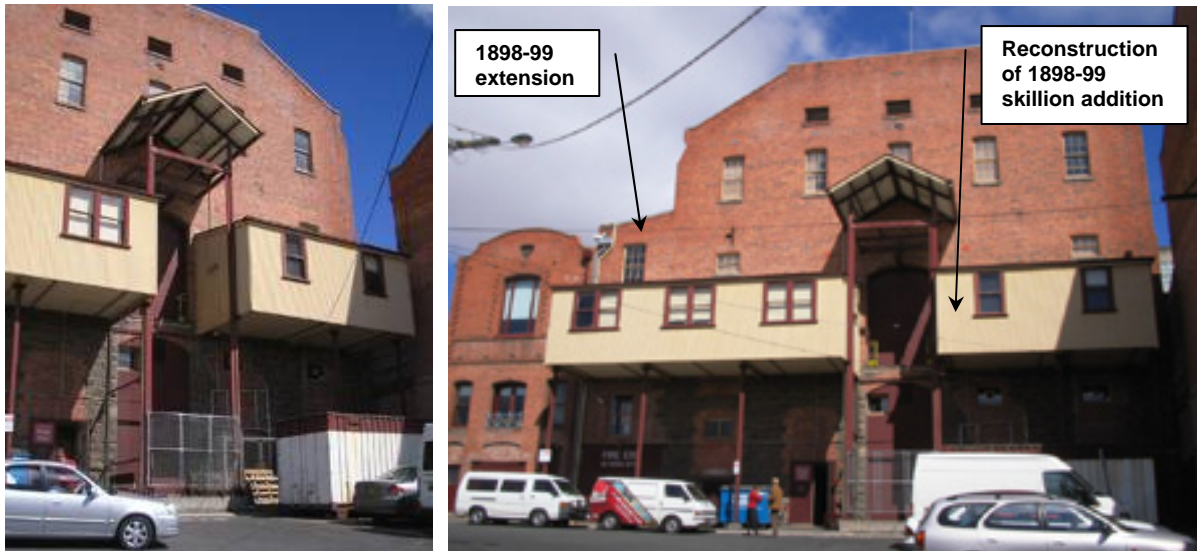
6.2.4 East (Rear - Lewis Street) Elevation

The east elevation is constructed in face red brick with bluestone to the lower levels. There have been a number of changes to this elevation. Generally it is in good condition, although there are areas of brickwork where mortar is missing, in particular below the upper southern window which corresponds to a crack which appears to travel down the building. This has resulted in missing mortar to the brickwork and bluestone at the lower levels.

- Continue to maintain this elevation.
- Re-point missing mortar to sections of brickwork and stonework.
- Opportunities to expand the theatre complex into the adjacent apartments, the Mechanics Institute or through the extension of the skillion addition should be investigated as part of the overall feasibility study.
- Surface mounted pipes are not considered appropriate and no further external piping or fittings should be permitted. In the long term, internal relocation of current surface mounted plumbing pipes is recommended.

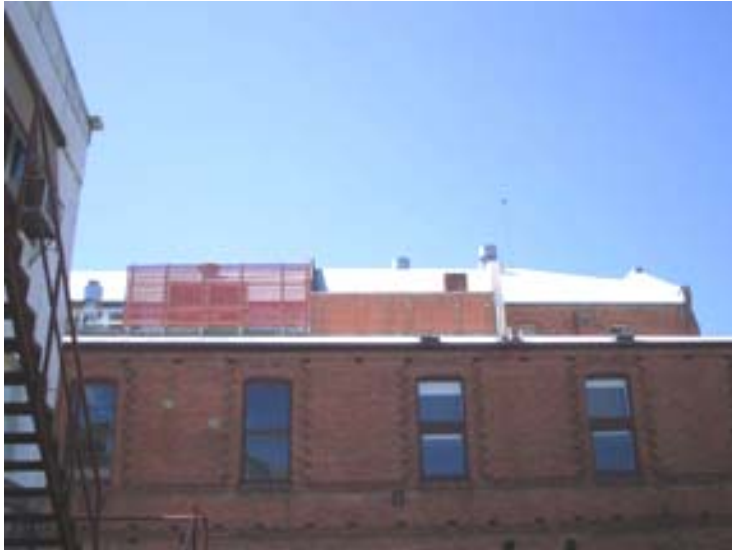
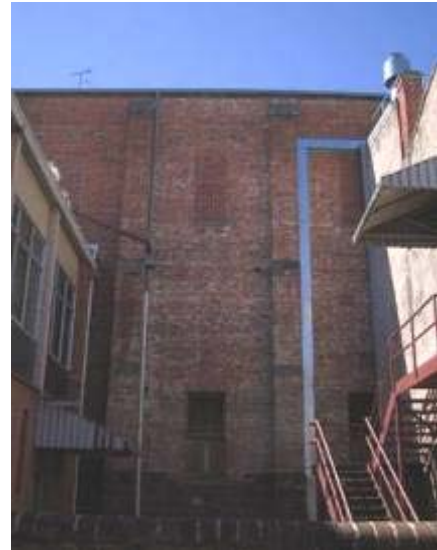
6.2.5 South Elevation

The south elevation is largely built against, but can be viewed above the roof of the adjacent southern building.

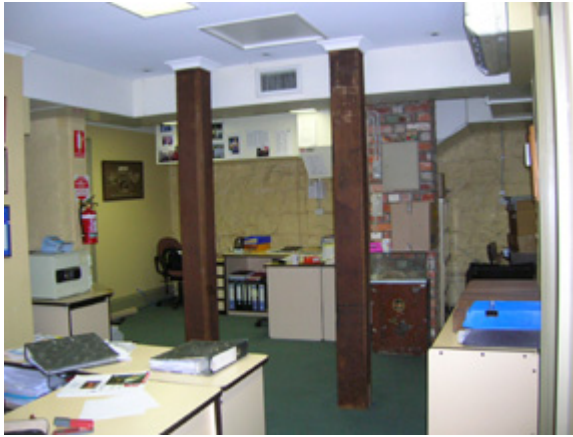
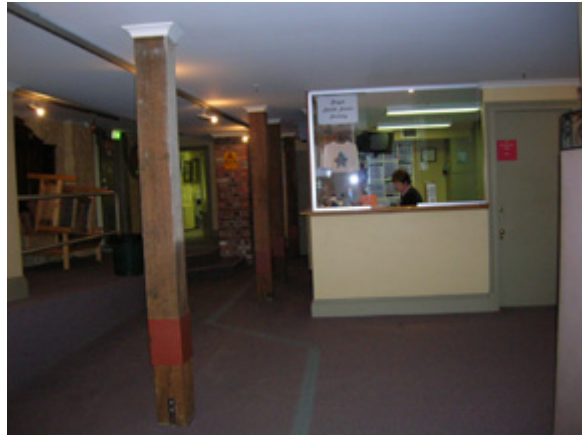
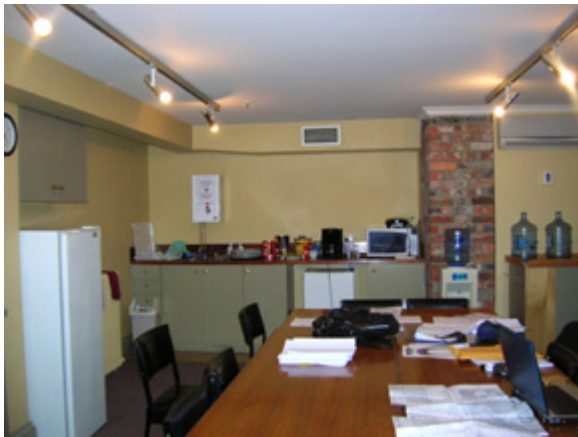
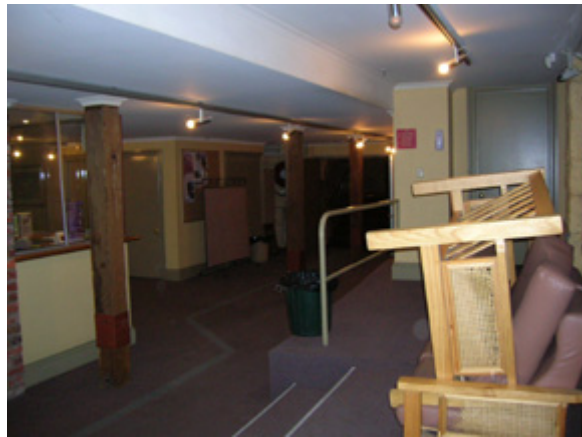
- **Sub-basement Level One - Theatre Offices Rooms (133, 139, 146,147 and other offices)**

The offices of both Her Majesty's Theatre and the Royal South Street Society were constructed during the 1988-90 restoration works. Formerly a basement storage area, the area also houses the Kittson Room (the RSSS's meeting/board room named in honour of J.F. Kittson, who played an important part in organising the acquisition of the theatre in 1965).

- Consider relocation of offices elsewhere or renovating offices to provide more comfortable work spaces.
- Removal of structure (eg. walls and posts) need to be assessed on a case by case basis as adaptation is anticipated.
- Consider installing a plaque or similar to convey the significance of the area beneath the Theatre Director's office.
- This area is already subject to a Permit Exemption Declaration and changes to this area are anticipated.

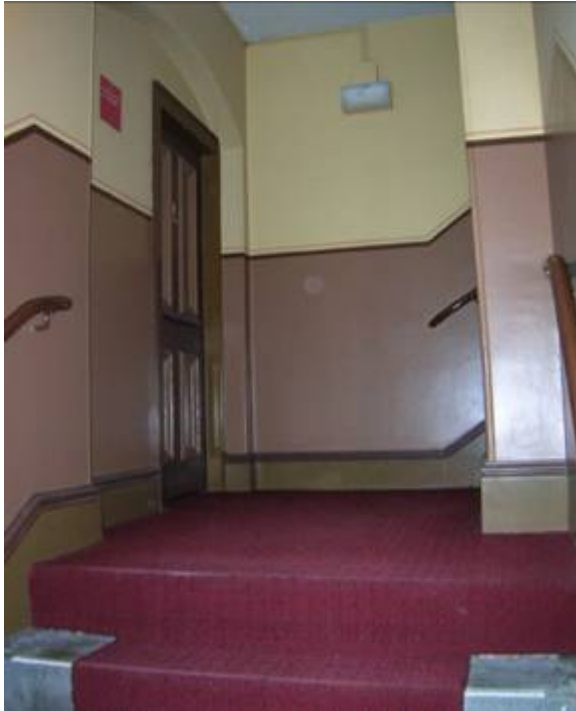
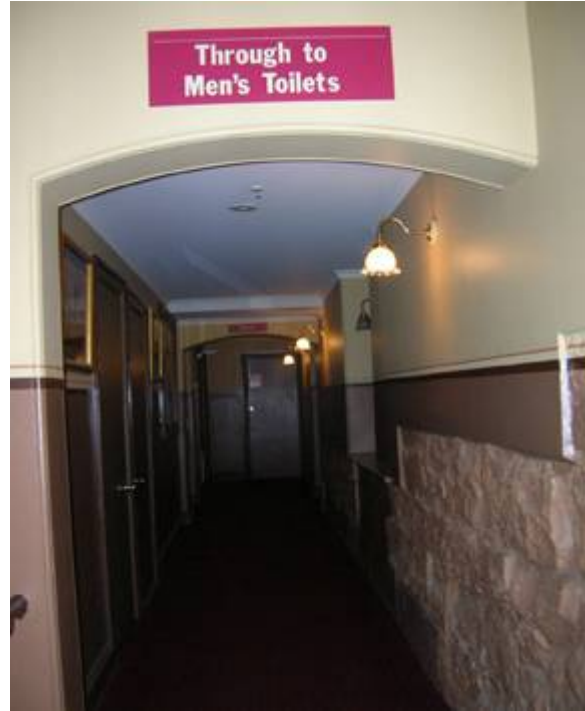
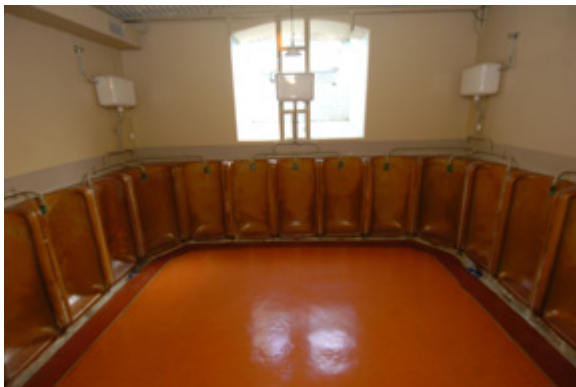
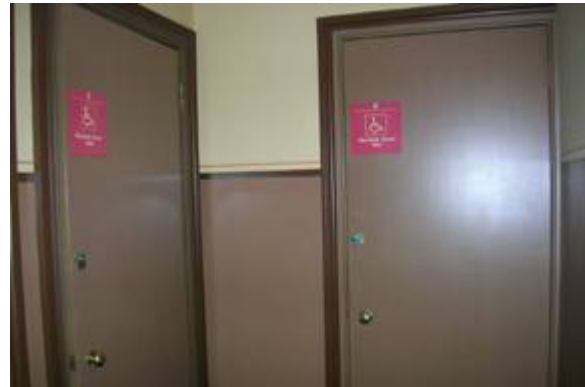
- **Basement Level Two - Amenities and Store Rooms (201-216)**

The main theatre toilets are housed in an area that was the storage basements of the original shops/offices in the front of the building. They were converted into toilets in 1927. The area is not an ideal location for amenities due to its distance from patrons.

- Continue to maintain this area.
- Upgrading of wet areas (including access for disabled) could be considered. Current disabled access does not comply and upgrading of the lift access zone is required.
- The men's urinal (214) is of interest and retention of early fittings is encouraged within a framework of current plumbing standards.

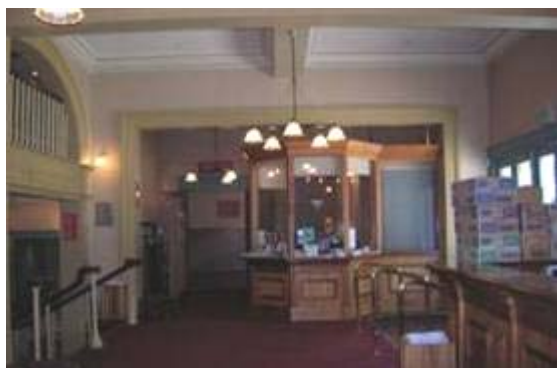
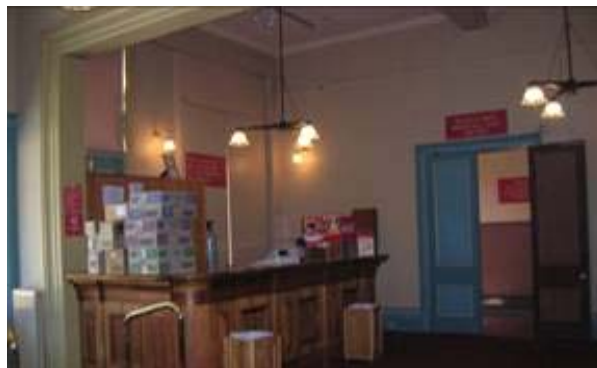
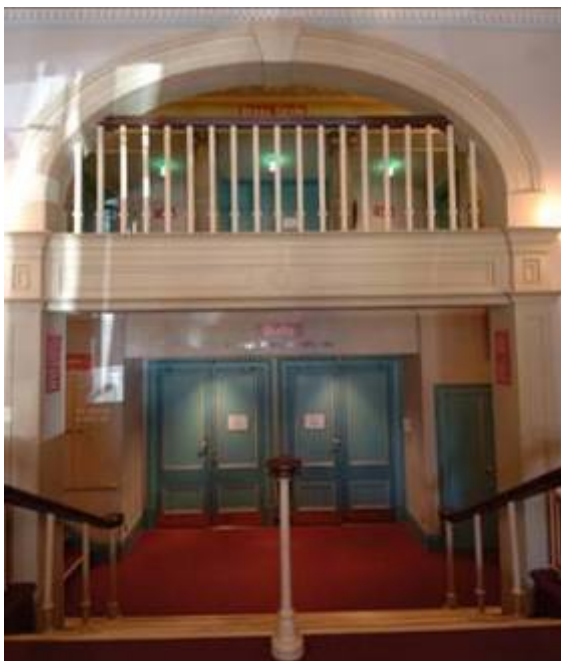
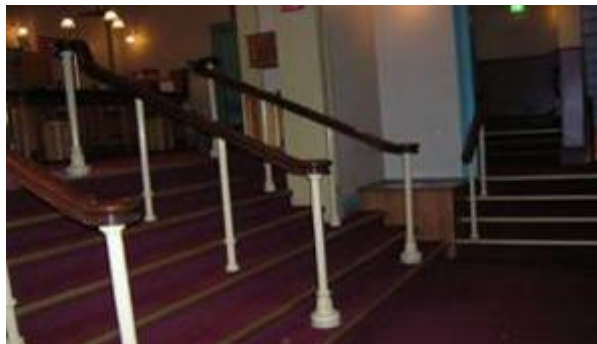
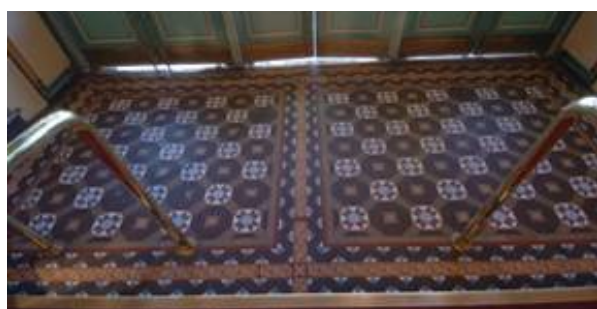
- **Entry Foyer (301-306, 310)**

Current concerns for the foyer area include: multiple levels, cramped size of foyer, poor signage and trip hazards of stairs and flashing light points on entrance stairs. Although the 1988-90 conservation works were carefully undertaken to recreate a suitable foyer interior, the upgrade did not address problems of cramped foyer space, and did not solve the problems of trip hazards and level changes.

- Install a foyer signage system that is visible to all patrons.
- In the short-term, continue to maintain finishes and fittings whilst devising more suitable and workable foyer space.

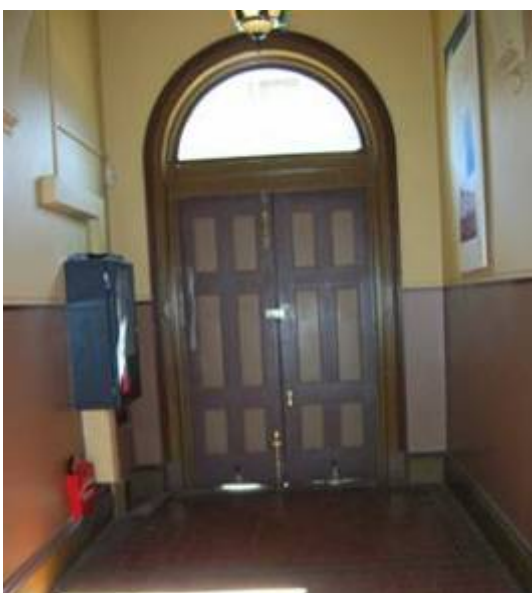
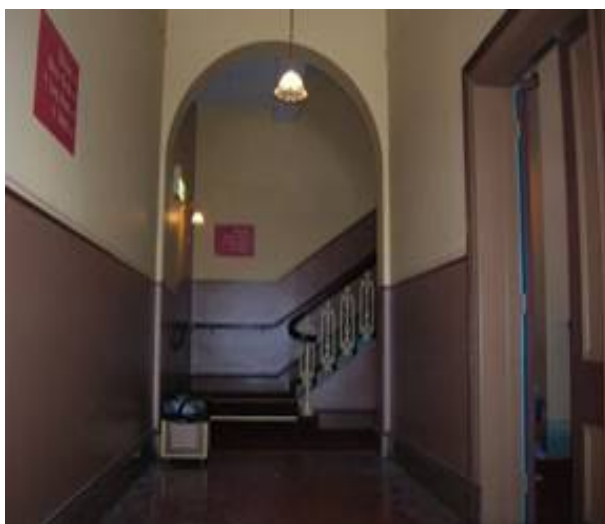
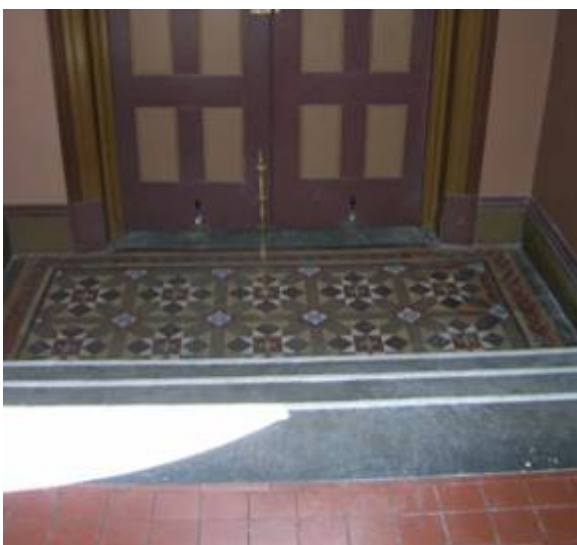
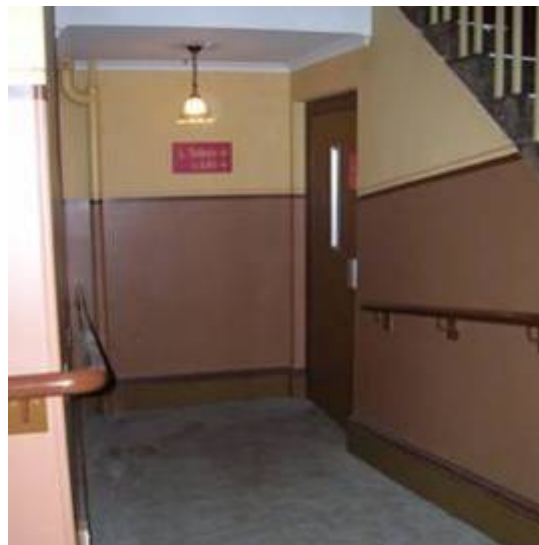
- **Side Passages and Staircases (307-309, 313-315)**

The side passages originally gave access to the different levels of the auditorium without connections through to the central foyer area (the adjoining spaces were given over for commercial purposes).

- Continue to maintain staircases and passages.
- Consider incorporation of the side passage floor space into the foyer space to increase the size of the foyer.
- Consider carpeting or placing a carpet runner and installing a 'protective rail' to protect wall and skirtings of southern passageway leading to disabled lifts (concrete floor area).
- Removal of the lift from the building (and associated ramping) is recommended and could be explored.

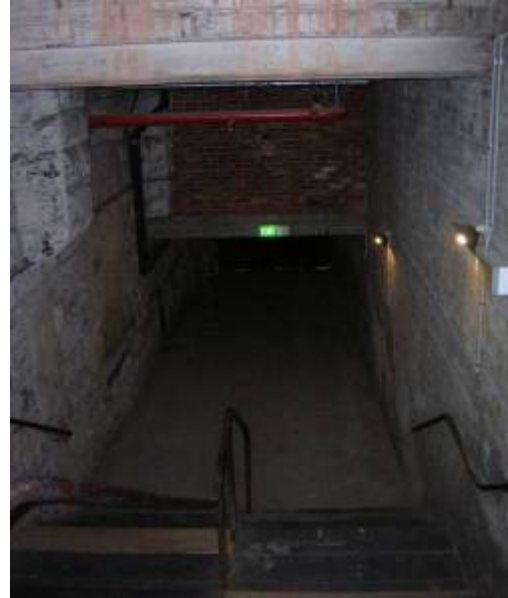
View of fire escape (121)

- The skillion is not original. It could therefore be expanded in size to provide more floor space adjacent to the stage.
- This area is already subject to a Permit Exemption Declaration and changes to this area are anticipated.

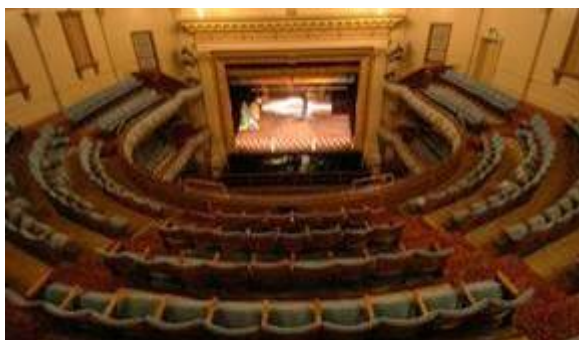
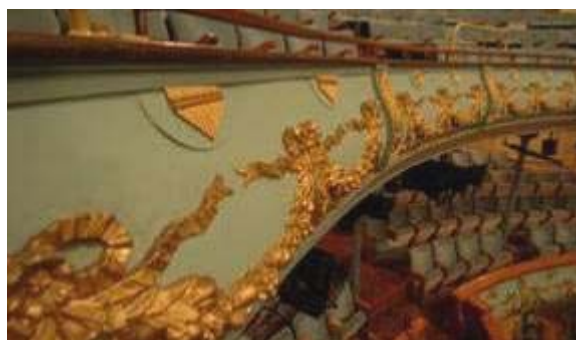
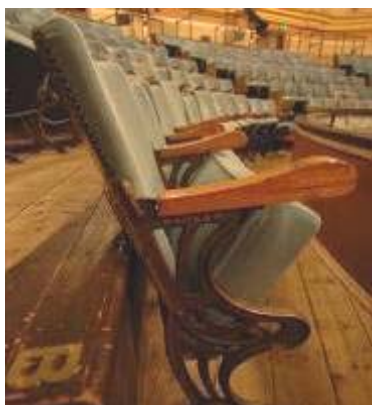
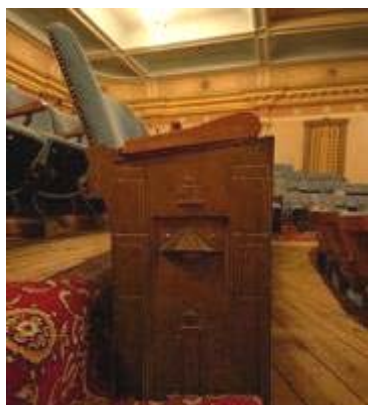
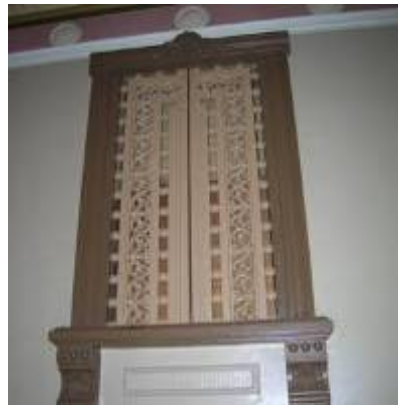
- **Balcony (503-504)**

The balcony level retains the original timber flooring, the earliest seats in the theatre and an encircling balcony which forms a lyre shape (hence the name 'lyric' theatre). The balustrade of the balcony appears to be low (height of 700 mm). Attempts have been made to address the safety issue of the balcony height by the installation of hand rails. The current hand rails were installed in 1988-90 and replaced flimsy handrails previously installed. An additional raised safety bar has been installed at the end of the aisles.

During the 1988-90 works, the standing room area at the rear was rebuilt and additional handrails were installed. As part of installation of air conditioning in 2003, the central bank of standing room was raised to allow for the installation of air conditioning equipment.

- Maintain and repaint as required in Paterson Brothers' colour scheme.
- Safety bar at the end of the aisles should be replaced with a bar with simple detailing more sympathetic to the theatre.

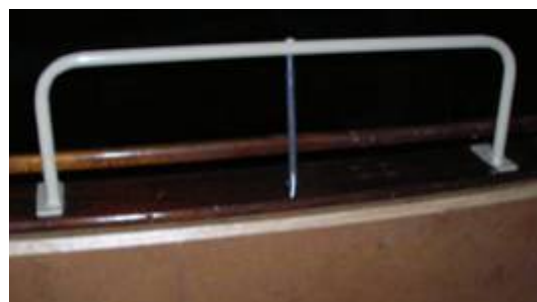
View of existing hand rail

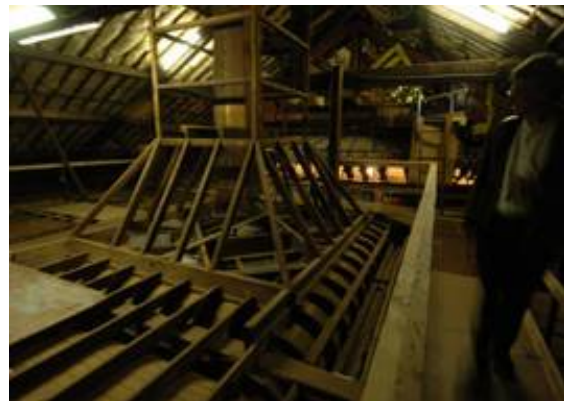
View of ventilation shaft
(Source of photo: Jeremy Bannister)

- Continue to maintain the roof space area.
- The opening mechanism for the old dome and associated equipment should be retained and conserved.
- Continue to maintain and conserve the ventilation shaft and other elements which date back to the original Browne and Pitt designs.

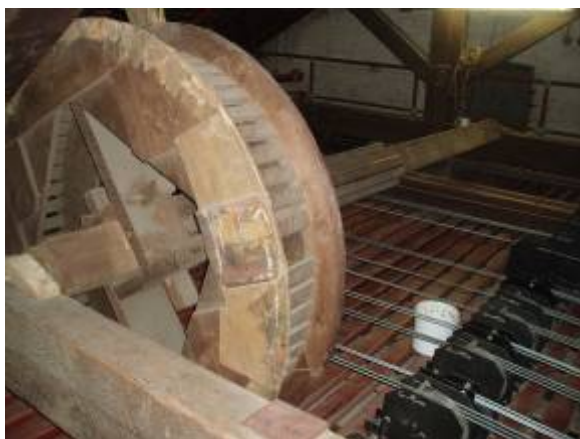
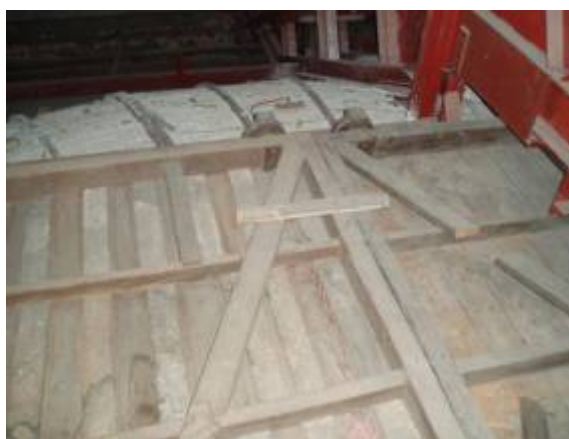
Views of mechanisms used to open Pitt's 1898 dome
