MCDUGALL & VINES

**HER MAJESTY'S THEATRE
BALLARAT**

**CONSERVATION MANAGEMENT
PLAN
October 2006**

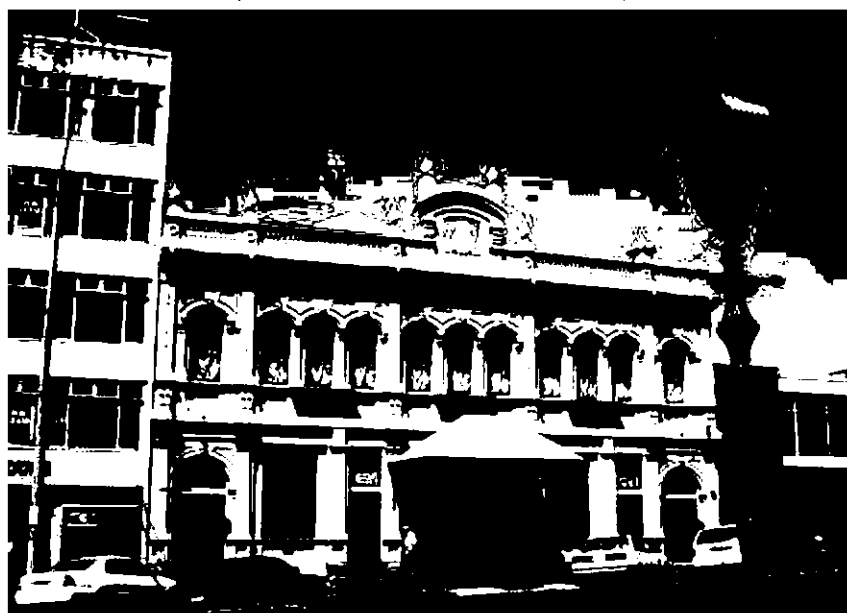
Current view of theatre in 2006

The front façade is rendered and is in excellent condition. Most of the façade comprises 1874 and 1898 detailing (either original or reconstructed). Numerous changes have been made to the front façade over time. The recent 1988-90 conservation works have successfully reinstated the c1912 portico (which was removed c1940), the parapet details and associated stucco ornamentation and the ground floor opening configurations.

Concerns have been expressed about heaviness of front entrance doors, trip hazards of central and left hand entrance doors (white painted line to assist with definition) and width of crossover bluestone gutter.

- The front façade needs to be regularly maintained with regular repainting of the colour schedule as devised by Wendy Jacobs in the 2001 façade conservation works.
- Reinststate cast iron balconettes to the windows.
- Current concerns could be addressed by exploring alternative door mechanisms and possible grading of external footpath (although this would impact on the glass bricks positioned at the entrance threshold).
